Date : 09/08/2021  
Project No : 2021C074  
Client Company : DR Horton West  
Arrival Time : 09/08/2021 08:30  
Onsite Hours : 01:30

ASEC Report ID : 33870  
Name of the Project : Oakhurst Glen - Ph 4  
Project Location : Mallord Drive, South Fulton, GA  
Weather : Partly cloudy  
Departure Time : 09/08/2021 10:00  
ASEC Technician Name : Christopher Burrow II

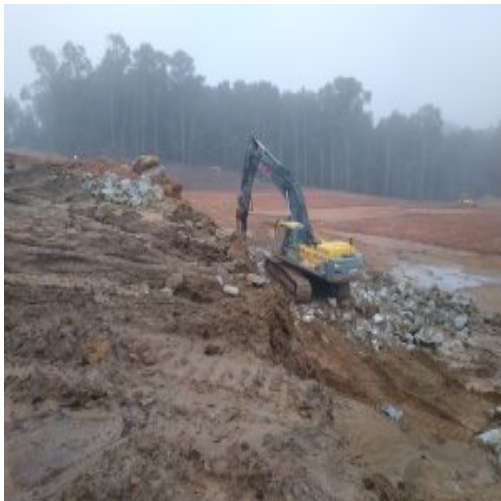
Rock Breaking on site.

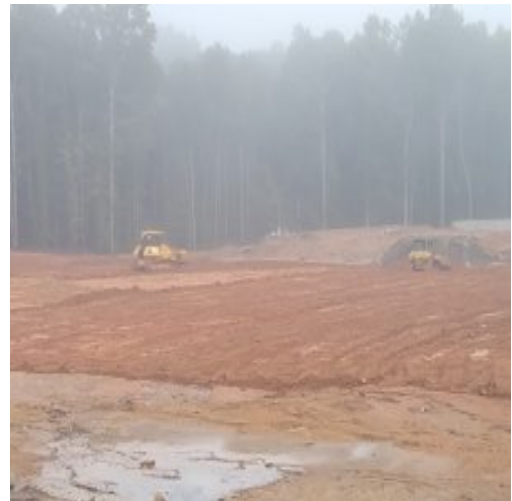
Turning up soil to dry it for future filling.

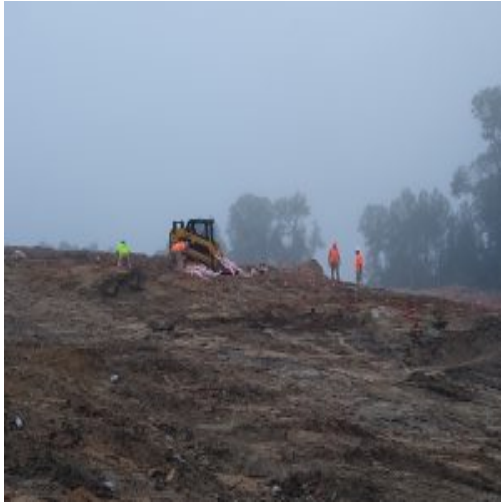
Precision blasting preparing for rock blasting.
