Date : 09/09/2021  
Project No : 2021C074  
Client Company : DR Horton West  
Arrival Time : 09/09/2021 13:30  
Onsite Hours : 03:00

ASEC Report ID : 33914  
Name of the Project : Oakhurst Glen - Ph 4  
Project Location : Mallord Drive, South Fulton, GA  
Weather : Partly Cloudy  
Departure Time : 09/09/2021 16:30  
ASEC Technician Name : Christopher Burrow II

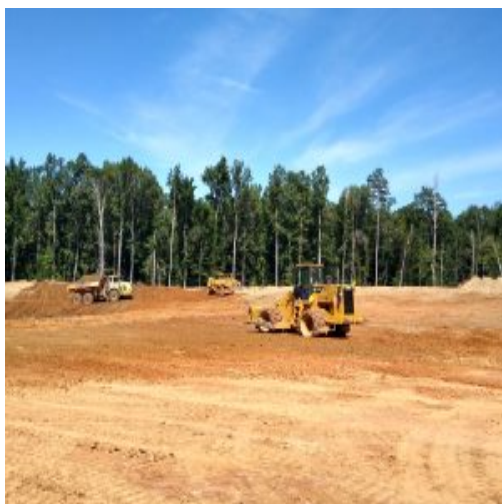
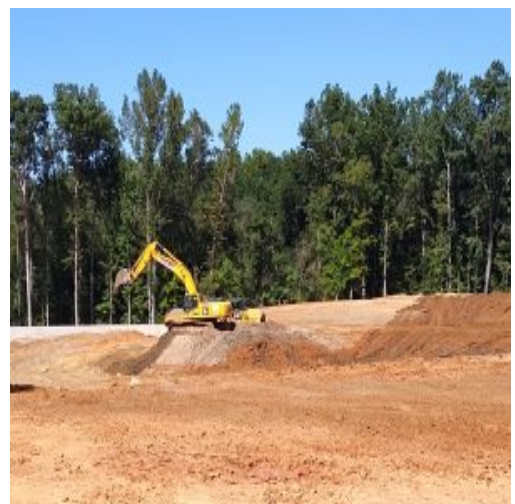
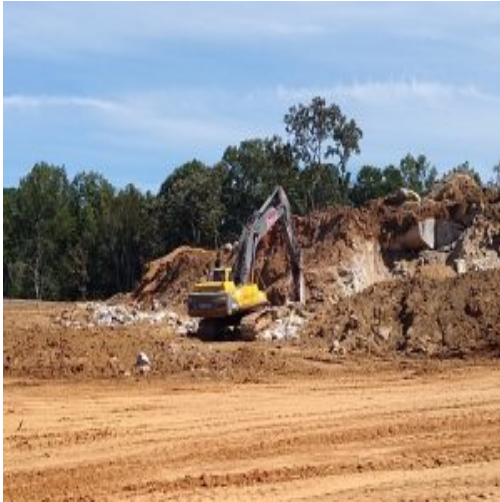
As requested, a ASEC Inspector was present at the above referenced site for the purpose of observing the placement of structural fill at the area of lots 346 through 347 and 291 through 292 approximate size 50 feet by 200 feet. Based on review of guidelines for fill placement, the required compaction for structural fill at the above mentioned area is 95 % of standard proctor. Fill was placed in 8 to 12 inch thick lifts and compacted using CAT 815F sheepsfoot compactor(weight; 45,757 lbs.).

Based on density testing, the fill placed today at elevations between approximately -6 feet and -5 feet below finished grade was compacted according to fill placement guidelines. See attached density test results for more details.

- Rock Breaking on site is continued.
- Removing piles of unsuitable soils on property and placing it in green areas and fill slopes.

ASEC recommends sealing of the surface of placed fill from inclement weather and maintain the positive drainage.
