Date : 09/14/2021  
Project No : 2021C074  
Client Company : DR Horton West  
Arrival Time : 09/14/2021 08:30  
Onsite Hours : 04:00

ASEC Report ID : 34003  
Name of the Project : Oakhurst Glen - Ph 4  
Project Location : Mallord Drive, South Fulton, GA  
Weather : Partly cloudy  
Departure Time : 09/14/2021 12:30  
ASEC Technician Name : Christopher Burrow II

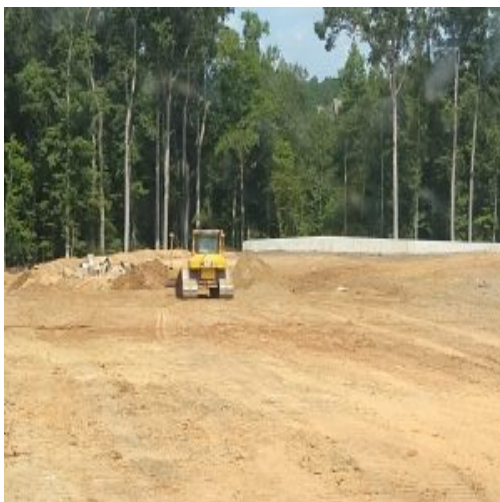
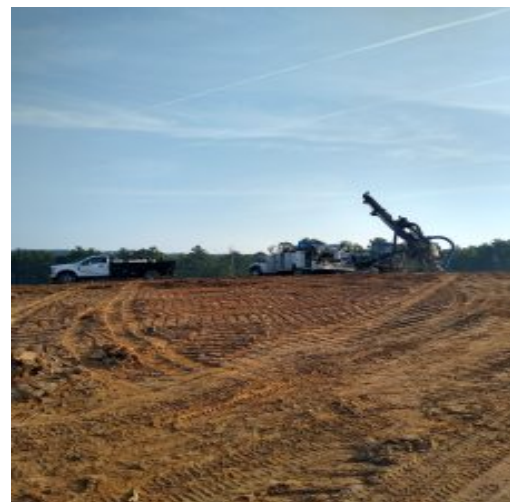
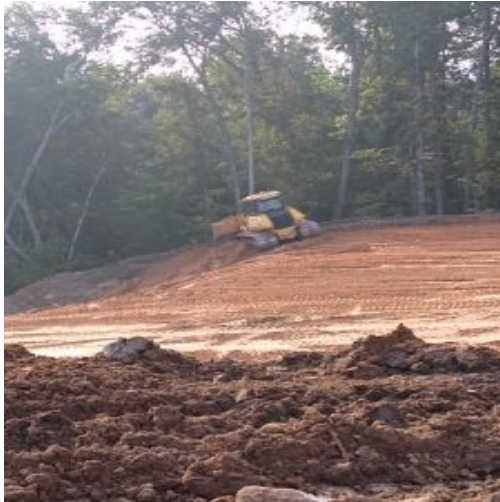
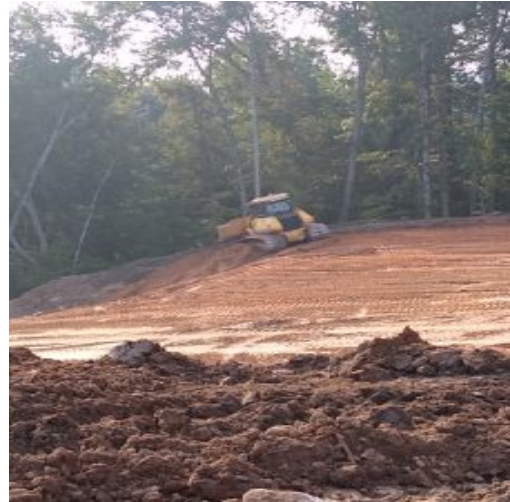
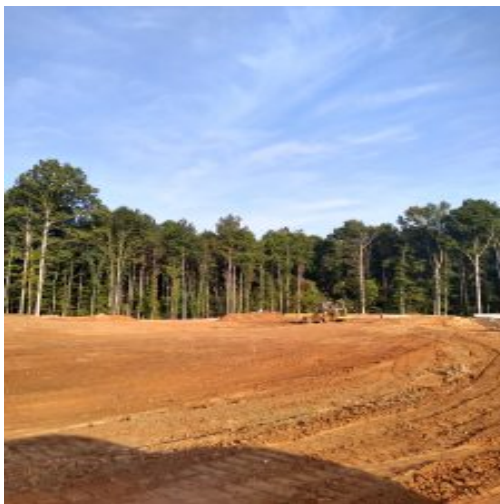
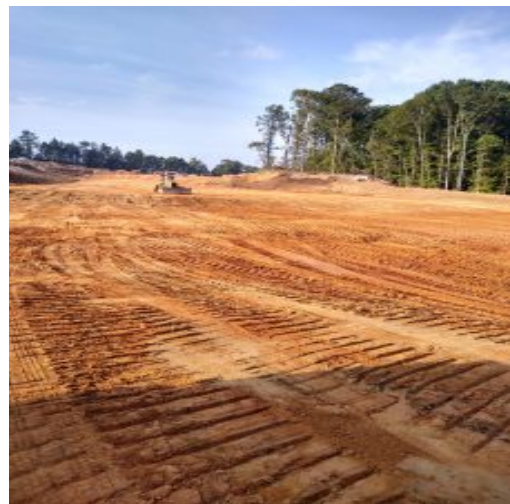
As requested, a ASEC Inspector was present at the above referenced site for the purpose of observing the placement of structural fill at the area of lots 292 through 294 approximate size 40 feet by 100 feet. Based on review of guidelines for fill placement, the required compaction for structural fill at the above mentioned area is 95 % of standard proctor. Based on visual observation and field measuring, the fill was placed in 8 to 12 inch thick lifts and compacted using CAT 815F sheepsfoot compactor(weight; 45,757 lbs.).

Based on density testing, the fill placed today at elevations between approximately -6 feet and -5 feet below finished grade was compacted according to fill placement guidelines. See attached density test results for more details.

- Continuing to move unsuitable soils.
- Preparation for oncoming rain on site.

ASEC recommends sealing of the surface of placed fill from inclement weather and maintain the positive drainage.
