Date : 09/15/2021  
Project No : 2021C074  
Client Company : DR Horton West  
Arrival Time : 09/15/2021 08:30  
Onsite Hours : 04:30

ASEC Report ID : 34014  
Name of the Project : Oakhurst Glen - Ph 4  
Project Location : Mallord Drive, South Fulton, GA  
Weather : partly cloudy/slight rain  
Departure Time : 09/15/2021 13:00  
ASEC Technician Name : Christopher Burrow II

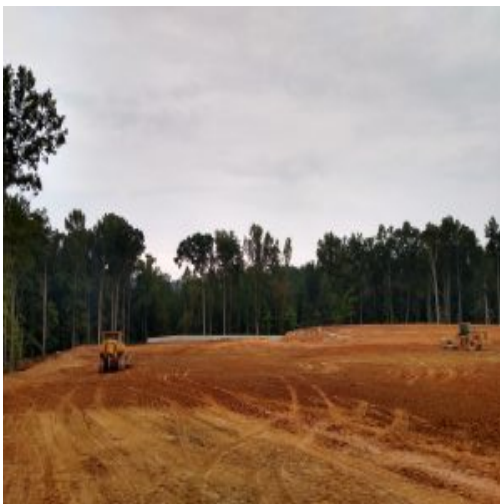
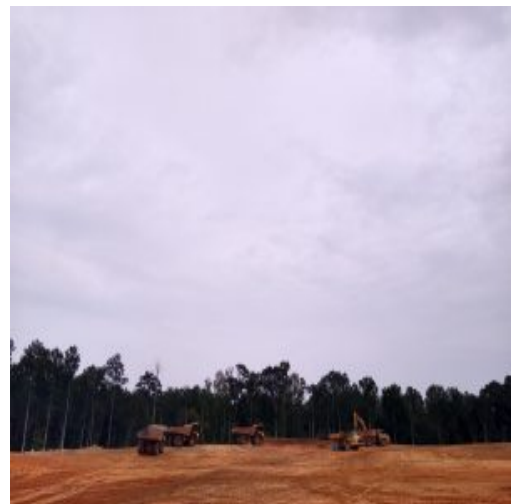
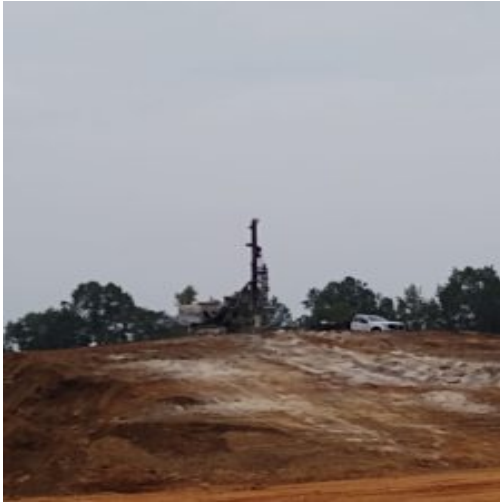
As requested, a ASEC Inspector was present at the above referenced site for the purpose of observing the placement of structural fill at the area of lots 293 through 296 and lot 347 approximate size 200 feet by 210 feet. Based on review of guidelines for fill placement, the required compaction for structural fill at the above mentioned area is 95 % of standard proctor. Based on visual observation and field measuring, the fill was placed in 8 to 12 inch thick lifts and compacted using CAT 815F sheepsfoot compactor(weight; 45,757 lbs.).

Based on density testing, the fill placed today at elevations between approximately -3 feet and -3 feet below finished grade was compacted according to fill placement guidelines. See attached density test results for more details.

- precision blasting continued drilling on site.

ASEC recommends sealing of the surface of placed fill from inclement weather and maintain the positive drainage.
