Date : 04/18/2023  
Project No : 2023C111  
Client Company : 2MATL  
Arrival Time : 04/18/2023 08:00  
Onsite Hours : 02:00

ASEC Report ID : 58700  
Name of the Project : DOA Fiber Infrastructure Improvements  
Project Location : HJAIA  
Weather : Sunny  
Departure Time : 04/18/2023 10:00  
ASEC Technician Name : Isaac Davis

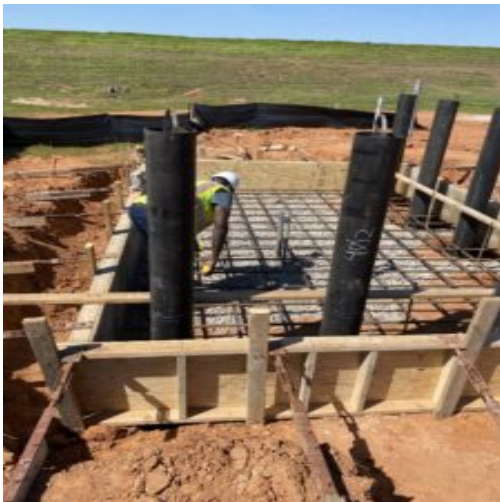
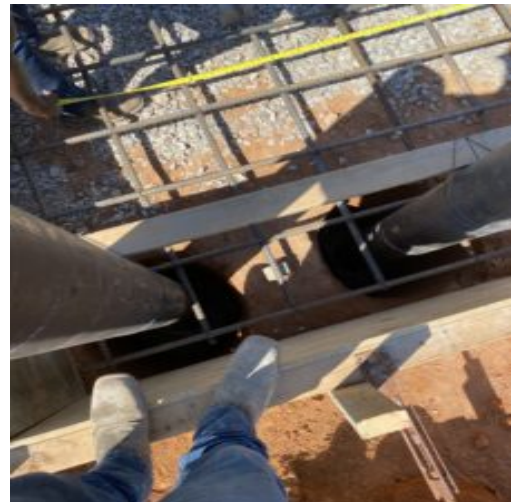
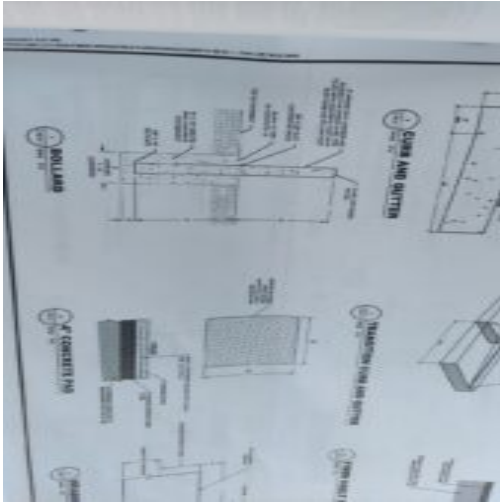
- The writer arrived on site to verify the subgrade for the proposed vault 2 generator pad. The generator pad is a 16' 8" X 11' 8" section and was excavated to proposed bottom of concrete elevation at this time.
- While probing the ground within the footprint, the writer noted approximately 11 feet 8 inches X 5 feet section on the north side, loose to a depth of approximately 4 to 6 inches.
- The writer recommended this area be remediated by removing the top 6-inches of this section and replacing it with structural fill or #57 stone.
- The contractor chose to replace the under-cut section with # 57 stone. The subgrade is now acceptable and ready for rebar installation.
- The form work and the bottom mat of the pad are being installed.
