Date : 03/22/2024  
Project No : 2024C112  
Client Company : SR Homes  
Arrival Time : 03/22/2024  
Onsite Hours :

ASEC Report ID : 65730  
Name of the Project : Sterlington  
Project Location : Canton  
Weather : overcast  
Departure Time : 03/22/2024  
ASEC Technician Name : Russell Hendrix

**Location:** Sterlington Entrance, St. 1+25 to 2+00

## Daily Field Report

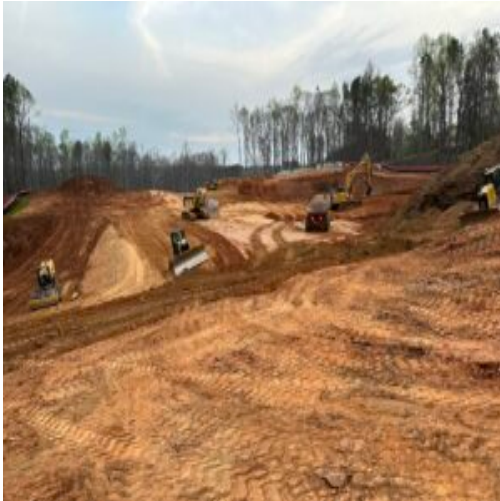
**Summary:** Upon arrival at the site, compaction work was ongoing at the entrance section of Sterlington from St. 1+25 to 2+00, including the area designated for the future roadway. Compaction was being carried out using a ride-on vibratory sheepsfoot. A Troxler 3430, with serial number 30942, was employed to test the compaction.

section worked at entrance

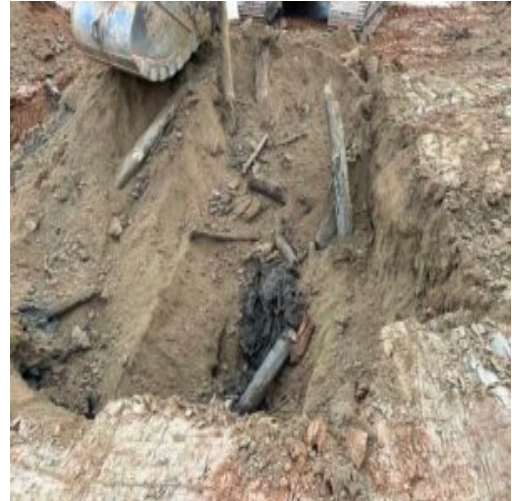
**Excavation:** An excavation was initiated near the entrance after movement was detected at the future roadway, specifically at St. 1+00 at minus 13 elevation. Upon exploration, a previous buried pit measuring approximately 50 feet x 40 feet x 10 feet deep was uncovered. Buried organics were found in this area. The area has been refilled with quality structural material, with the surplus material currently stored onsite. The intention is to sift through this material to eliminate sizable stumps and large organic matter. The finer material will be distributed over the site as topsoil, while the larger organic pieces will be transported offsite.

organics found

**Inclement Weather:** As a rain event commenced, the full extent of the buried pit could not be determined. Further exploration of buried material was deferred to another day. After removing the exposed organics, the excavation was backfilled to prevent damage from the rain.

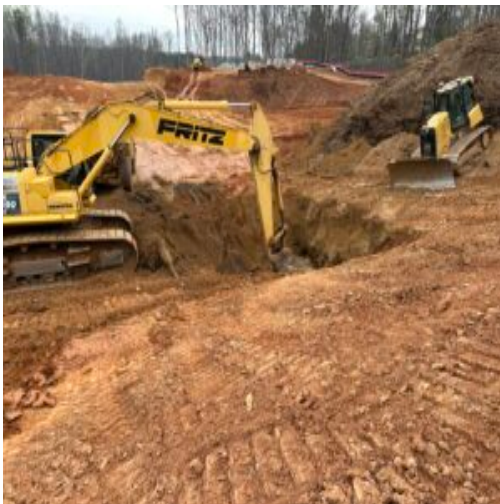
burry pit found

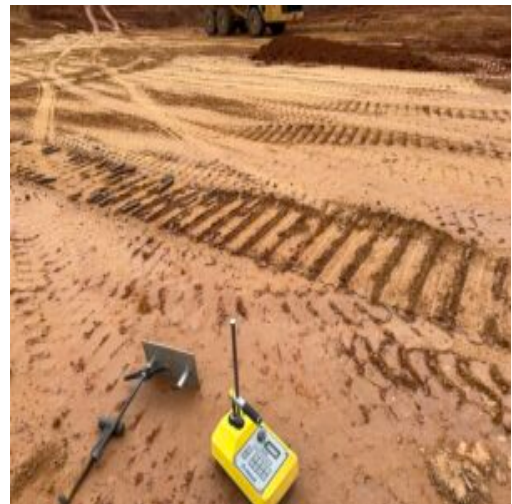
**Test Results:** The first test yielded unsatisfactory results, with a Dry Density of 79.4 and Moisture of 33%. This lower compaction and higher moisture content were attributed to a previous rain event.

testing at entrance future road st. 1+75

**Action Taken:** A discussion was held with the site foreman, and the soils were scarified to lower the moisture content. No further compaction was conducted on that day.

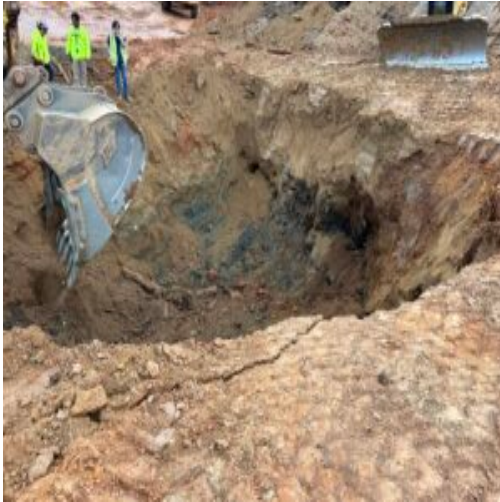
burry pit exploration
