Date : 07/13/2026  
Project No : 2025C215  
Client Company : Artisan  
Arrival Time : 07/13/2026 07:30  
Onsite Hours : 06:00

ASEC Report ID : 96204  
Name of the Project : NW Unit 4 Parkway Ext. Phase 1  
Project Location : Dallas  
Weather : cloudy  
Departure Time : 07/13/2026 13:30  
ASEC Technician Name : Clyde Smith

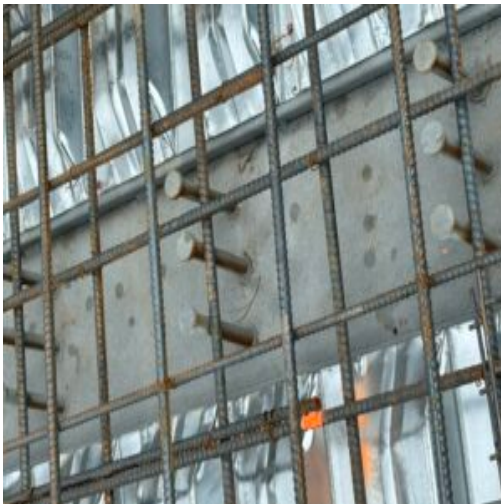
The writer also also observed the Wall contractor installing reinforcing steel at bridge panels.

Observation of reinforcing steel being installed at bridge panels

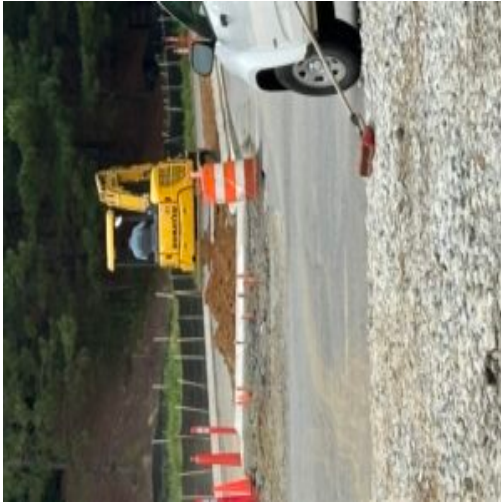
Also the writer observed the Grading contractor backfilling poured curbing at round about.

Backfill at round about curbing

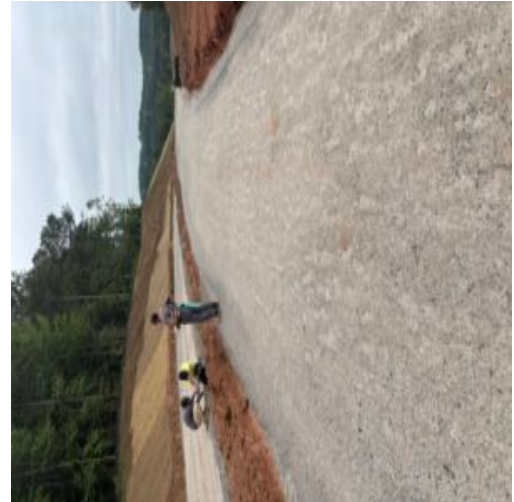
Paving contractor installing grade stakes at  
Nature Walk

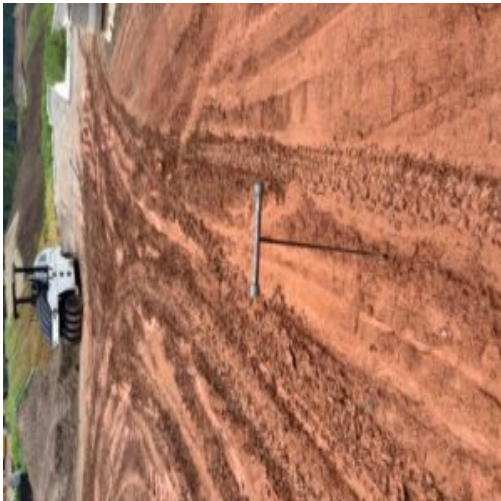
On the above date the writer was onsite as requested and met with the Paving contractor (NWGP) to observe sub grade and sub base conditions after recent rain event. The remaining sub grade approximately 150' both sides of roadway appeared too wet with rutting observed from sub contractors traffic. With additional rain forecasted for today it was decided not to repair and place additional base stone on today. The Paving contractor reminded onsite setting grade stakes and blading roadway.

Observation of sub grade after rain event at Nature  
Walk
