Date : 06/04/2026  
Project No : 2026C101  
Client Company : Artisan  
Arrival Time : 06/04/2026 08:00  
Onsite Hours : 07:00

ASEC Report ID : 95095  
Name of the Project : Seven Hills PHASE 13, UNIT 4 Lots  
Project Location : Dallas  
Weather : sunny  
Departure Time : 06/04/2026 15:00  
ASEC Technician Name : Samara Simha Reddy Kandi

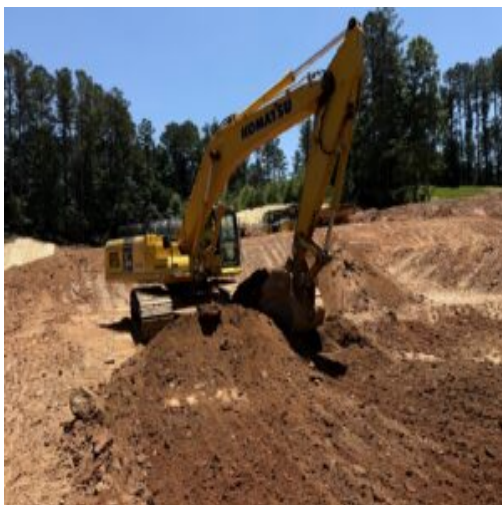
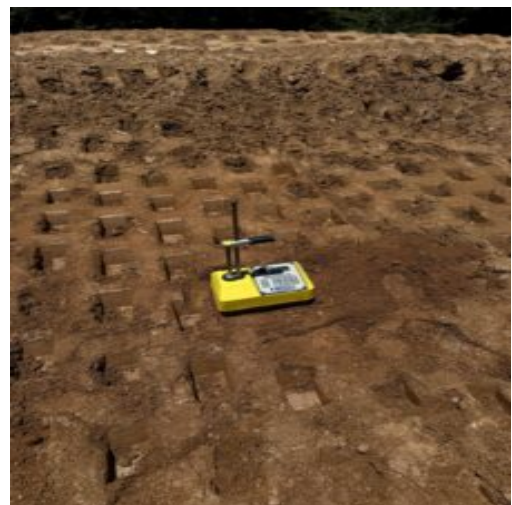
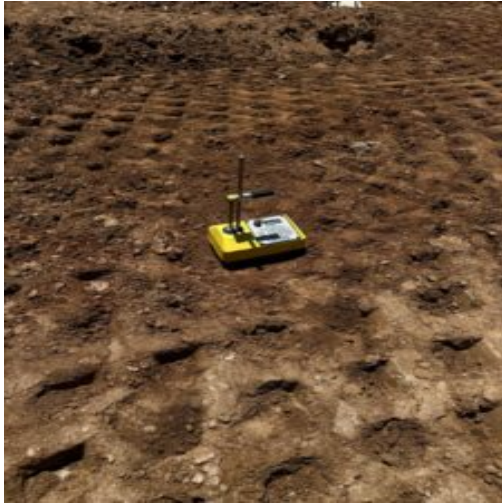
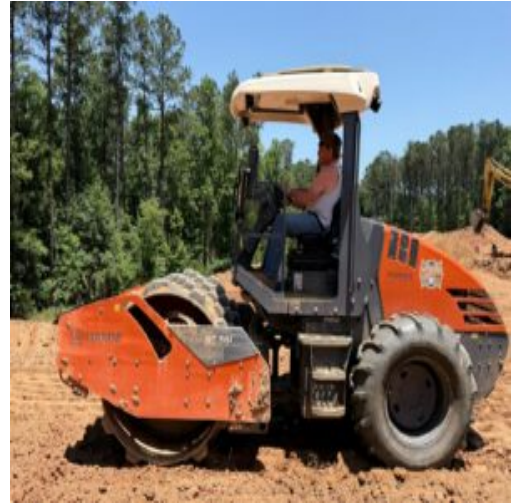
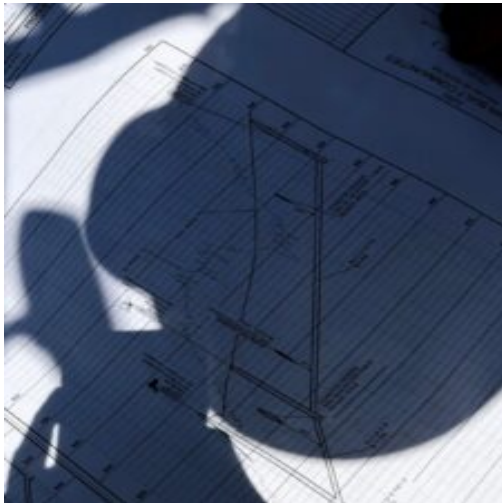
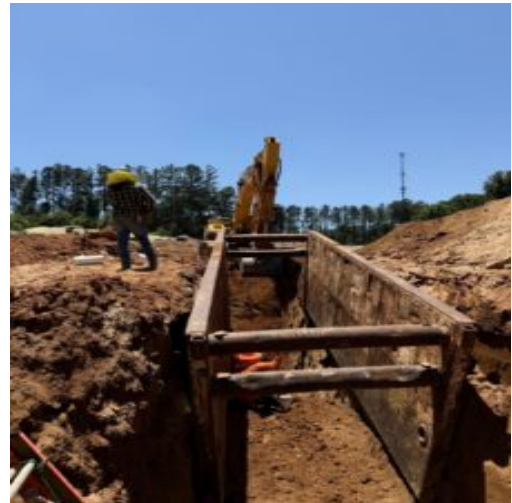
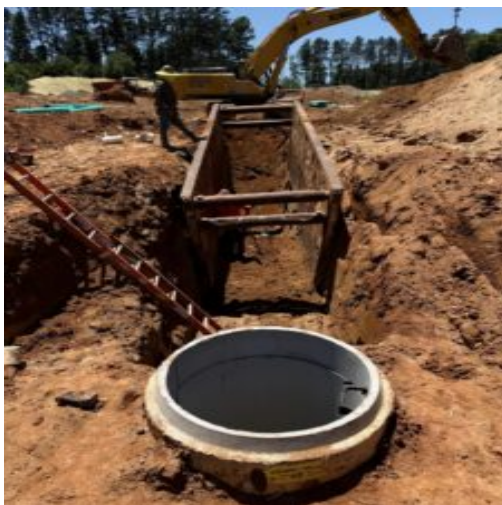
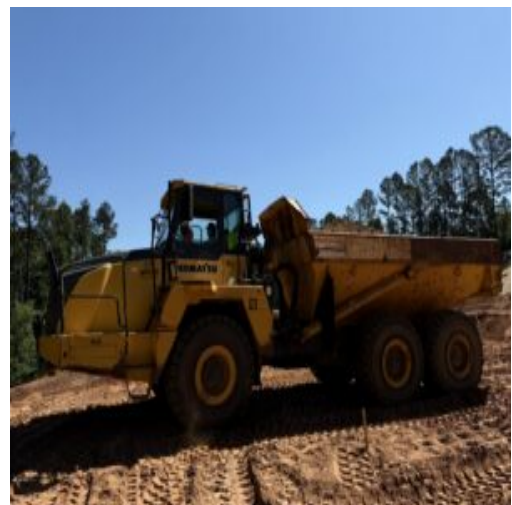
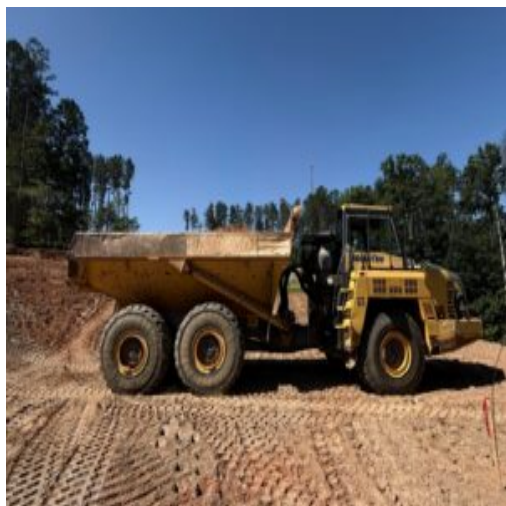
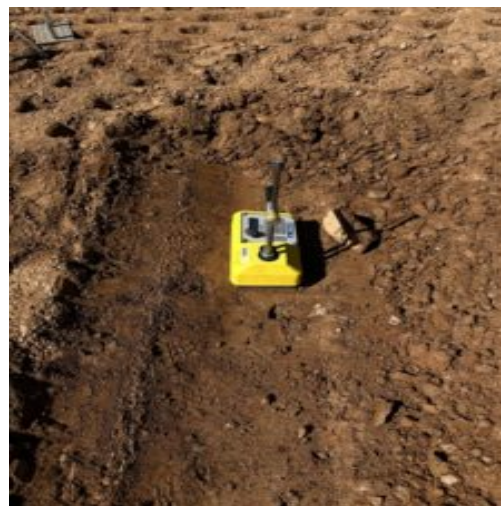
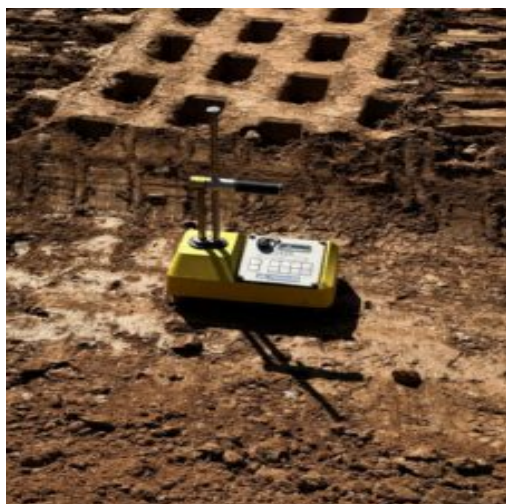
At Lots #26, 27, and 28, density tests were performed and failed to meet the required compaction. A proof-roll was subsequently performed, during which movement was observed throughout all three pads. The subgrade soils exhibited pumping and rutting, indicating excessive moisture within the fill material. In response, the crew undercut approximately 1 foot of material from the affected areas to facilitate aeration and drying efforts. The exposed material was reworked using a sheep-foot roller, while loaded trucks were utilized to assist in kneading and proof-rolling the areas. Due to the wet conditions, the pads were left exposed to dry for the remainder of the day. Backfilling and re-compaction operations are scheduled to continue on the next working day once acceptable moisture conditions are achieved.

At Lots #33, 34, and 35, the crew performed cut operations to bring the pads down to the required design elevations, the exposed material was then reworked and compacted using a sheep-foot roller to prepare the areas for subsequent construction activities.

Elsewhere on site, the crew continued sewer installation from Manhole Z10 toward Manhole Z11. The trench subgrade was trimmed and leveled to the required line and grade, and No. 57 stone bedding was placed. Installed 8" PVC pipe and following pipe installation, approximately 8 inches of loose backfill material was placed above the pipe; however, the material had not yet been compacted at the time of observation.
