Date : 07/16/2026  
Project No : 2026C125  
Client Company : Lewis Contracting  
Arrival Time : 07/16/2026 08:00  
Onsite Hours : 04:00

ASEC Report ID : 96218  
Name of the Project : Pittman Park - Garibaldi St. Stormwater  
Project Location : Atlanta  
Weather : cloudy  
Departure Time : 07/16/2026 12:00  
ASEC Technician Name : Clyde Smith

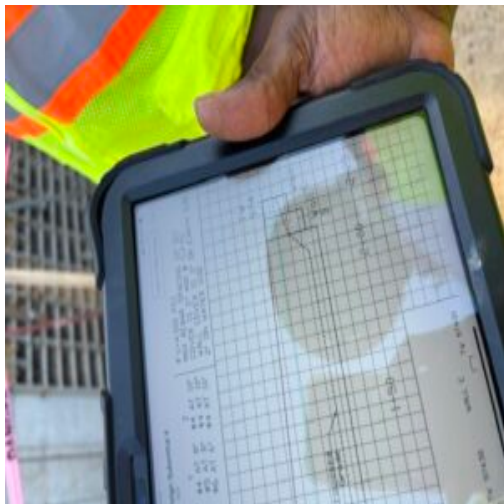
Observed wall location

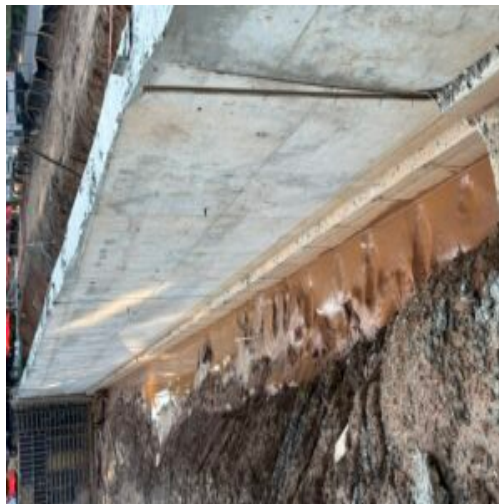
Existing observed conditions at inside wall

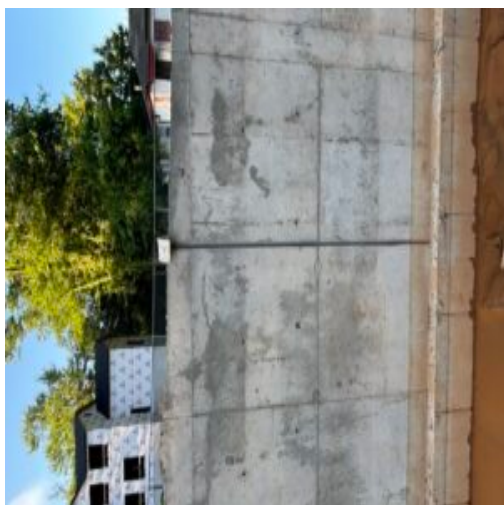
Existing observed outside wall conditions
