Date : 07/09/2026  
Project No : 2026C101  
Client Company : Artisan  
Arrival Time : 07/09/2026 08:00  
Onsite Hours : 04:00

ASEC Report ID : 96064  
Name of the Project : Seven Hills PHASE 13, UNIT 4 Lots  
Project Location : Dallas  
Weather : sunny  
Departure Time : 07/09/2026 12:00  
ASEC Technician Name : Samara Simha Reddy Kandi

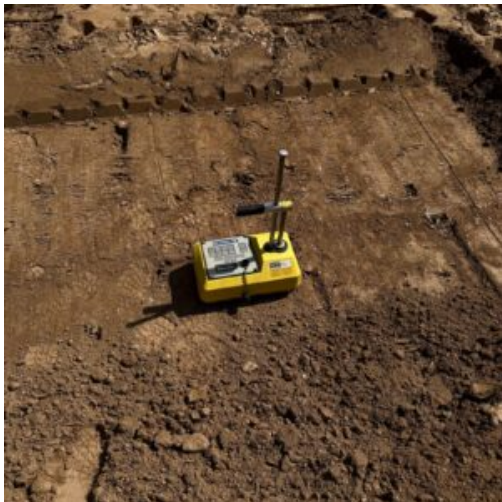
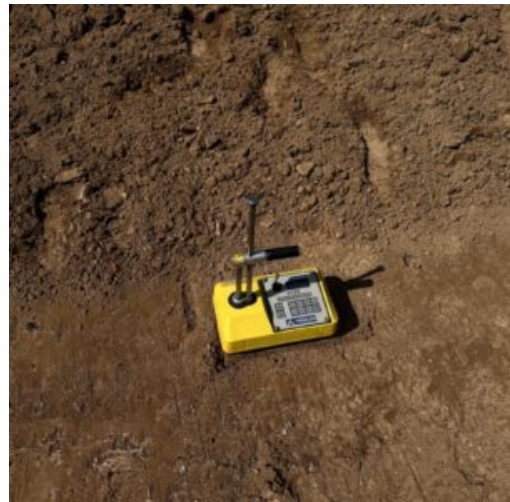
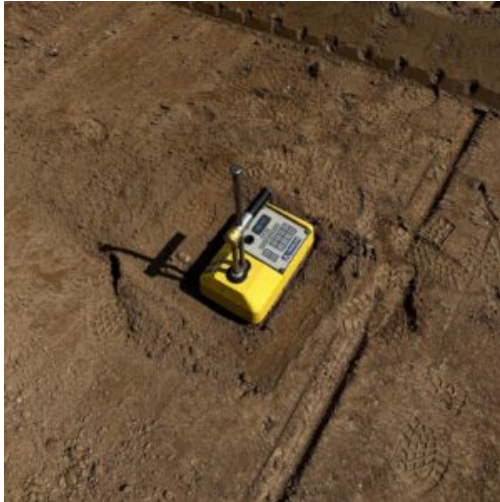
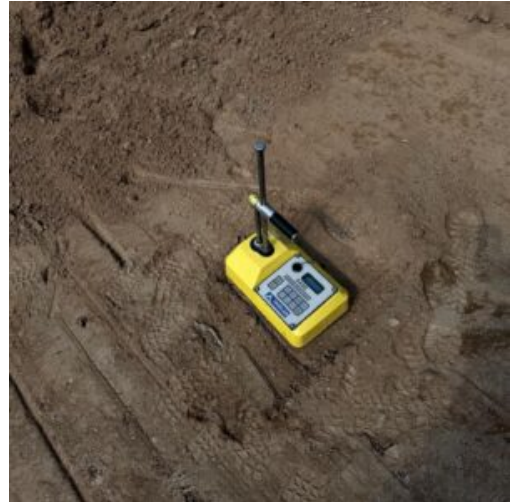
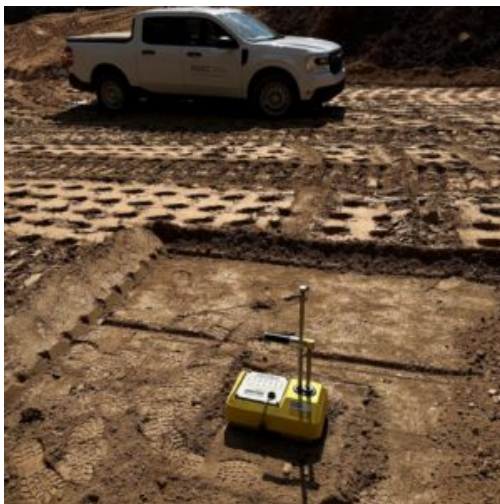
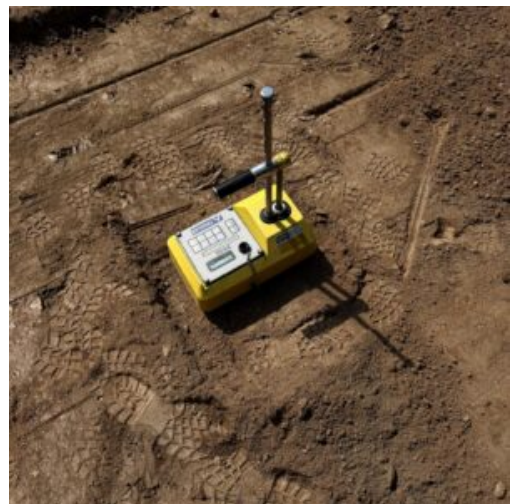
At Lots 29 and 30, the crew continued fill placement and compaction activities. Fill material was placed, spread, and leveled to provide a uniform lift before being compacted using a sheep foot roller. Multiple roller passes were made across the lot areas to achieve consistent compaction. I observed the placement and compaction operations and performed in-place density testing at selected locations within both lots. The density test results met the required project compaction specifications at the locations tested. The compacted fill appeared firm, uniform, and stable at the time of inspection.

In-place density tests were performed on the backfill between SSMH Z19.1 and SSMH Z19.2. The test results met the required project compaction criteria at the locations tested.
