Date : 07/27/2026  
Project No : 2025C214  
Client Company : Artisan  
Arrival Time : 07/27/2026 06:30  
Onsite Hours : 06:00

ASEC Report ID : 96467  
Name of the Project : NW Unit 4 BRIDGE (Materials Testing)  
Project Location : Dallas  
Weather : cloudy  
Departure Time : 07/27/2026 12:30  
ASEC Technician Name : Clyde Smith

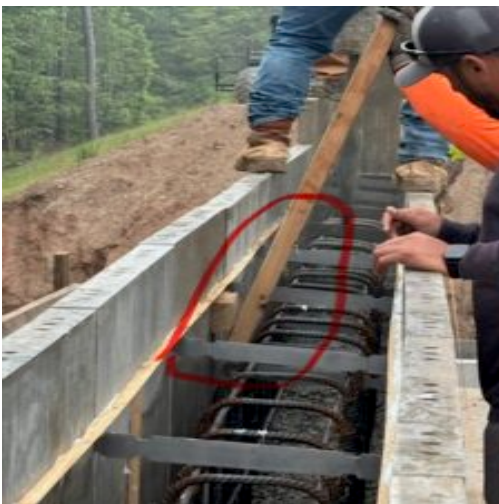
Observing clearance discrepancies corrected

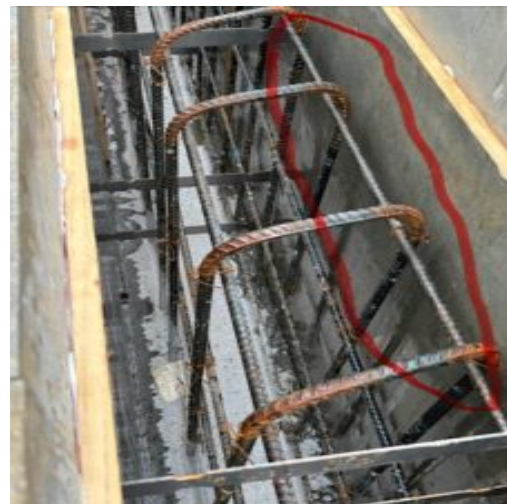
Showing discrepancies

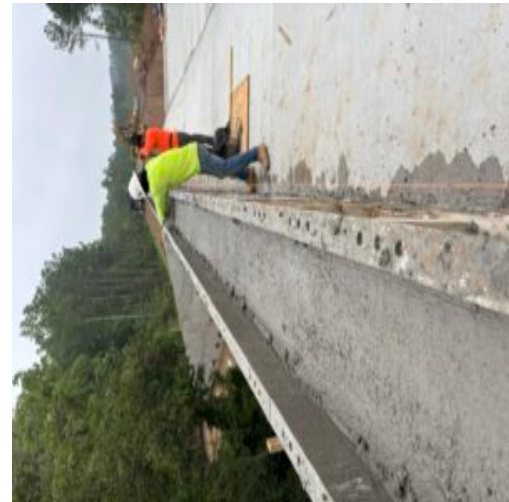
Poured barrier wall

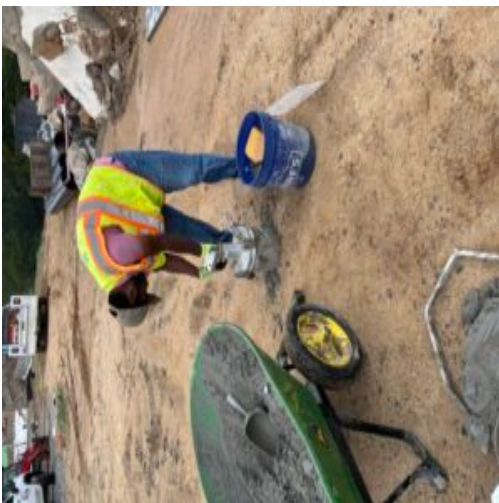
Sampling concrete

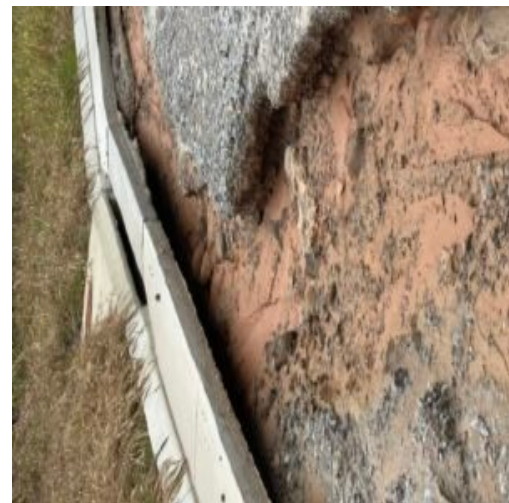
The writer observed subbase stone at Naturewalk parkway phase 1 after a severe rain event. Severely eroded reels were observed at both sides of the curb lines which will require repairs. Also, several manhole structures were filled with washed silt, and some previous poured curbs were undermined requiring repairs. The writer recommended filling deep eroded reels with full depth GAB stone.

Erosion at existing poured curbing

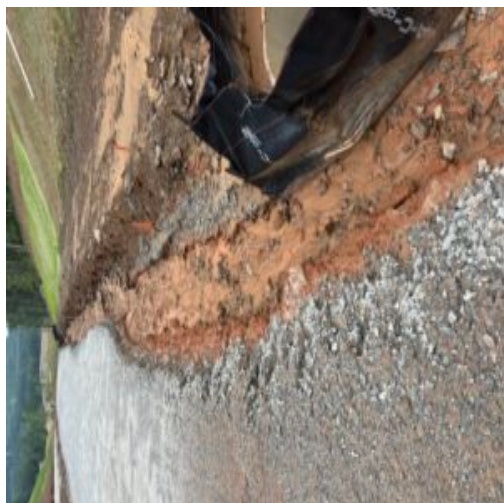
Eroded reels at curb lines

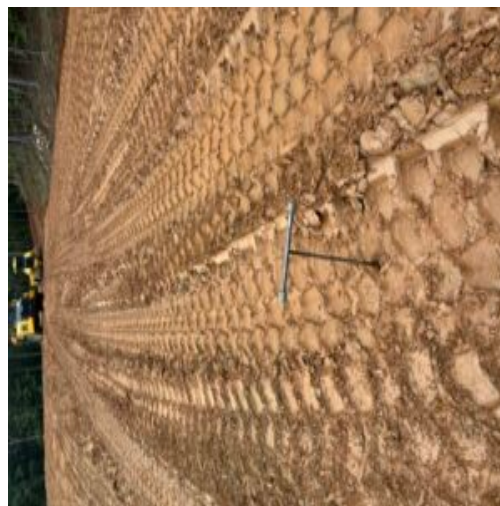
The writer observed the grading contractor placing fill for Unit 4 Phase 3 being placed over saturated surface soils within the top two feet of subgrade between Lots #133 and 134. It was recommended that fill placement should not continue with the severe rutting conditions that now exist.

Observation at fill placement at Unit 4 Phase 3,  
recommended to stop

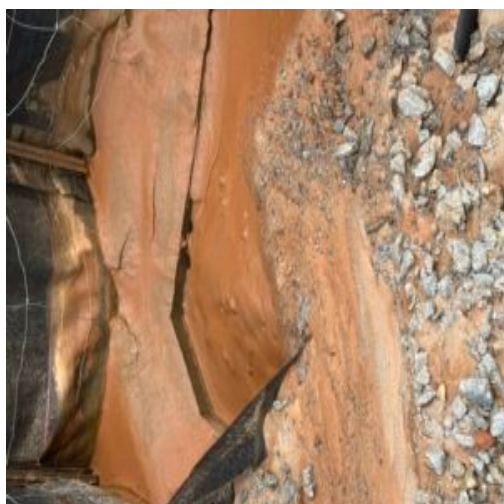
Filled manhole with wash silt

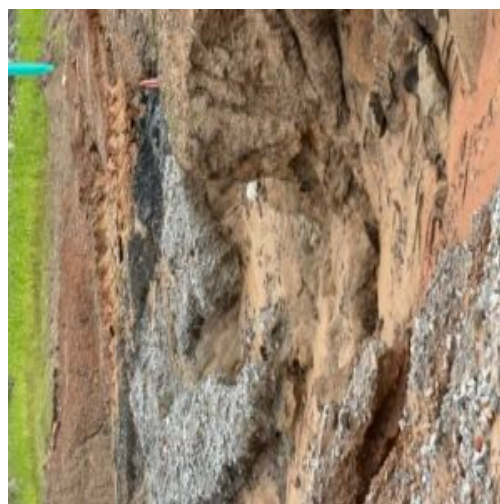
Existing eroded conditions at Nature Walk parkway
