Date : 07/16/2026  
Project No : 2026C125  
Client Company : Lewis Contracting  
Arrival Time : 13:30  
Onsite Hours : N/A

ASEC Report ID : 96227  
Name of the Project : Pittman Park - Garibaldi St. Stormwater  
Project Location : Atlanta  
Weather : Clear / Sunny  
Departure Time : 16:00  
ASEC Technician Name : Ramchandra Mogulla

AS Engineering and Consulting, LLC (ASEC) conducted a site visit on July 16, 2026, to perform a visual evaluation of reported cracking in the cast-in-place reinforced concrete retaining wall at Pittman Park Garibaldi Street Stormwater project in Atlanta. The purpose of the visit was to observe the nature, extent, and apparent characteristics of the reported cracking and to provide an engineering opinion based on the conditions observed at the time of the inspection.

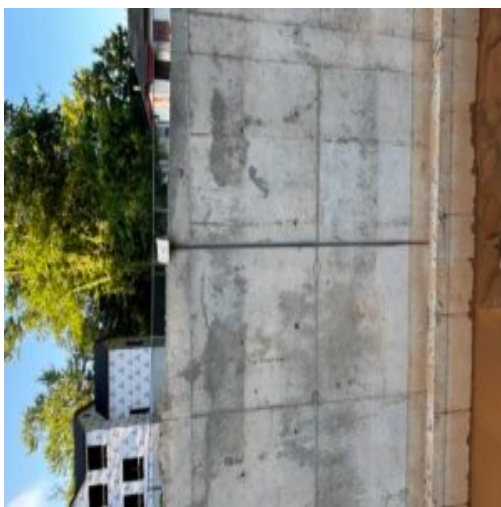
Vertical hairline crack

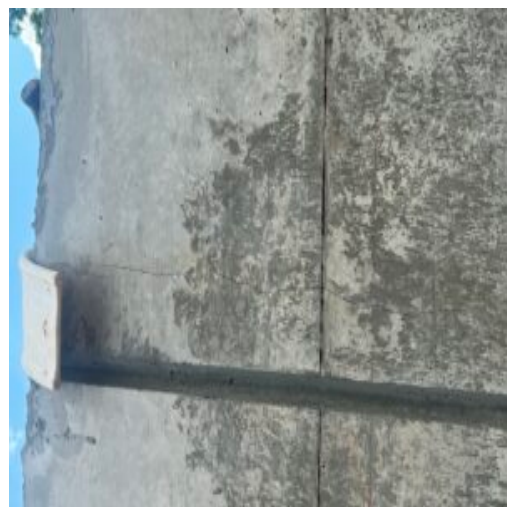
Vertical crack in the vicinity of the control joint

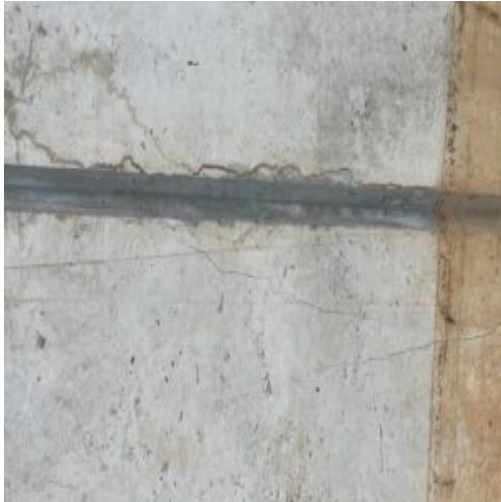
Vertical hairline crack
