ASEC Report ID : 96326  
Name of the Project : NW Unit 4 Parkway Ext. Phase 1  
Project Location : Dallas  
Weather : cloudy  
Departure Time : 07/21/2026 14:30  
ASEC Technician Name : Clyde Smith

As requested, the site was visited by our AS Engineering and Consulting (ASEC) representative for the purpose of providing quality control inspection and testing services. Visual observation techniques were employed to verify compliance with project drawing/specifications, applicable codes, and materials submittals. The following observations were observed on site this day.

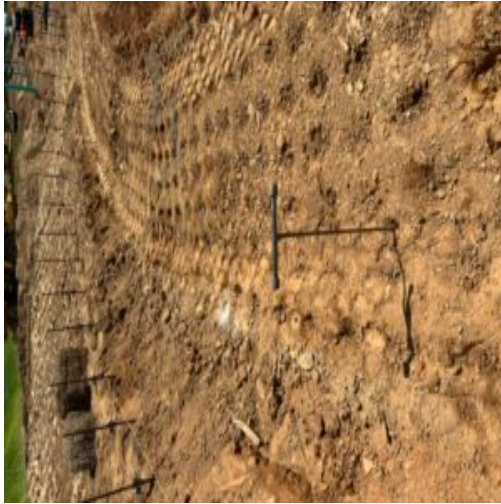
The curbing contractor J&W was onsite at Seven Hills phase 13 setting up for a curbing pour at the roadway past the gas line crossing. The writer observed subgrade soils by probing using a 3/8" diameter rounded end steel rod. Most areas observed appeared to be above optimum moisture contents with estimated in-place compaction results ranging from 90% to 92%. The contractor has elected to pour curbing at these current conditions.

Probing sub grades at roadway curbing with estimated compaction efforts of 90% to 92%.

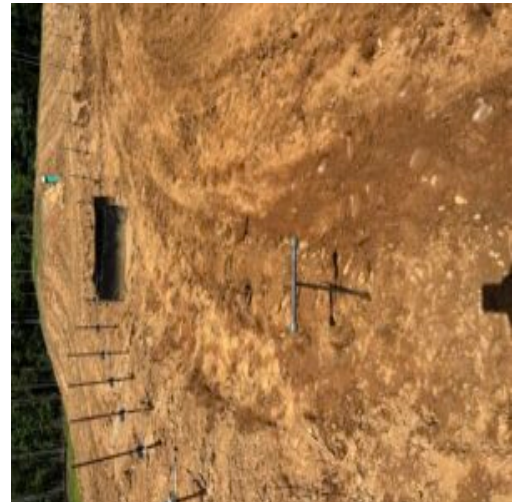
Probe rod depths -8" to -16"

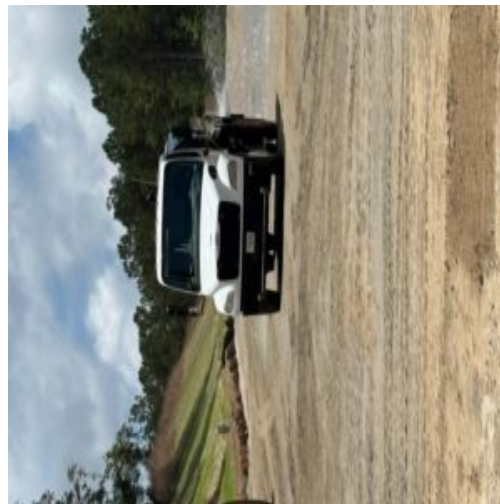
Sub base prep.at Nature Walk Pkwy.

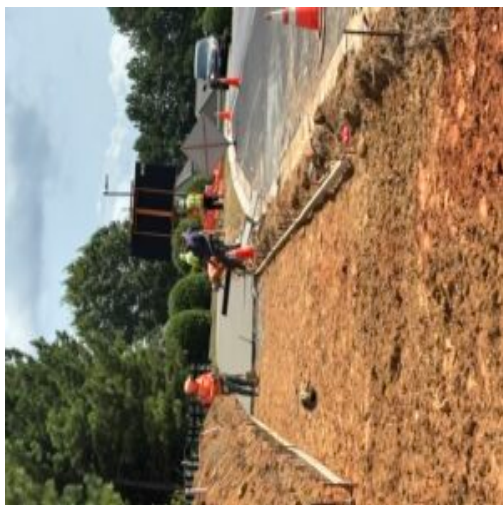
Pouring sidewalk at Seven Hills Boulevard

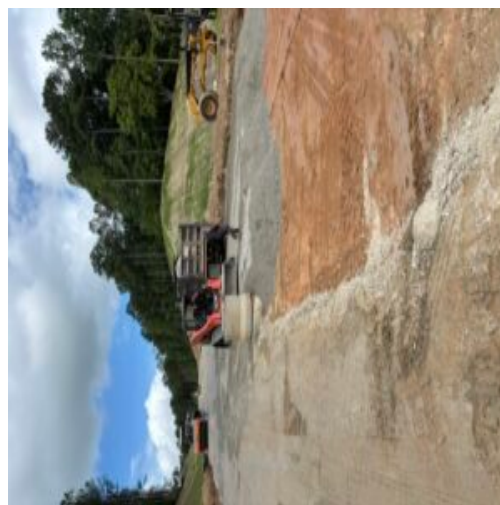
On the above date our representative was onsite to continue observing the paving contractor (NWGP) perform subbase preparation and subgrade repair for Naturewalk Parkway west side of sanitary sewer manhole #12. The contractor undercut existing subgrade soils as recommended, removing saturated subgrade soils that displayed severe rutting. The contractor placed 285.05 tons of base stone for the undercut with contract stone included in this total. The contractor also is filling in eroded reels at curb line from a previous rain event. The curb line replacement will require proof-rolling prior to pouring curbing.

Undercut repairs at Nature Walk Pkwy. west of  
sanitary sewer manhole #12

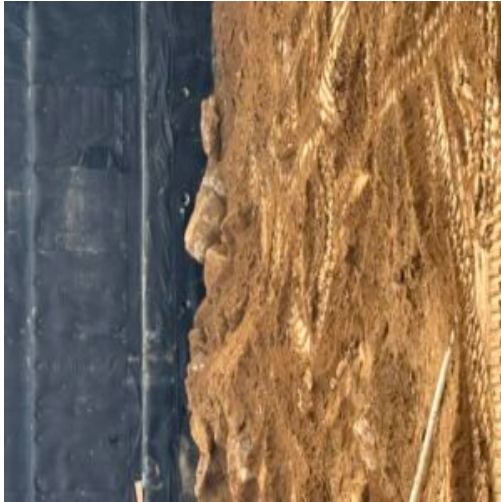
The writer observed the wall contractor (RWS) installing tension rods for dead man wall. The contractor was reminded that large rocks are not allowed within ten feet of the wall.

Backfill at westside bridge abutment showing large rocks at wall. The contractor was reminded that no large rocks are required within ten feet of the wall.

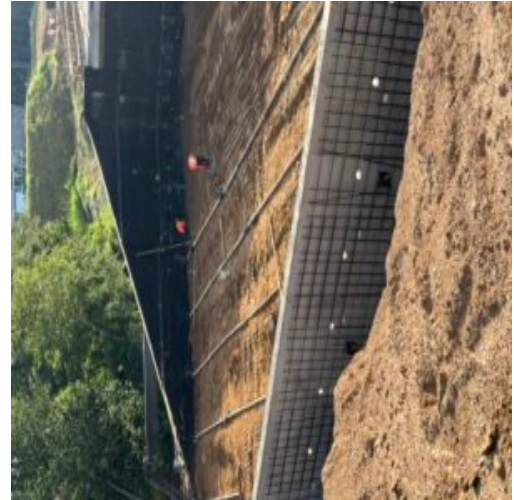
Installation of tension rods at dead man footing
