Date : 07/30/2026  
Project No : 2025C215  
Client Company : Artisan  
Arrival Time : 07/30/2026 07:30  
Onsite Hours : 08:30

ASEC Report ID : 96585  
Name of the Project : NW Unit 4 Parkway Ext. Phase 1  
Project Location : Dallas  
Weather : cloudy  
Departure Time : 07/30/2026 16:00  
ASEC Technician Name : Clyde Smith

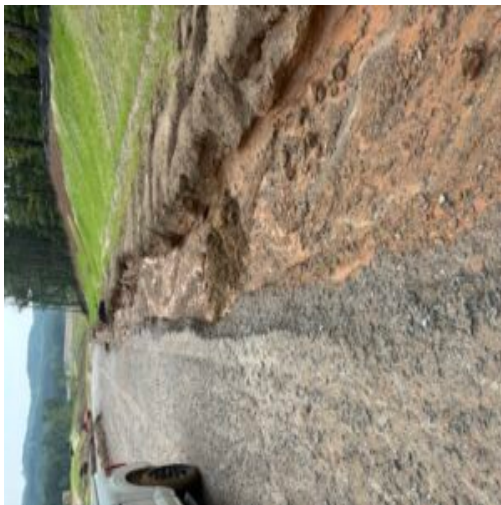
On the above date our representative met with sub-contractors for paving, grading and curbing to discuss current subbase conditions concerning repairs for occurring erosion issues at Naturewalk parkway due to recent consistent rain events. The writer recommended using a lean concrete mix to fill eroded subbase reels that had occurred at the curb line and washed conditions at previous poured curbing which has recently been undermined. The sub-contractors elected to continue standard repair measures replacing eroded areas with GAB stone and adding check dams using silt fence. This should be sufficient if rain doesn't occur prior to curb placement. There may be additional repair measures required at previous poured curbing.

Eroded areas at curb line

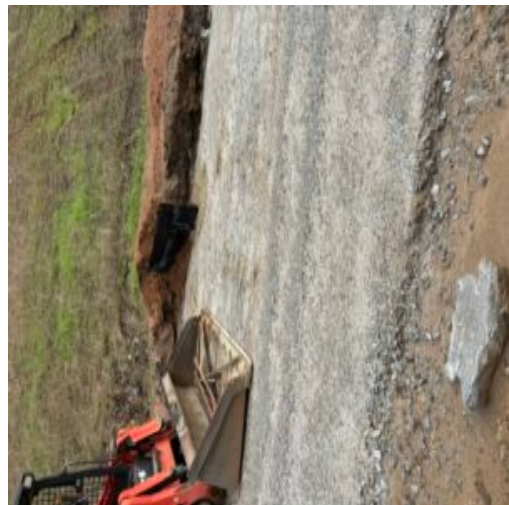
Sub base prep. and check dam installations

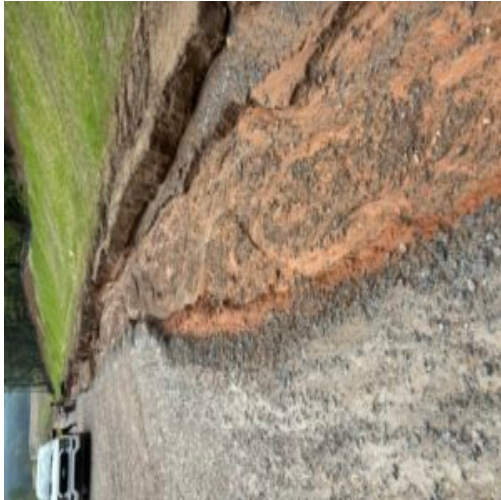
Eroded curb line

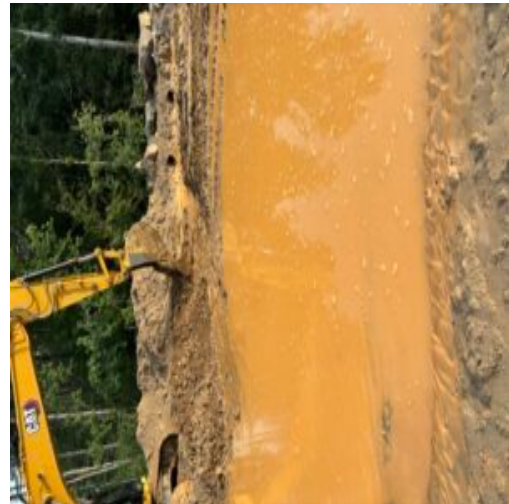
Site condition at Nature walk Pkwy.sub grade after rain event near west side of bridge

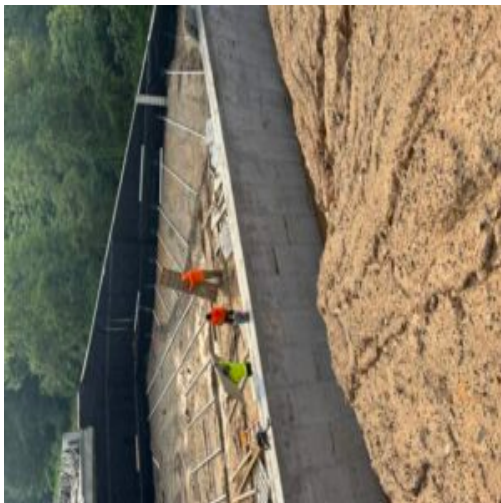
Wall contractor stripping form work at second wall pour at dead man footing

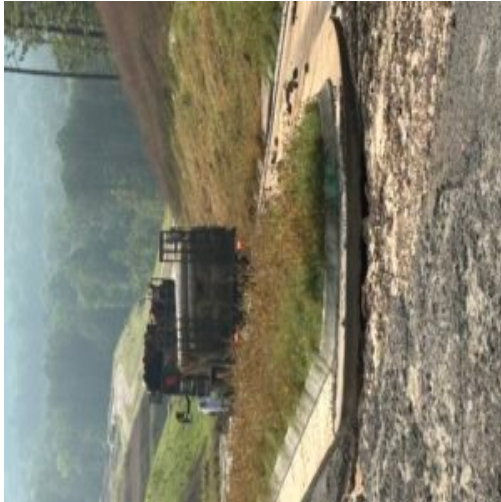
Washed erosion at parkway
