Date : 08/19/2026  
Project No : 2026C101  
Client Company : Artisan  
Arrival Time : 08/19/2026 07:30  
Onsite Hours : 04:00

ASEC Report ID : 97036  
Name of the Project : Seven Hills PHASE 13, UNIT 3 Lots  
Project Location : Dallas  
Weather : Sunny  
Departure Time : 08/19/2026 11:30  
ASEC Technician Name : Clyde Smith

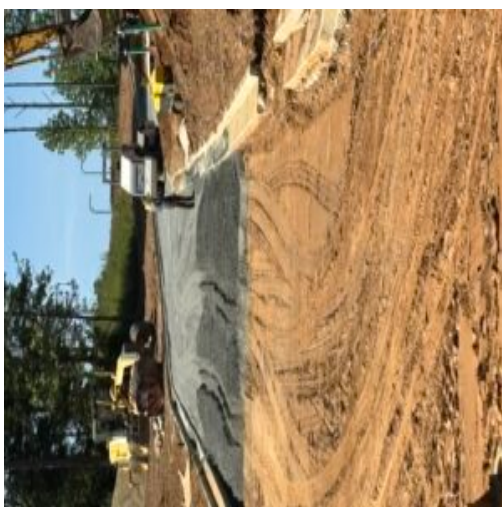
On the above date our representative was on site to observe the paving contractor J&W continue subbase preparation, placing base stone at the roadway from Lot #28 to the cul-de-sac. The sub grade was re observed for the cul-de-sac after truck traffic was turning around during placing base stone causing additional rutting. It was reminded to the contractor that all trucks should be backing in and back dumping keeping off the exposed subgrade which will cause further clipping and cost for additional base stone. The average undercut at the cul-de-sac is -8" replacing with additional base stone.

Continue sub base prep.at roadway to cul de sac

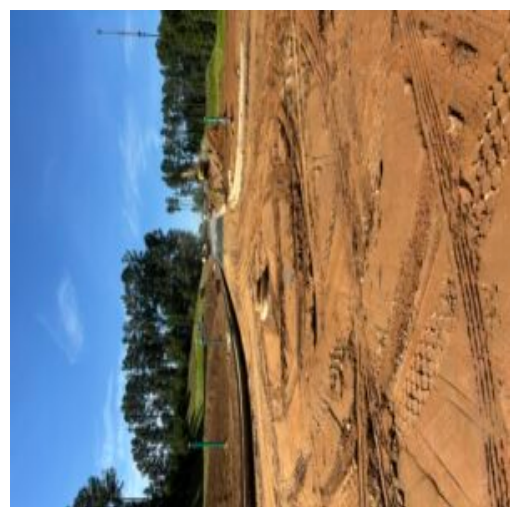
Observation of sub grade at cul de sac requiring additional clipping due to truck traffic.

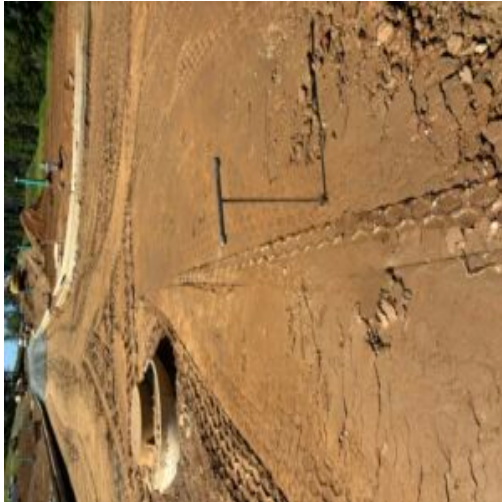
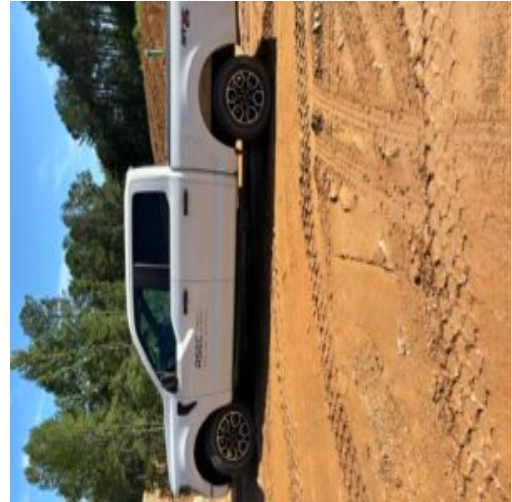
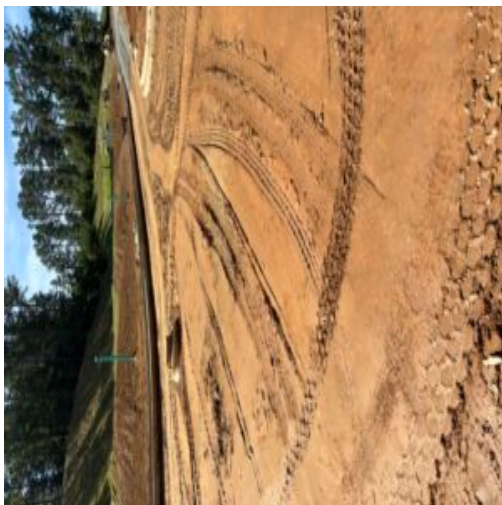
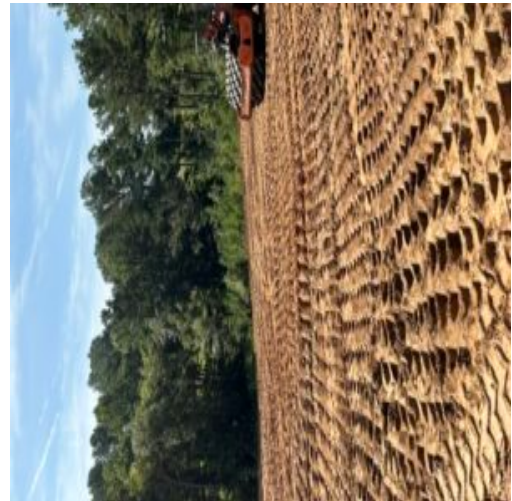
The writer observed the grading contractor Thompson continue placing fill for the roadway and slope embankment near the detention pond between B2 ST JB and AO STHW. The contractor continued placing topsoil for the slope embankment to two to three feet in depth. The contractor is reminded that storm lines must be installed through embankment fill and should be clean and compacted.

Compacting fill at roadway near pond.

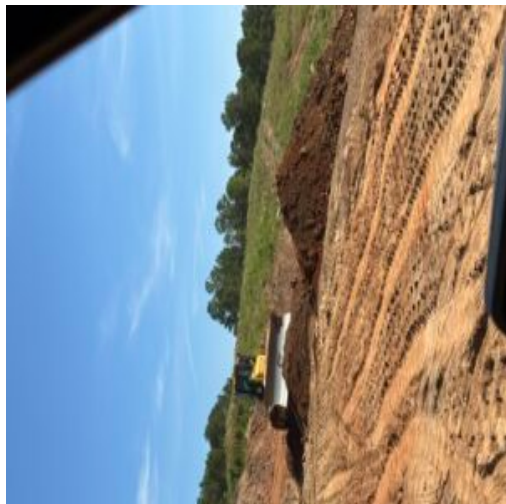
Placing topsoil at slope embankment recommending additional compacting efforts.

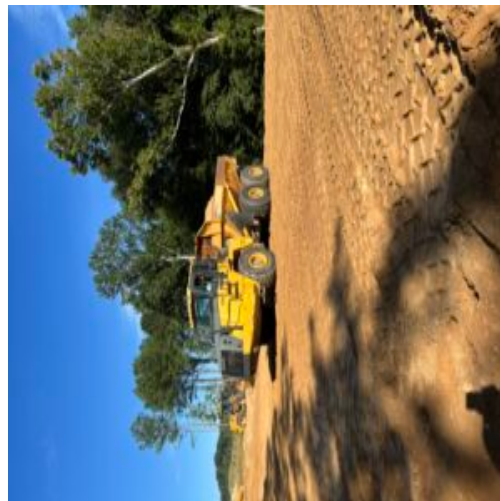
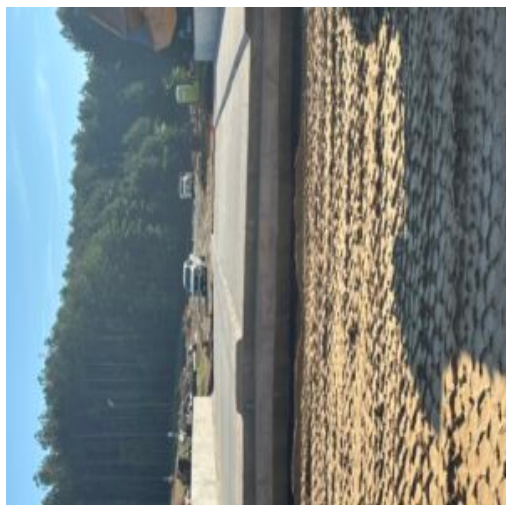
The writer continued observing backfill placement at the bridge abutment which was stopped by the wall contractor RWS who provided a sketch slowing to stop fill placement -8" down below pipe opening and extend 20' outward from wall to allow tightening of the tension rods.

Fill placement at bridge abutment
