Date : 08/25/2026  
Project No : 2026C101  
Client Company : Artisan  
Arrival Time : 08/25/2026 07:30  
Onsite Hours : 07:00

ASEC Report ID : 97167  
Name of the Project : Seven Hills PHASE 13, UNIT 3 Lots  
Project Location : Dallas  
Weather : Sunny  
Departure Time : 08/25/2026 14:30  
ASEC Technician Name : Clyde Smith

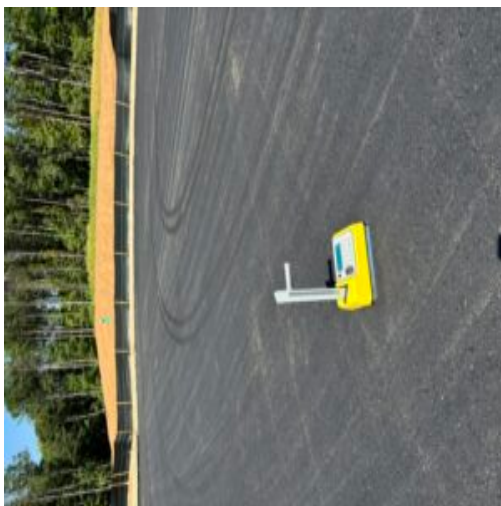
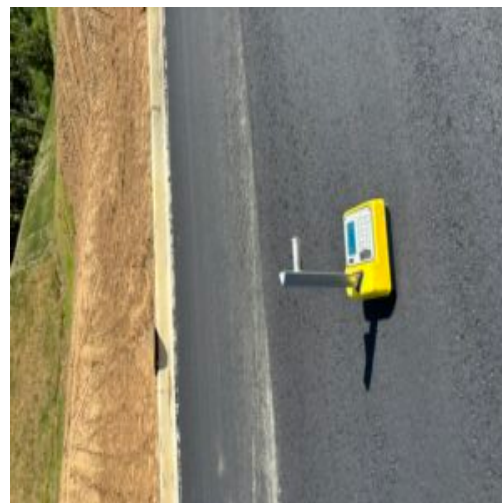
The writer observed asphalt 19mm SP binder mix placed at roadway on 8/25/26 by performing density checks using a Troxler Nuclear gauge model 3430, serial no. 91643. Results were 136.5, 139.1, 136.5, 139.0, 135.3, 141.6, 143.6, 142.6, 140.6, 144.1, 142.0, 139.4 and 144.2, all pcf. During paving placement there was no additional information provided (specific gravity or theoretical value). Based on an estimated value of 152.0 pcf compaction efforts would range between 90% and 93%. The lower compaction efforts were located near the Plantation Gas lines crossing. These results were reported to the paving contractor.

Density checks performed on 19mm SP asphalt binder on 8/24/26

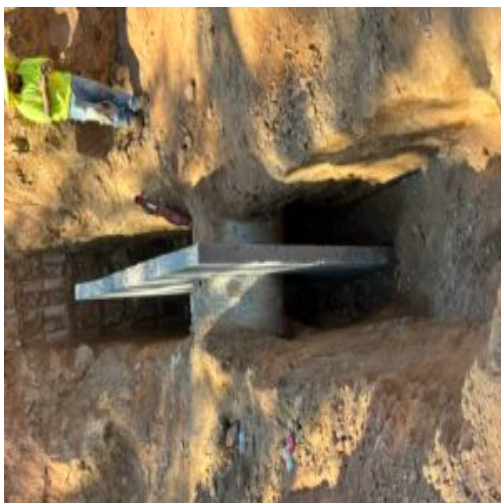
On the above date, our representative was on site to observe the removal of form work for the Pond A anti-seep collars with an average width of five inches. The contractor began backfilling over the 36" RCP and anti-seep collars after approximately 19 hours. It was recommended to the contractor to only use hand tamp backfilling for the sides of the anti-seep collars to prevent water from entering the bottom of the excavation. The contractor continued backfilling over top of the pipeline and anti-seep collars. The writer reobserved backfill after placement of two feet additional fill over top of the anti-seep collars. Density tests were performed with recommendations made to perform additional compacting efforts to achieve 95%.

Anti seep collar observed at Pond A

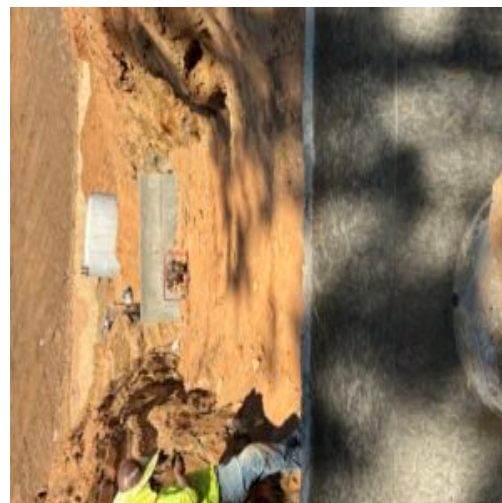
Foundation slab for retrofit at Pond A

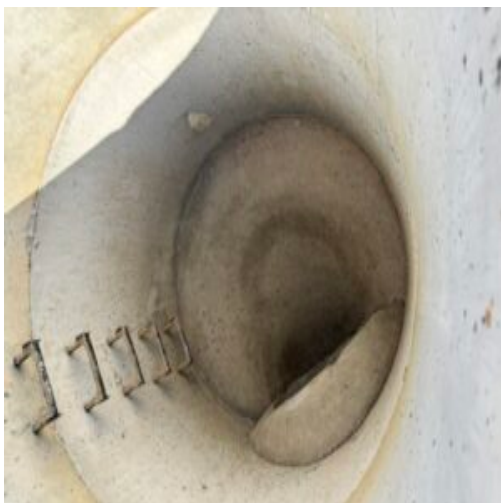
Poured invert at OCS

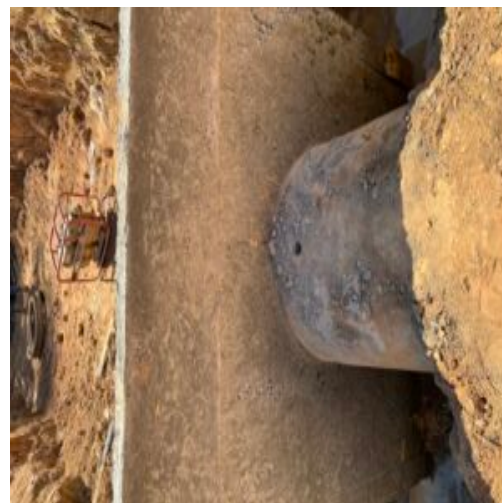
Anti seep collar

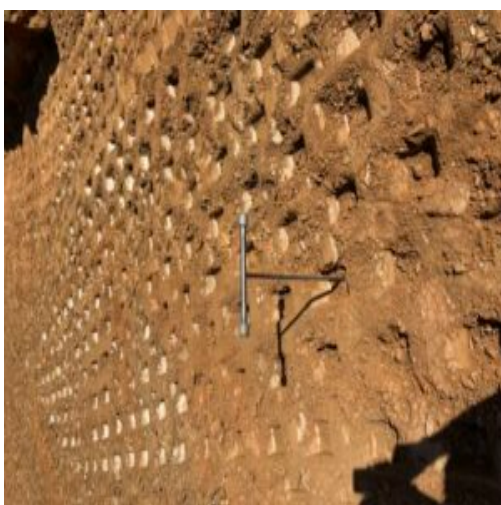
Backfill at Pond A OCS and 36" rcp

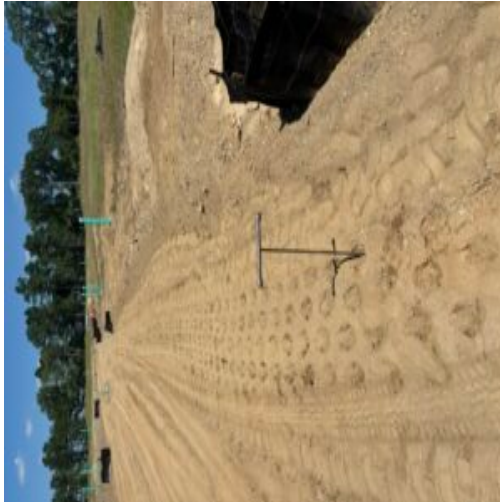
The writer also observed subgrade conditions for curbing at Unit 4 Phase 2 main section of roadway by probing using a rounded end steel rod. Several areas were observed having loose compacting efforts with recommendations made to recompact existing subgrade soils prior to curbing placement. The writer reobserved subgrade soils after additional compacting efforts were made and approved subgrade soils for curb placement.

Observation of sub grade for curbing at Unit 4 Phase 2 with recompactng efforts
