Date : 09/16/2026  
Project No : 2026C101  
Client Company : Artisan  
Arrival Time : 09/16/2026 07:30  
Onsite Hours : 10:00

ASEC Report ID : 97686  
Name of the Project : Seven Hills PHASE 13, UNIT 3 Lots  
Project Location : Dallas  
Weather : Sunny  
Departure Time : 09/16/2026 17:30  
ASEC Technician Name : Clyde Smith

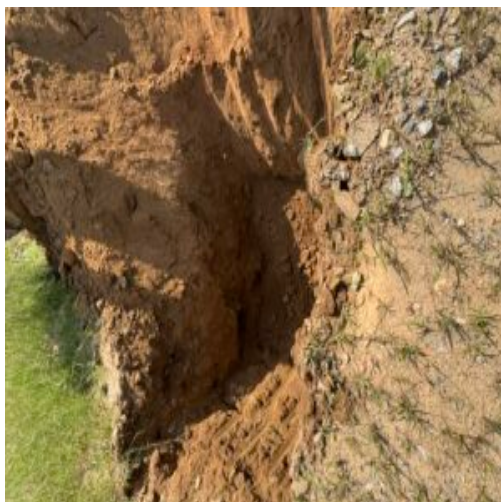
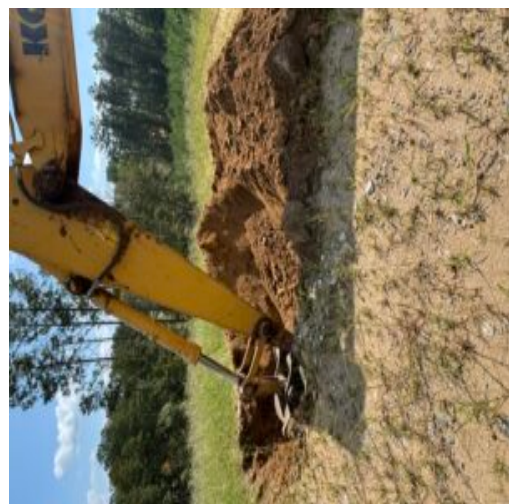
The writer also observed existing stockpiled materials at south side at Shelly Boulevard by dug test pits to determine suitability for structure fill placement at building lots. The fill contained some boulders, topsoil and saturated soils. The materials were recommended for placement at the slope embankments. The material will be monitored during excavation to determine suitability for structure fill suitability.

Test pits observed at onsite stockpile at Shelly Blvd.

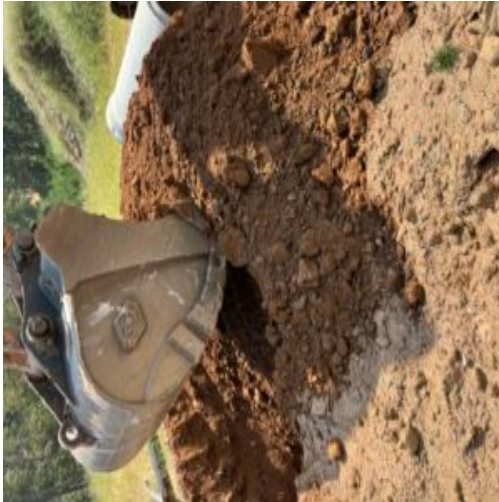
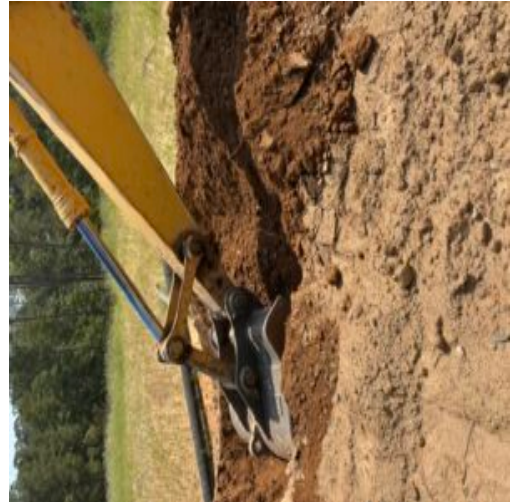
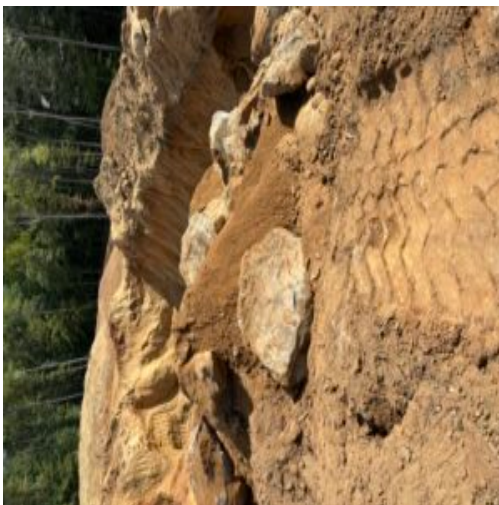
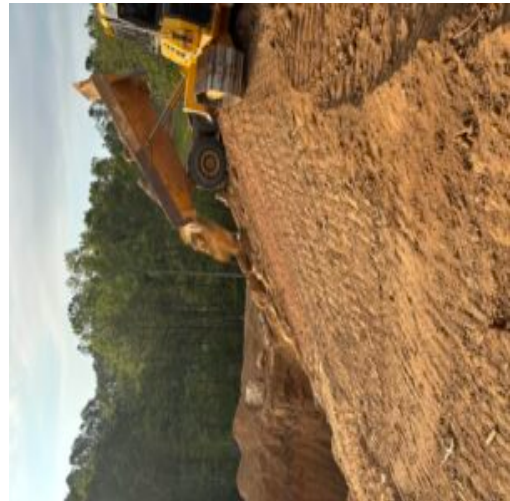
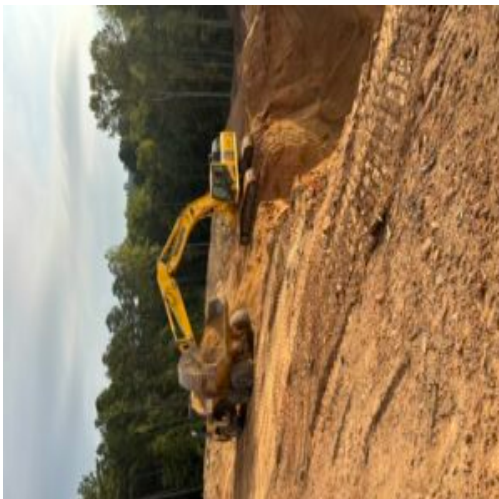
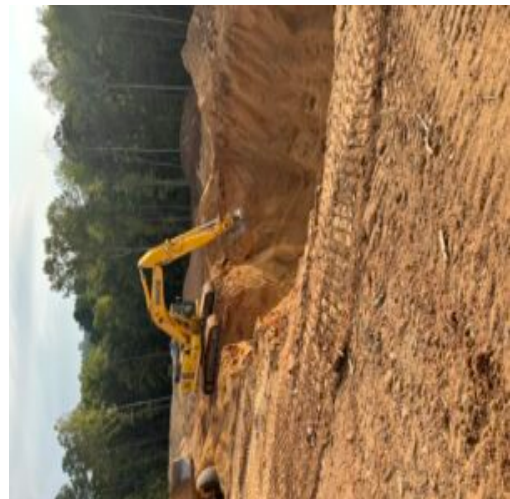
On the above date our representative was on site to observe the grading contractor continue excavation at the borrow pit and placing fill at building Lots #13 thru 15 using clean soil fill. The contractor also placed rockfill at the old temporary detention pond in roadway near sanitary sewer manhole Z19. Density tests were performed at building Lots #10 thru 14 using a Troxler Nuclear gauge model 3430, serial no. 91643. Compaction results were suitable as per job specifications. The rockfill placement at the old detention pond was in compliance with recommendations and suitable for compaction requirements. The contractor also began filling the excavated borrow pit with broken boulders.

Excavation at borrow pit and rock fill replacement

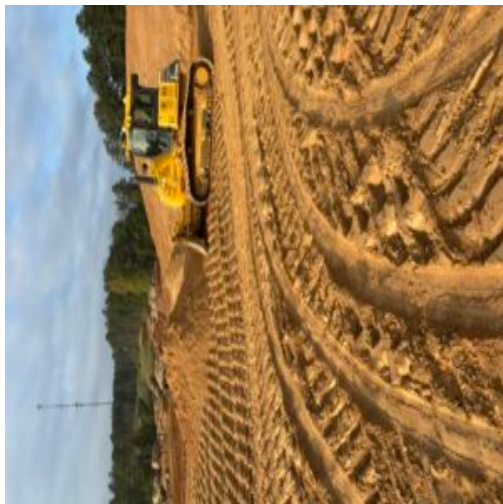
Fill placement at building lots

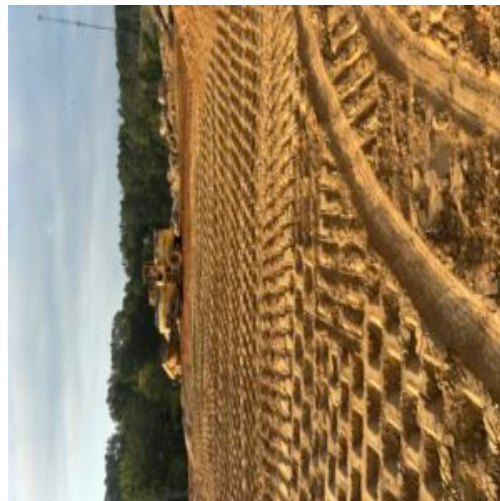
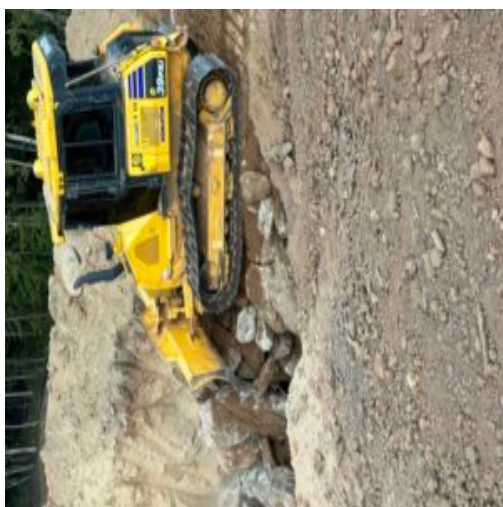
Placing boulder fill at excavated borrow pit

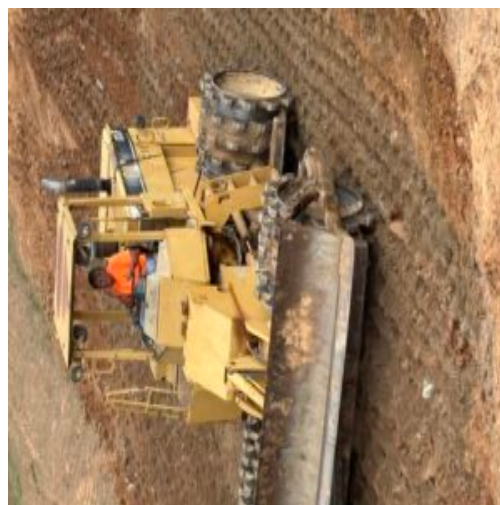
Compacting rockfill and placement at old detention pond in roadway near Z19

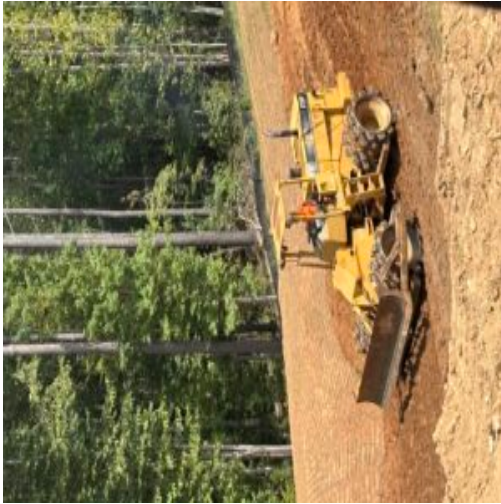
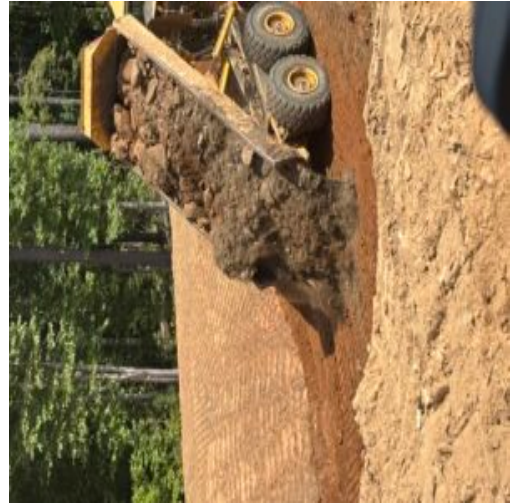
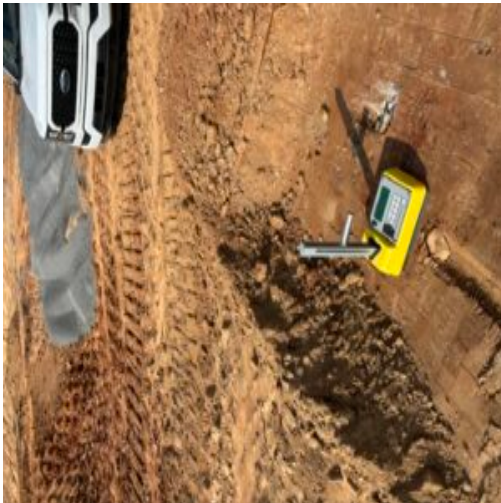
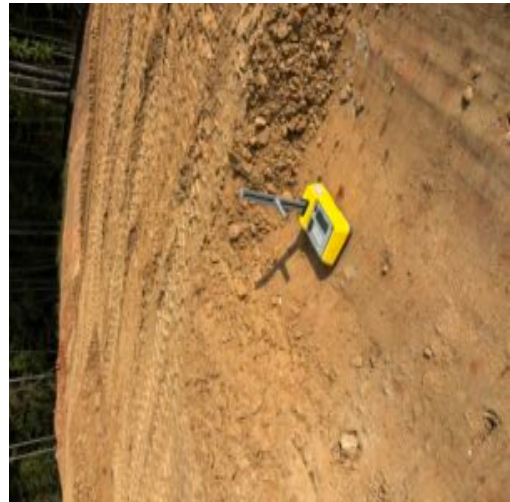
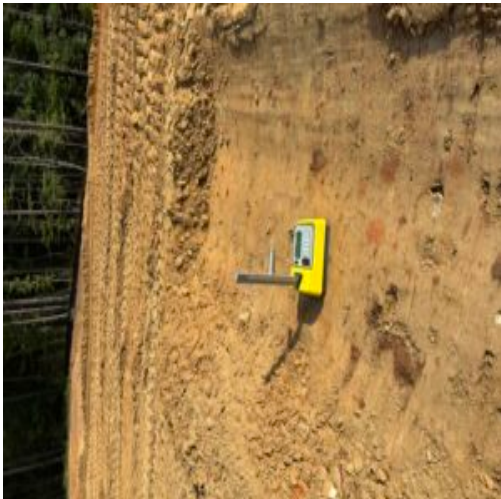
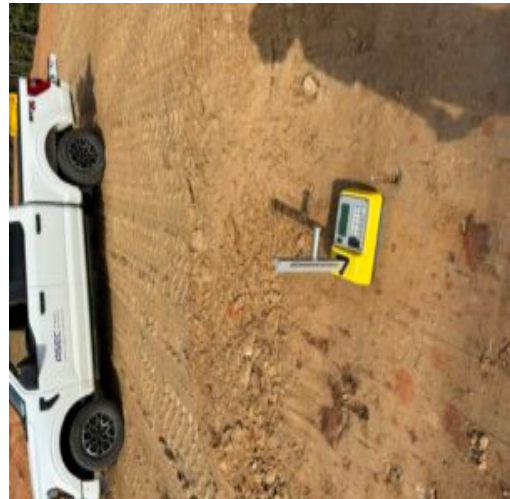
Density tests performed at building lots 10 thru 14
