Date : 09/23/2026  
Project No : 2026C103  
Client Company : Artisan  
Arrival Time : 09/23/2026 07:30  
Onsite Hours : 10:00

ASEC Report ID : 97823  
Name of the Project : NW PH 2, UNIT 4  
Project Location : Dallas  
Weather : Sunny  
Departure Time : 09/23/2026 17:30  
ASEC Technician Name : Clyde Smith

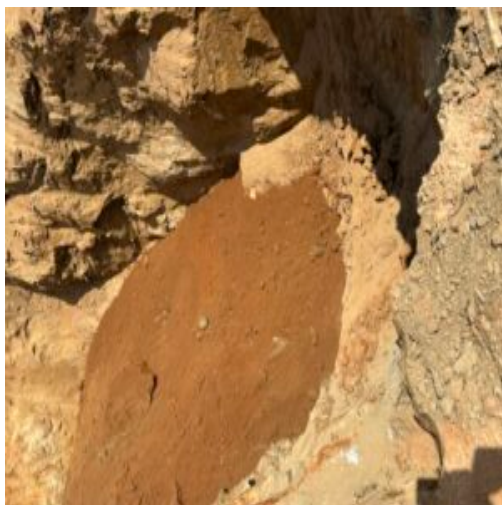
The grading contractor also continued fill placement at Seven Hills Unit 4 phase 13 building Lots #22 and 23. Fill soils with some rock fragments were used in filling in borrow pit #2 south of building Lot #24.

Fill soils being placed back into excavated borrow pit #2 south of building lot # 24

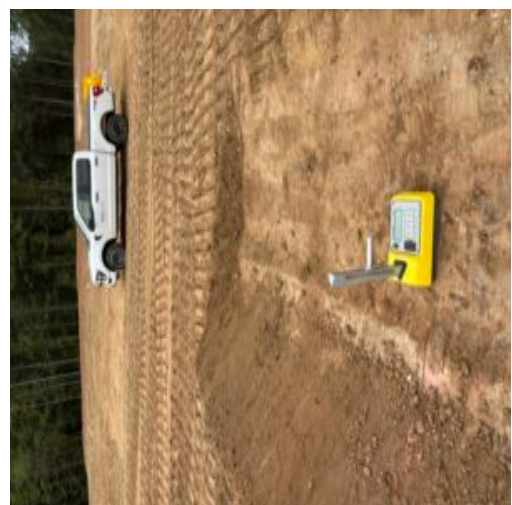
On the above date our representative observes the grading contractor Thompson placing fill at Unit 4 phase 3 building lots. There was no additional information available for lot numbers or elevations, however, the approximate depth is 8 feet below finished grade. The writer performed density tests using a Troxler Nuclear gauge model 3430, serial no. 91643. Compaction results were suitable for requirements of 95 % to 98 %.

Density tests performed at Unit 4 phase 3

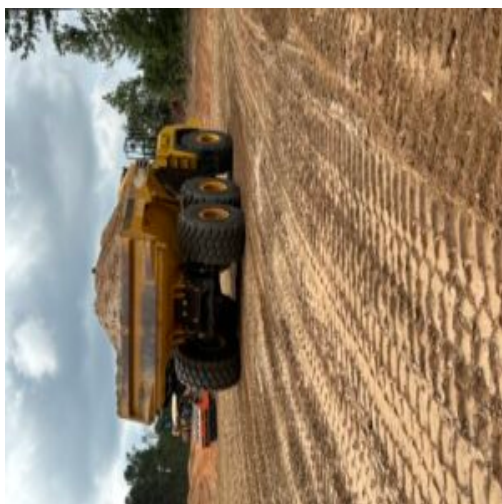
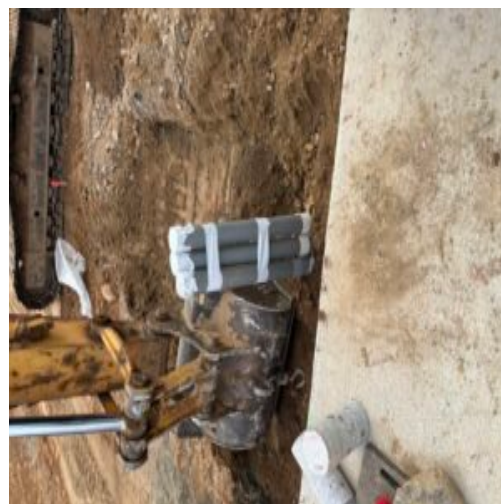
The grading contractor Thompson backfilled the electrical conduit holes at the east and west side bridge abutments. Compaction results met project specifications.

Backfilling at electrical conduits holes at bridge abutments.

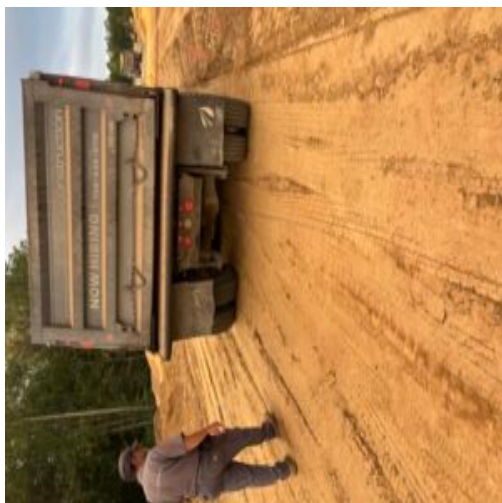
The writer also observed the paving contractor continue subgrade preparation at Nature Walk Parkway between sanitary sewer manhole #3 and #2. The subgrade was proof-rolled using a loaded tandem dump truck. The subgrade soils appeared stable under traffic except one small, isolated area (12' x 6') which was clipped -4" and replaced with additional base stone. The contractor plans to start placing base stone tomorrow.

Observing proof rolling of subgrade at Nature Walk Pkwy. between sanitary sewer manhole #3 and #2

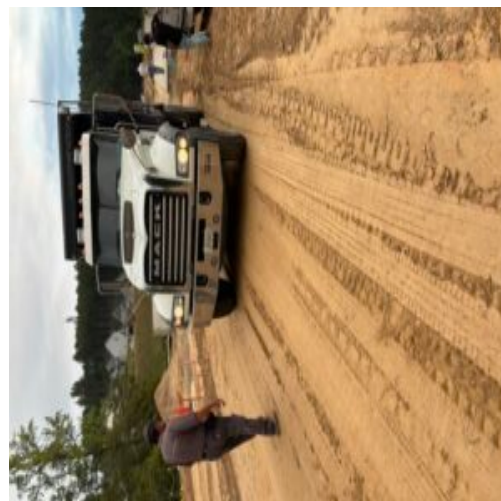
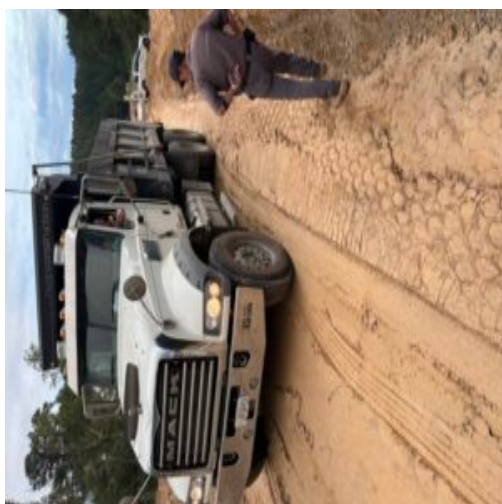
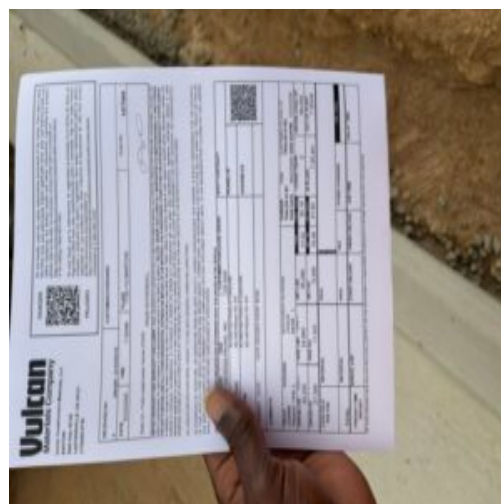
Truck ticket used for proof roll
