Date : 10/08/2026  
Project No : 2024C202  
Client Company : CCG  
Arrival Time : 10/08/2026 10:30  
Onsite Hours : 02:00

ASEC Report ID : 98027  
Name of the Project : Old Griffin Rd - Hawthorne Reserve  
Project Location : Dallas  
Weather : Sunny  
Departure Time : 10/08/2026 12:30  
ASEC Technician Name : Clyde Smith

On the above date our representative visually observed continuous exterior wall footings at Lot #90 for Hawthorne Ridge, 252 Wildflower Ridge Road (project no. 888338). The writer observed backfill along the left side sub wall appearing to be at least 4' to 5' in depth. The footings and wall backfill was observed by probing using a rounded end steel rod. The backfill along the sub wall was very loose probing to the full depth of the 3.5 feet rod. The front left corner also probed loose within the top 18". The left half of the rear footing had soft in place fill materials appearing to have been saturated where some materials had been removed but still probed -12" to -18". The right-side exterior wall footing also was observed having consistent loose fill in place probing -12" to -18". The front of the exterior wall footing appeared to be firm except at the left si

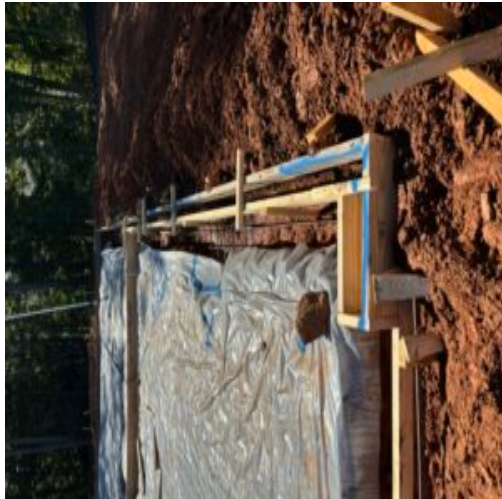
Right side exterior wall footing

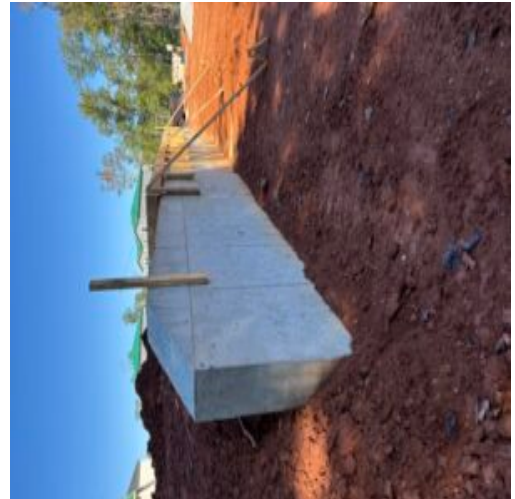
Sub wall a long left side of house

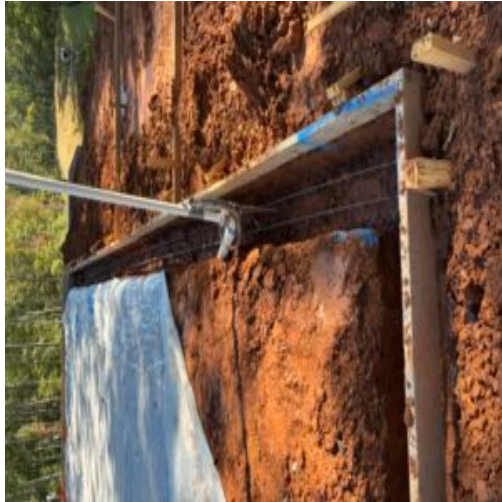
Right side exterior footing and slab

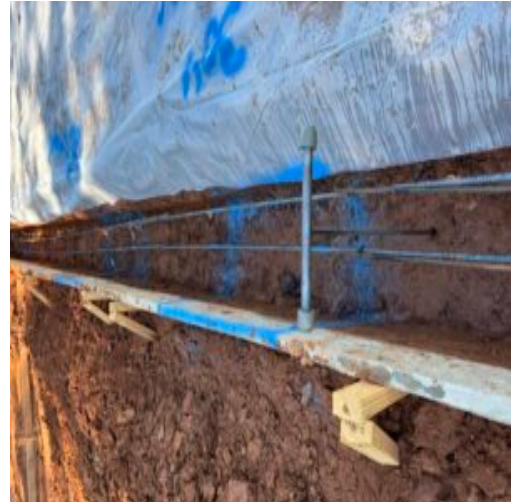
Left half of rear footing probed soft

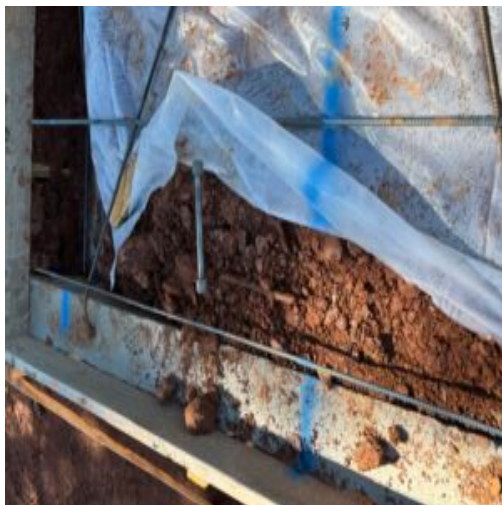
Probing loose backfill at sub wall

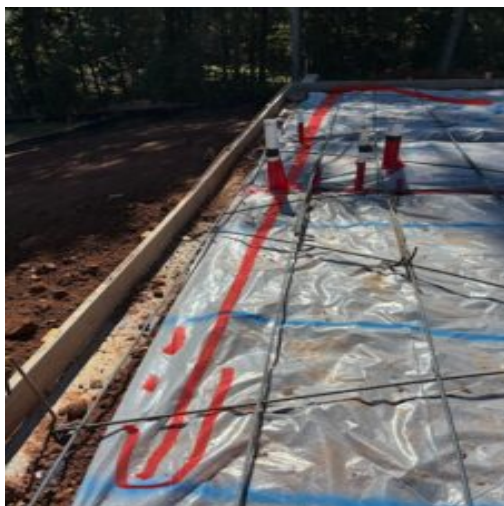
Red line indicates loose fill along sub wall left side

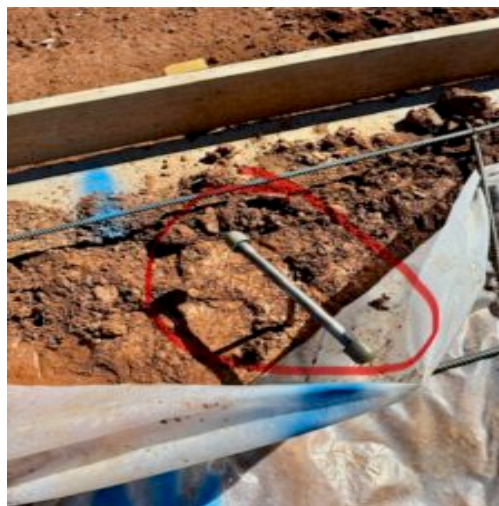
Probing loose backfill along sub wall
