Date : 03/07/2023  
Project No : 2022C235  
Client Company : Jackson Demolition Service, Inc.  
Arrival Time : 03/07/2023 06:00  
Onsite Hours : 10:30

ASEC Report ID : 57512  
Name of the Project : Plant Gorgas Demolition and Grading  
Project Location : 460 Gorgas Rd, Parrish, AL 35580  
Weather : Sunny  
Departure Time : 03/07/2023 16:30  
ASEC Technician Name : Vidal Dias

AS ENGINEERING AND CONSULTING, LLC (ASEC) representative Vidal Dias visited the site at the request of Jackson Demolition representative Josh Kelly. The undersigned representative was present to monitor, verify and document the ongoing project activities.

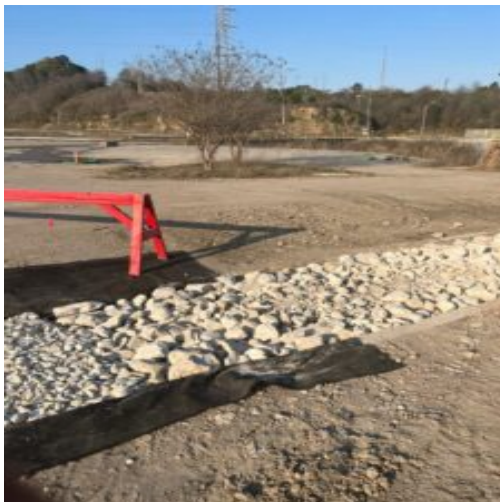
1. The contractor received thirty-nine (39) loads of fill material and placed it in area H8 of the basement. Fill was placed in accordance with ITP-001. Material was placed in 2 foot lifts as part of the planned bridge lift. No testing was performed on this day as the lift was not ready to be assessed.
2. Steel plates were placed to screen the HDPE pipe openings in the north and south trenches in accordance with ITP-012.
3. Riprap was placed adjacent to the steel plates in both trenches.

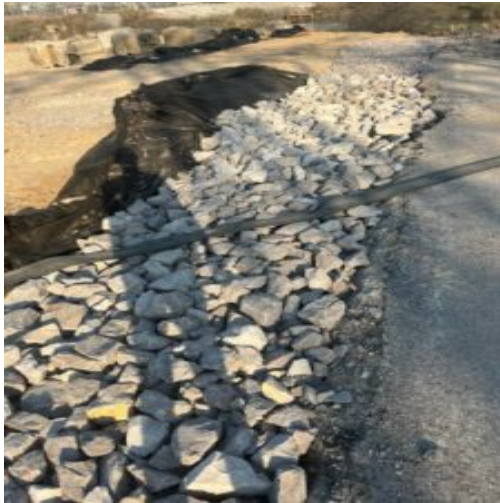
Steel plates cover pipe opening in the north trench. Four 5" - 6" holes were cut in steel to facilitate water flow and prevent rip rap from migrating into drains.

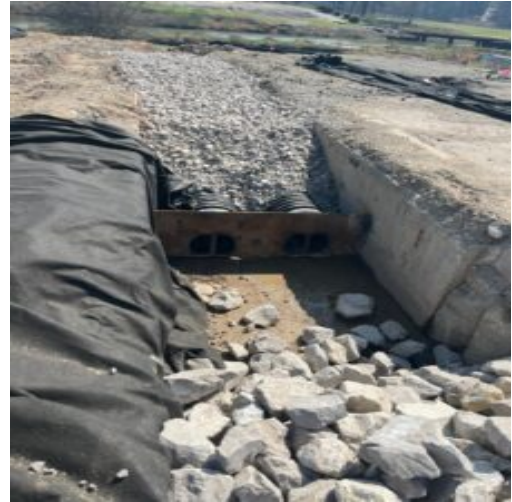
Steel plates between pipe and rip rap in south trench

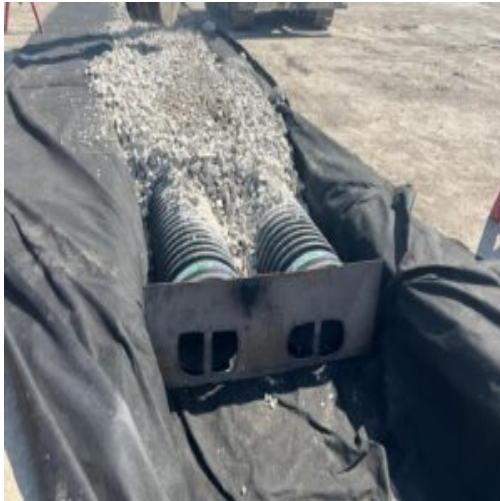
Steel plates cover the pipe opening in the south trench. Four 5" - 6" holes were cut in steel to facilitate water flow and prevent rip rap from migrating into drains.
