ASEC Report ID : 57416  
Name of the Project : Plant Gorgas Demolition and Grading  
Project Location : 460 Gorgas Rd, Parrish, AL 35580  
Weather : Sunny  
Departure Time : 03/03/2023 16:30  
ASEC Technician Name : Vidal Dias

Our AS ENGINEERING AND CONSULTING, LLC (ASEC) representative Vidal Dias visited the site at the request of Jackson Demolition representative Josh Kelly. The undersigned representative was present to observe, verify and document the ongoing project activities.

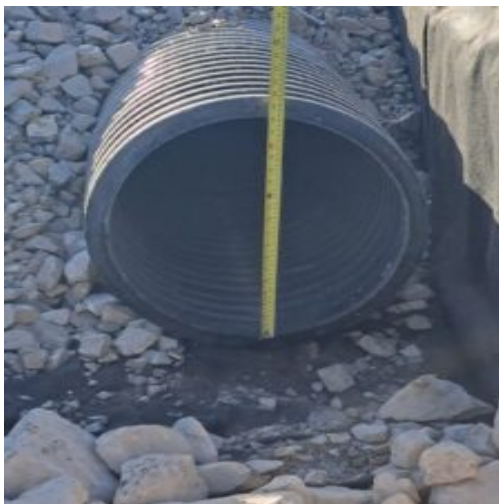
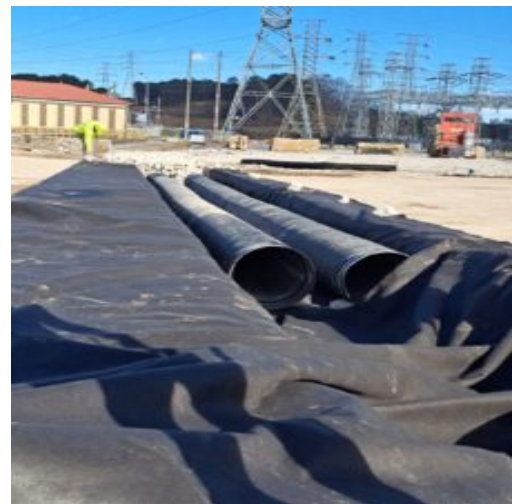
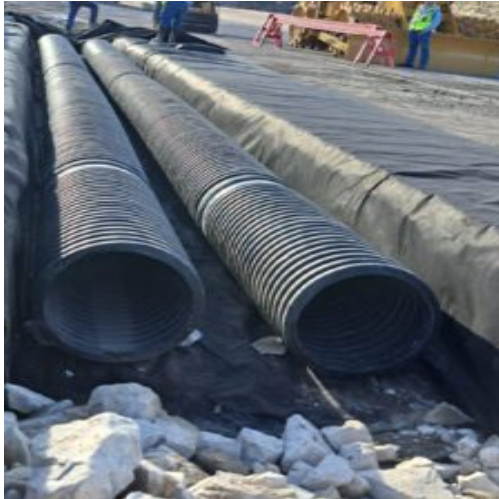
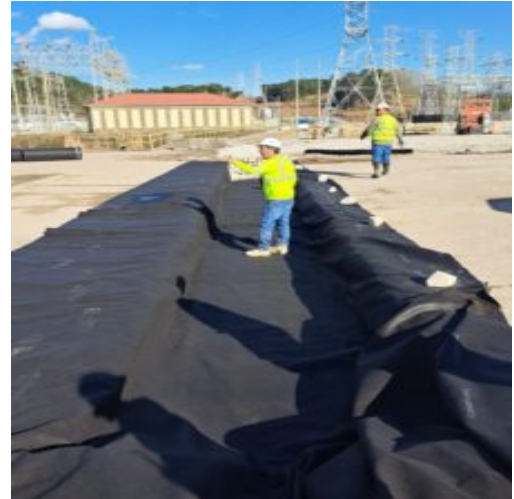
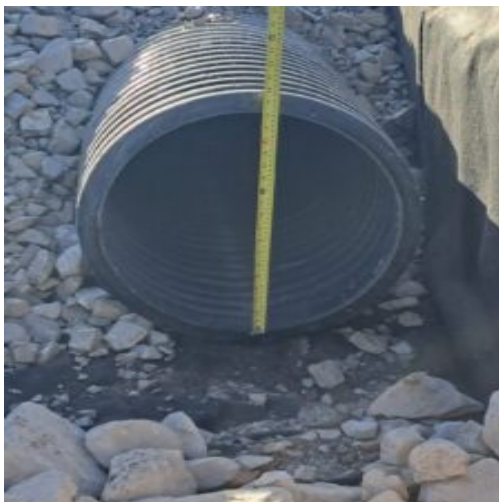
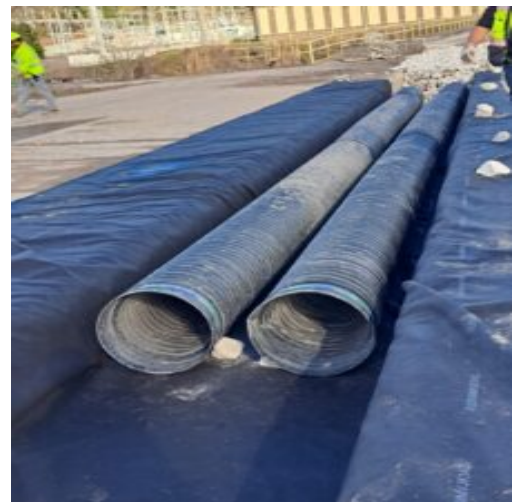
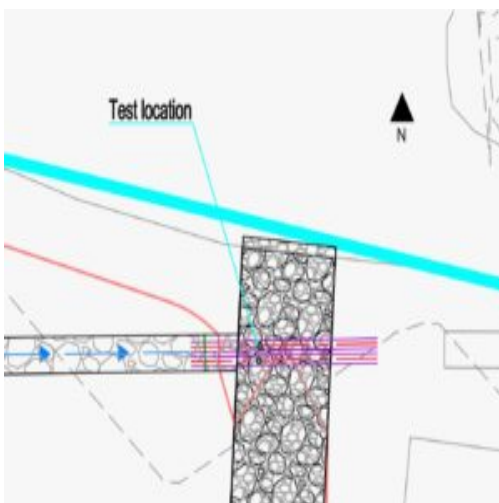
1. The contractor placed 8910 in a 100 ft trench on the northeast side of the basement in area C7 (on drawing E7200659). The graded-aggregate-base (GAB) placed in the west section of the trench was 8 inches thick, and placement thickness was decreased to 0 towards the east section of the trench. The approximate pitch was 0.67%

2. Two compaction tests were taken using the nuclear density gauge. Test 1 measured the compaction at a depth of 6 inches below the surface, and test 2 measured the compaction at a depth of 3 inches below the surface. Testing locations are shown on the attached drawing.

3. Textile fabric was placed, followed by the placement of two (2) 20-inch HDPE pipes I.D (18") O.D 21".
4. No. 57 stone was placed between pipes and trench walls, up to 4" inches of cover to the top of the pipe.

5. No. 57 and No. 24 stone was placed up to eight inches (8") below the finished grade.
6. Materials were placed in accordance with ITP: 012
