ASEC Report ID : 57749  
Name of the Project : Plant Gorgas Demolition and Grading  
Project Location : 460 Gorgas Rd, Parrish, AL 35580  
Weather : Partly Cloudy  
Departure Time : 03/13/2023 16:00  
ASEC Technician Name : Vidal Dias

Our AS ENGINEERING AND CONSULTING, LLC (ASEC) representative Vidal Dias visited the site at the request of Jackson Demolition representative Josh Kelly. The undersigned representative was present to observe, verify and document the ongoing project activities. During the visit, the following observations were made:

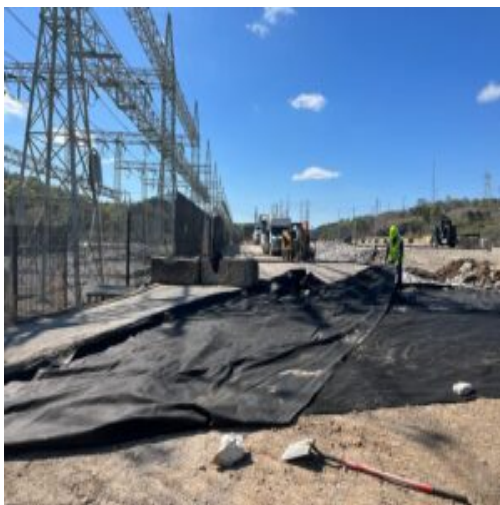
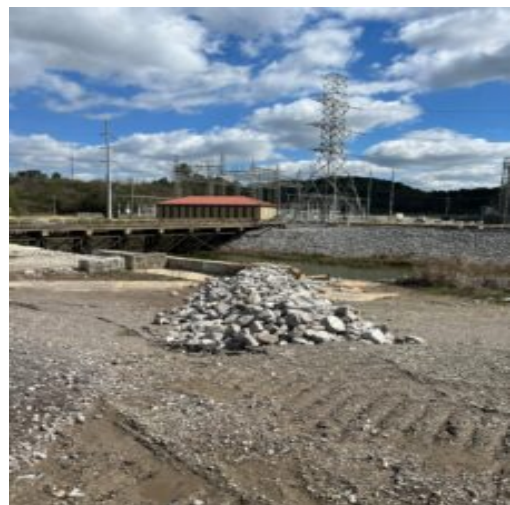
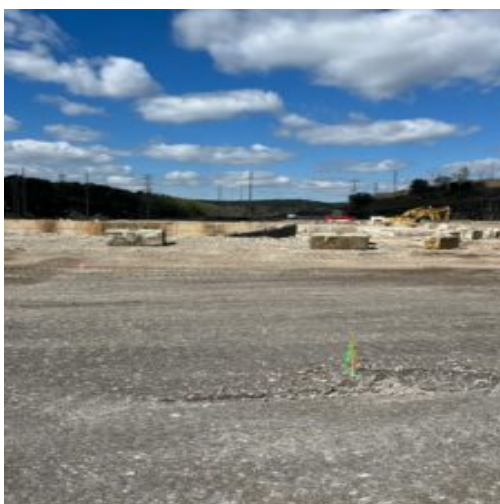
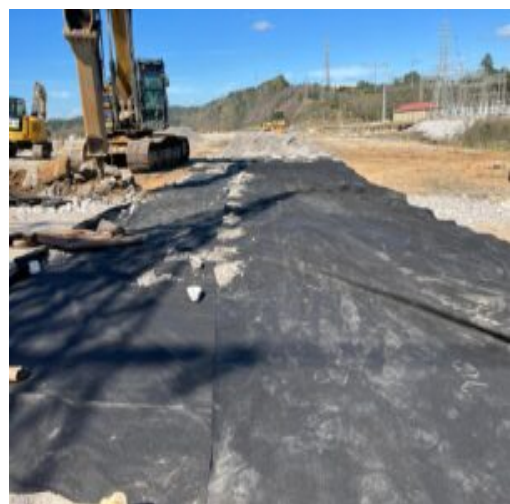
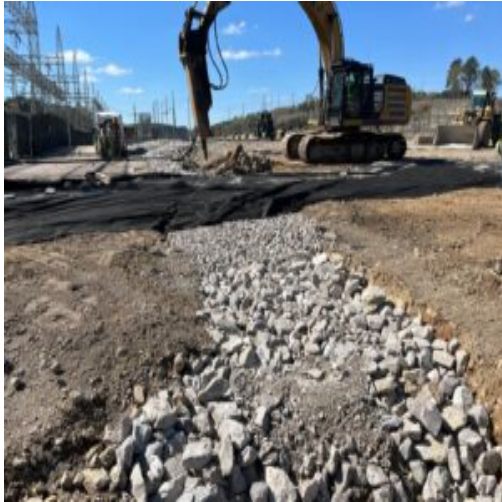
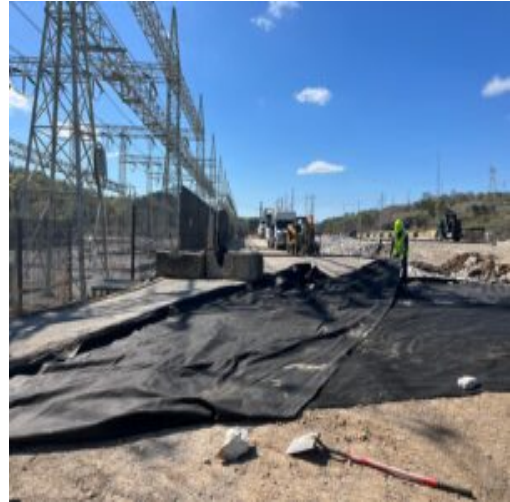
Photo documentation is included below:

1. 803.85 tons (33 loads) of 825B were received and placed in sections (H6, G6, and F6). The materials were placed in accordance with ITP-003.
2. Terra fabric was placed in area F6 and overlain with 825B in accordance with ITP-003.
3. Four (4) compaction tests were performed, and compaction test locations are labeled on the attached drawing. Tests were conducted per ITP-003 and were within the scope of the recommendations listed in ITP-003.
