ASEC Report ID : 58062  
Name of the Project : Plant Gorgas Demolition and Grading  
Project Location : 460 Gorgas Rd, Parrish, AL 35580  
Weather :  
Departure Time : 03/24/2023 16:30  
ASEC Technician Name : Vidal Dias

Our AS ENGINEERING AND CONSULTING, LLC (ASEC) representative Vidal Dias visited the site at the request of Jackson Demolition representative Josh Kelly. The undersigned representative was present to observe, verify and document the ongoing project activities. (Reference drawing E720661 S1 - R5, E720659 S1-R5.)

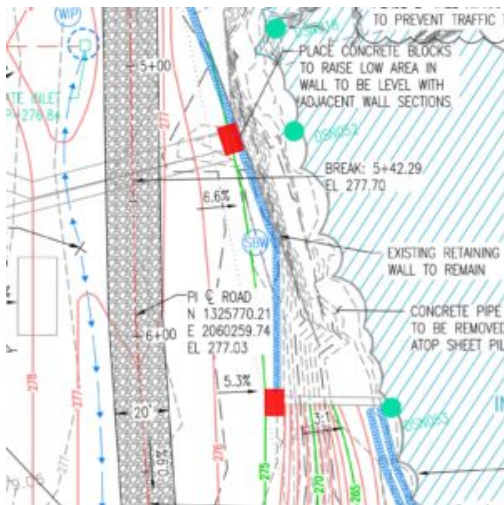
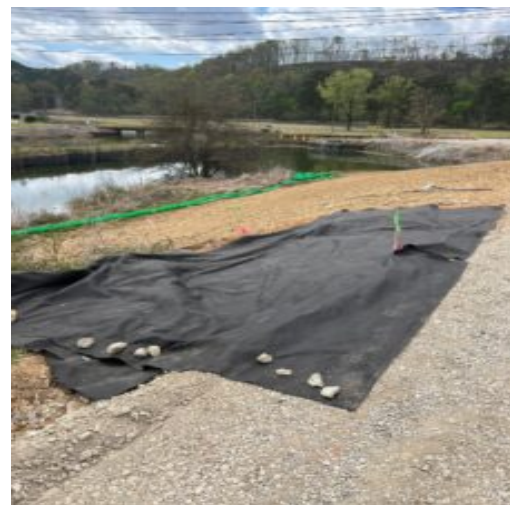
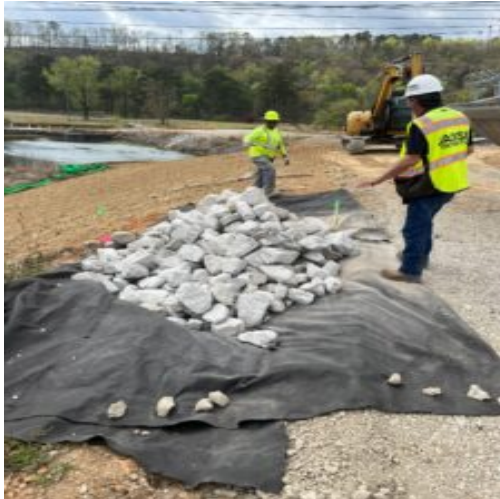
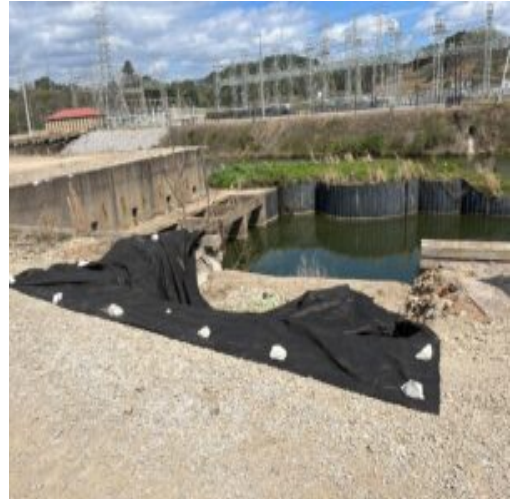
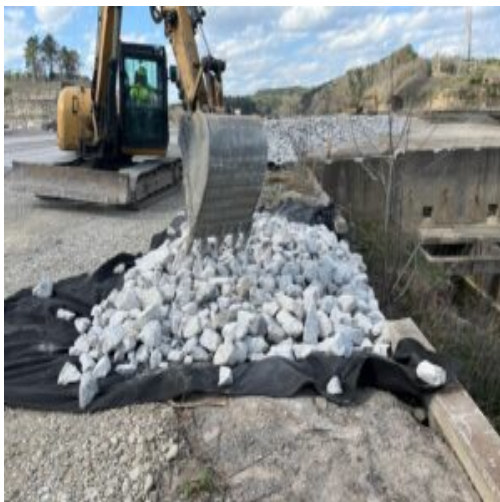
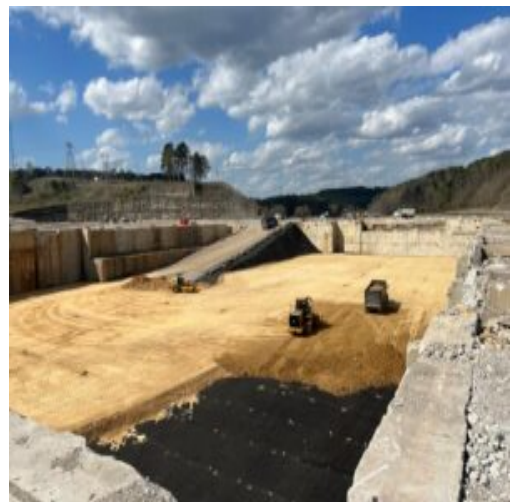
Photo documentation and test locations are attached:

1. Fifty-eight (58) loads of fill material were delivered, and one thousand forty-four (1044) cubic yards of fill material were placed in the basement for the two-foot bridge lift.
2. The placement and compaction of the fill materials are in accordance with ITP-001.
3. Additional compaction of fill material was conducted with a CAT CS54B roller.
4. Rip-rap was placed along the eastern-facing retaining wall in sections F6 and G6 (drawing E720659 S1-R5). The area is highlighted in red on the attached drawings.
5. Rip-rap was placed in accordance to ITP-003
