Date : 04/04/2023  
Project No : 2022C235  
Client Company : Jackson Demolition Service, Inc.  
Arrival Time : 04/04/2023 06:00  
Onsite Hours : 10:30

ASEC Report ID : 58336  
Name of the Project : Plant Gorgas Demolition and Grading  
Project Location : 460 Gorgas Rd, Parrish, AL 35580  
Weather : Mostly Cloudy  
Departure Time : 04/04/2023 16:30  
ASEC Technician Name : Vidal Dias

Our AS ENGINEERING AND CONSULTING, LLC (ASEC) representative Vidal Dias visited the site at the request of Jackson Demolition representative Josh Kelly. The undersigned representative was present to observe, verify and document the ongoing project activities. (Reference drawing E720661 S1 - R5, E720659 S1-R5.)

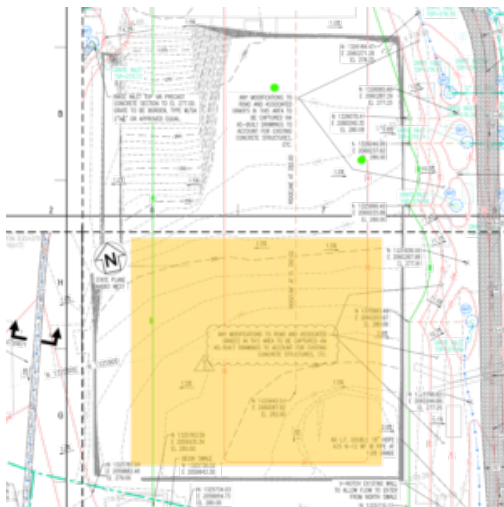
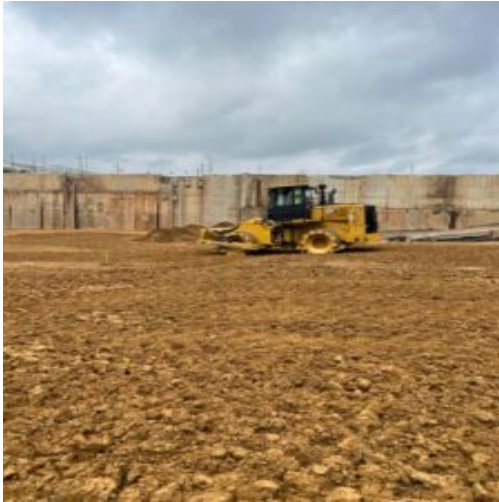
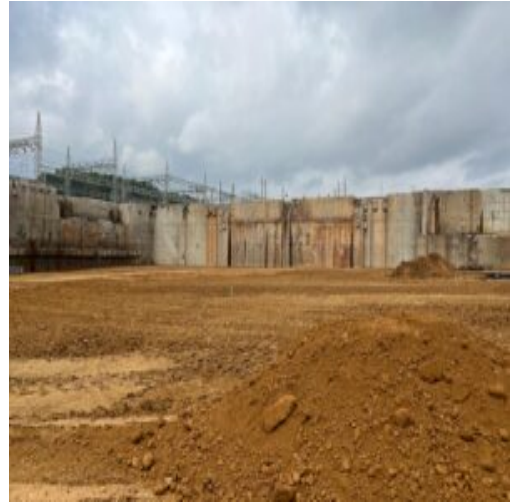
1. One thousand seven hundred sixty-four (1764) cubic yards of fill materials were placed for lift two in section 2 area G6 & G7 (drawing E720659) of the basement. The materials were placed in accordance with ITP-001, and the fill area is highlighted in orange on the attached drawing.
2. Two (2) moisture content and density tests were performed in section 1, area B7; the results were within acceptable limits. The test locations are shown in green on the attached drawing.
