Date : 04/05/2023  
Project No : 2022C235  
Client Company : Jackson Demolition Service, Inc.  
Arrival Time : 04/05/2023 06:00  
Onsite Hours : 10:00

ASEC Report ID : 58484  
Name of the Project : Plant Gorgas Demolition and Grading  
Project Location : 460 Gorgas Rd, Parrish, AL 35580  
Weather : Partly Cloudy  
Departure Time : 04/05/2023 16:00  
ASEC Technician Name : Vidal Dias

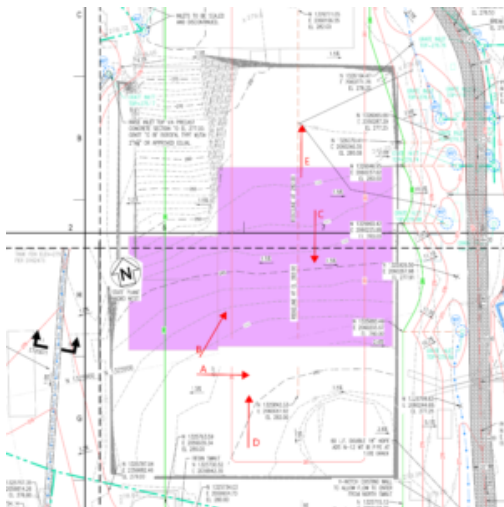
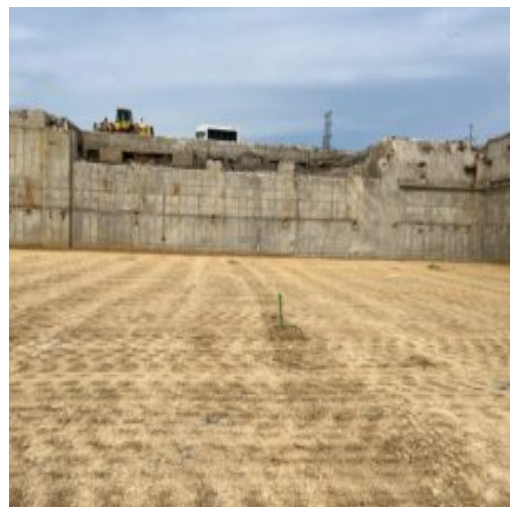
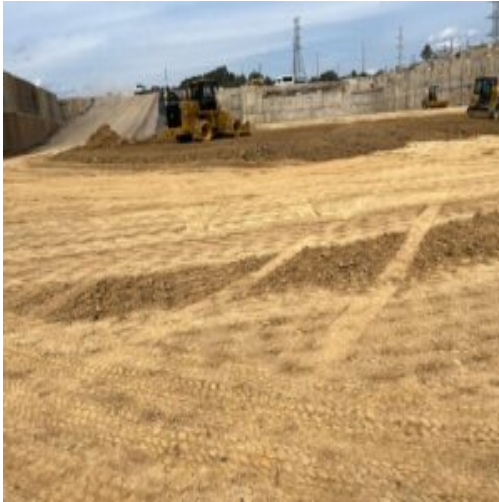
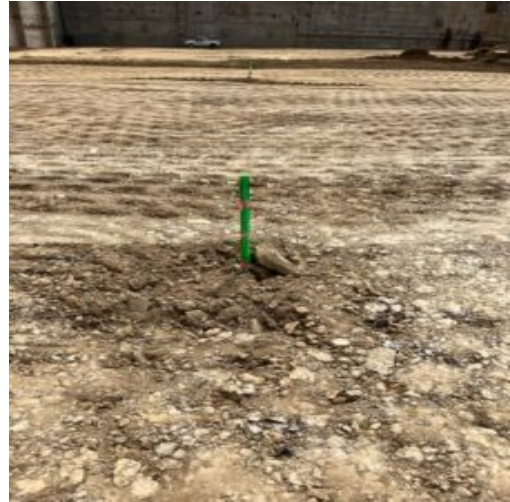
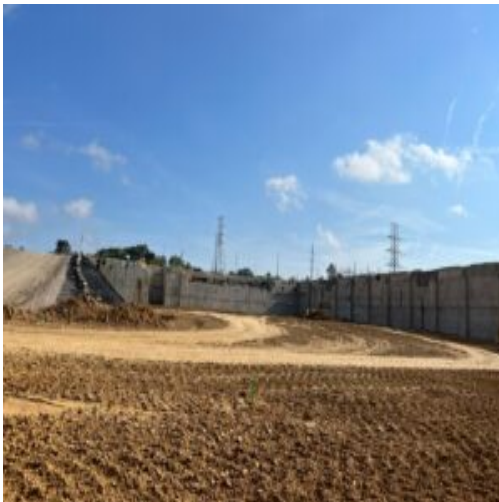
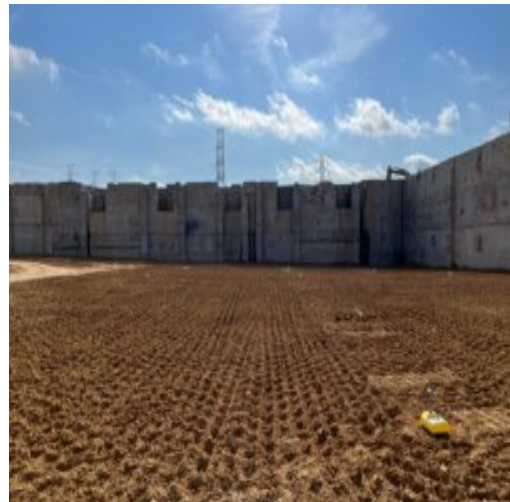
Photo documentation and test locations are attached:

1. Two thousand one hundred sixteen cubic yards of fill materials were placed in sections 1 & 2
2. The fill material was placed in general accordance with ITP-001. The area was probed, and two density tests were performed in section 1, area B7 (E720661 S1 - R5).
3. Photo locations are labeled on the attached drawing. The placement area is shaded in purple on the attached drawing.
