ASEC Report ID : 58596  
Name of the Project : Plant Gorgas Demolition and Grading  
Project Location : 460 Gorgas Rd, Parrish, AL 35580  
Weather : Sunny  
Departure Time : 04/12/2023 16:00  
ASEC Technician Name : Vidal Dias

Our AS ENGINEERING AND CONSULTING, LLC (ASEC) representative Vidal Dias visited the site at the request of Jackson Demolition representative Josh Kelly. The undersigned representative was present to observe, verify and document the ongoing project activities. (Reference drawing E720661 S1 - R5, E720659 S1-R5.)

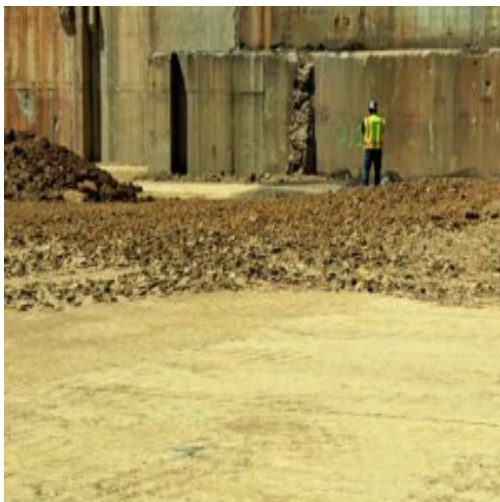
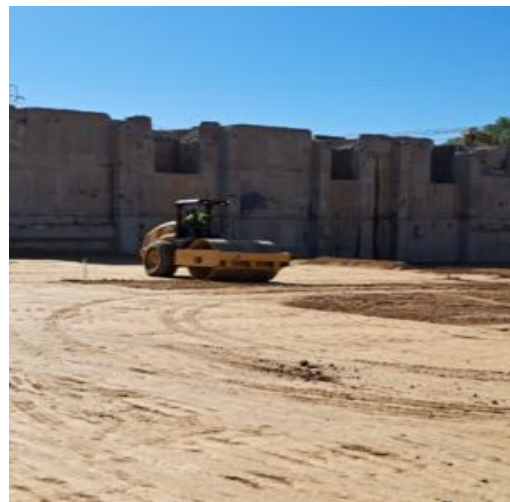
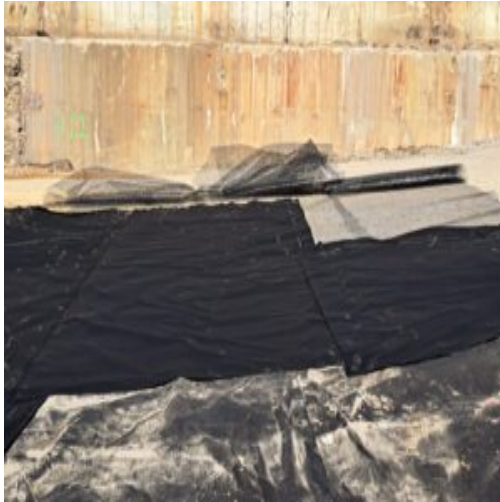
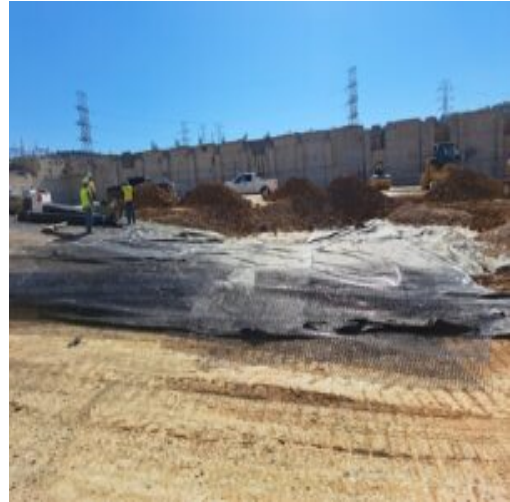
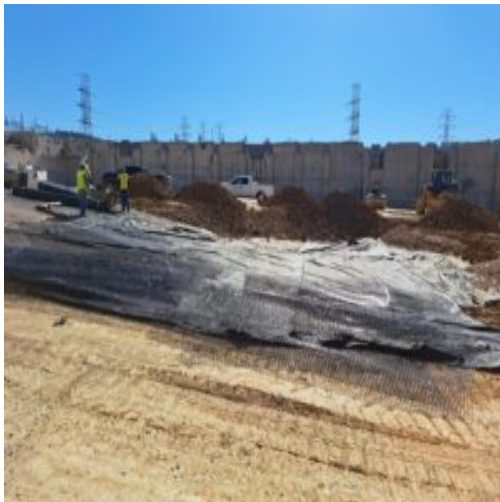
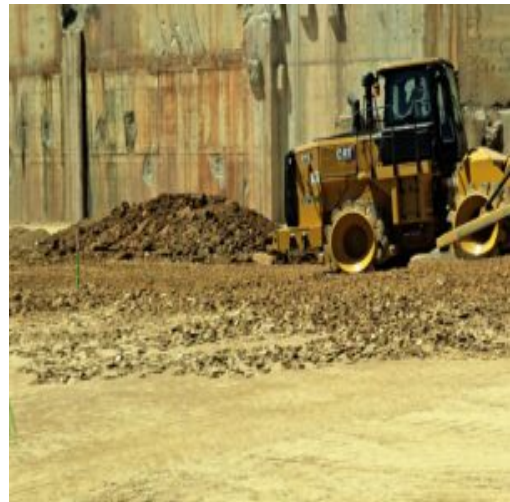
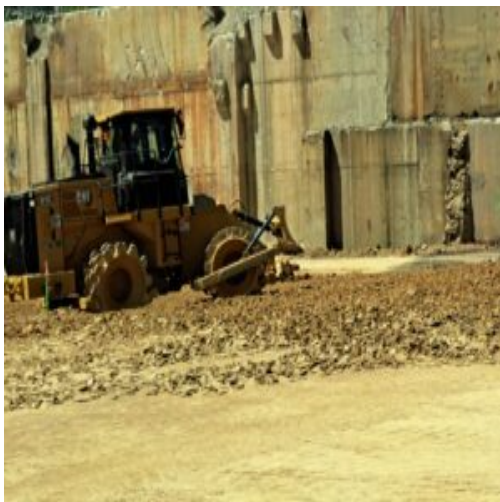
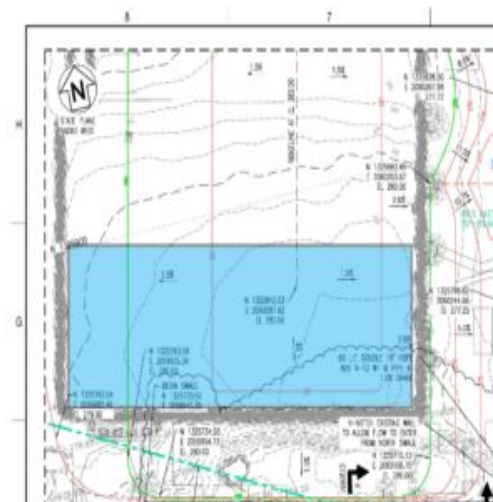
Photo documentation is attached below:

1. One thousand three hundred and thirty-four (1334) cubic yards of fill materials were placed for lift three (3) in section 2 area G7 of the second part (drawing E720659) of the basement. The materials were placed in accordance with ITP-001, and the fill area is highlighted in purple on the attached drawing.
2. Geogrid & filter fabric were placed near the base of the ramp, and fill materials were placed in accordance with ITP-001.
3. The area was probed, and two moisture density tests were performed in section 1 area B7 (E720661 S1 - R5), 130 ft from the north end wall, and section 2 area G8 (E720659 S1-R5), which is at 238 ft from the north end wall.
4. The wet soil was collected from the basement near the section-2 south wall and transferred from the end of the north wall to section-1.
