Date : 04/17/2023  
Project No : 2022C235  
Client Company : Jackson Demolition Service, Inc.  
Arrival Time : 04/17/2023 06:10  
Onsite Hours : 10:00

ASEC Report ID : 58645  
Name of the Project : Plant Gorgas Demolition and Grading  
Project Location : 460 Gorgas Rd, Parrish, AL 35580  
Weather : Partly Cloudy  
Departure Time : 04/17/2023 16:10  
ASEC Technician Name : Vidal Dias

Our AS ENGINEERING AND CONSULTING, LLC (ASEC) representative Vidal Dias visited the site at the request of Jackson Demolition representative Josh Kelly. The undersigned representative was present to observe, verify and document the ongoing project activities. (Reference drawing E720661 S1 - R5, E720659 S1-R5.)

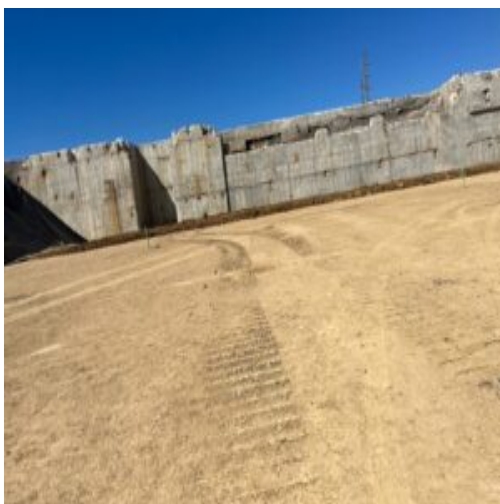
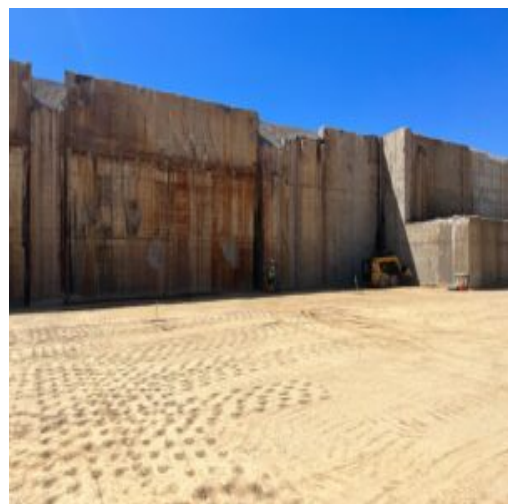
Photo documentation and test locations are attached:

1. One thousand three hundred fourteen (1314) cubic yards of fill material were received and placed in section two of the basement. The fill placement area is shown in *orange* on the attached drawing. The materials were placed in accordance with ITP-001.

2. Two density tests were performed to measure the compaction for a 12-inch lift in section 2 area G7 and 8 in a lift in section 2 area G8. Both compaction tests were 100% and within 3% of optimum moisture.

3. A twenty-foot section of material was removed and replaced due to water flowing into the area and disrupting soil consolidation. The area was excavated to the terrafabric, and HDPE liner was placed beneath the fabric. Several 8-inch lifts were placed atop the lined area and compacted using a walk-behind vibratory compactor. The area is highlighted in *purple* on the attached drawing.

4. Due to saturated soil conditions along the south wall, a 30-foot area needed to be filled. The area is highlighted in *yellow* on the attached drawing.
