ASEC Report ID : 58883  
Name of the Project : Plant Gorgas Demolition and Grading  
Project Location : 460 Gorgas Rd, Parrish, AL 35580  
Weather : Sunny  
Departure Time : 04/25/2023 16:00  
ASEC Technician Name : Vidal Dias

AS ENGINEERING AND CONSULTING, LLC (ASEC) representative Vidal Dias visited the site at the request of Jackson Demolition representative Josh Kelly. The undersigned representative was present to monitor, verify and document the ongoing project activities. (reference drawing E720661 S1 - R5, E720659 S1-R5.)

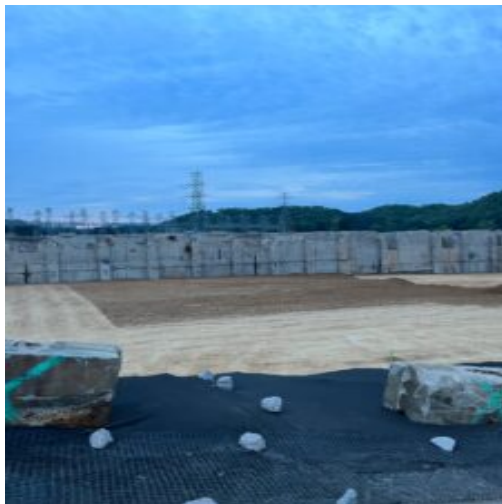
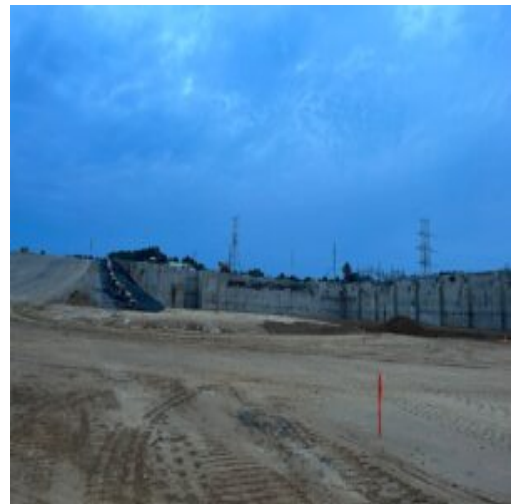
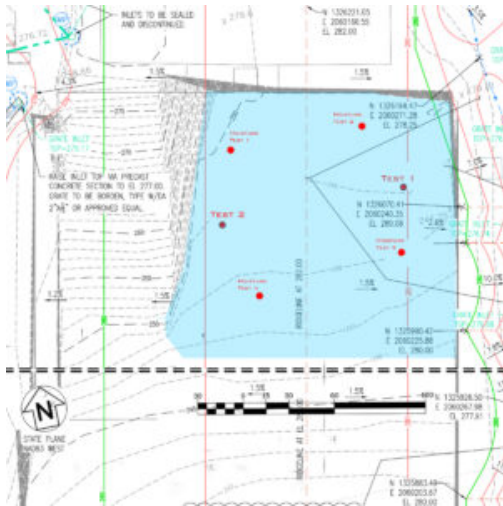
1. One thousand six hundred twenty (1620) cubic yards of fill materials were received and placed for lift eight (8) section one (1) area B7 (drawing E720661). The materials were placed in accordance with ITP-001, and the fill area is highlighted in blue on the attached drawing.
2. During the evaluation, two density tests and one proctor check were performed. The results are attached, and test locations are highlighted in red on the attached drawing.

Photo documentation and test locations are noted below.
