ASEC Report ID : 60050  
Name of the Project : Plant Gorgas Demolition and Grading  
Project Location : 460 Gorgas Rd, Parrish, AL 35580  
Weather : SUNNY  
Departure Time : 06/30/2023 16:30  
ASEC Technician Name : Avinash Bandham

AS ENGINEERING AND CONSULTING, LLC (ASEC) representative Avinash Bandam visited the site at the request of Jackson Demolition representative Josh Kelly. The undersigned representative was present to monitor, verify and document the ongoing project activities. (Reference drawing E720661 S1 - R8, E720659 S1-R8.)

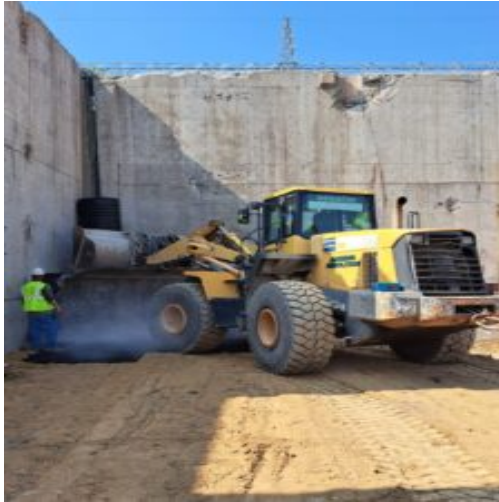
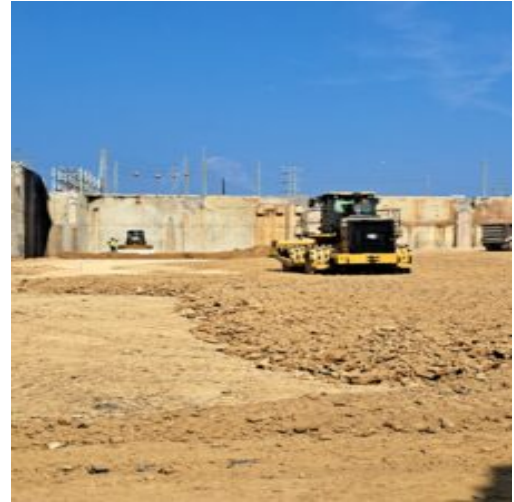
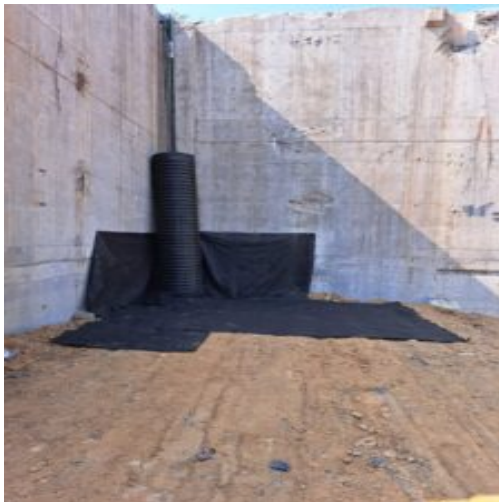
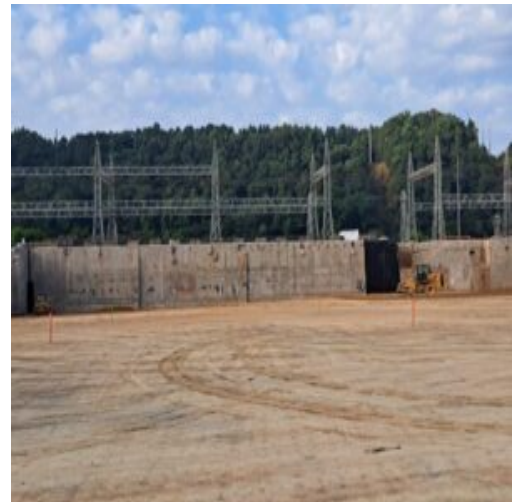
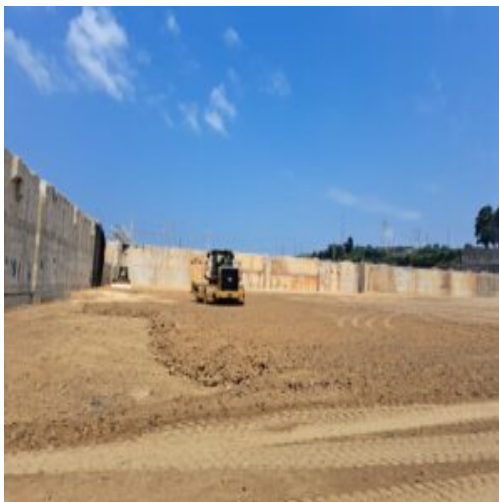
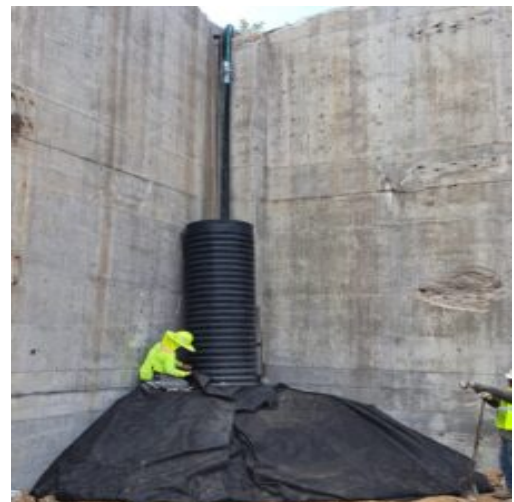
1. One thousand two hundred and forty-two (1242) cubic yards of fill materials were placed for lift (16) in section 2 part 2 area G7 (E720659 S1-R8) for the lift (16). The materials were placed and compacted in accordance with ITP-001, and the fill area is highlighted in brown as depicted in the attached drawing.

2. The basement area was probed using hand probe and performed three moisture density tests in section 1 and section 2 areas of the basement and a check plug has performed to verify the compaction, moisture content percentage with respect to the ASTM standards of the Proctor curves. The test locations are depicted in the enclosed and attached drawing.

3. The Geo-fabric and stone aggregate were placed and covered correspondingly around the HDPE pipe at the corner of the east and south end walls of the basement area G7. The placement of the Geo-fabric and stone aggregate were done in accordance with ITP-006 and ITP-003.
