ASEC Report ID : 59720  
Name of the Project : Carodel Farms @ Union Church Rd  
Project Location : Flowery Branch  
Weather : cloudy  
Departure Time : 06/06/2023 15:30  
ASEC Technician Name : Aminullah Azimi

As requested, the site was visited by our AS Engineering and Consulting (ASEC) representative for the purpose of providing quality control inspection and testing services, visual observation techniques were employed to assure compliance with project drawing/specifications, applicable codes, and materials submittals. The following observations were observed on site this day.

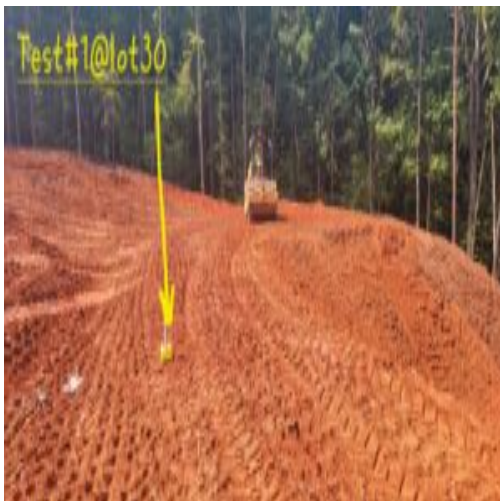
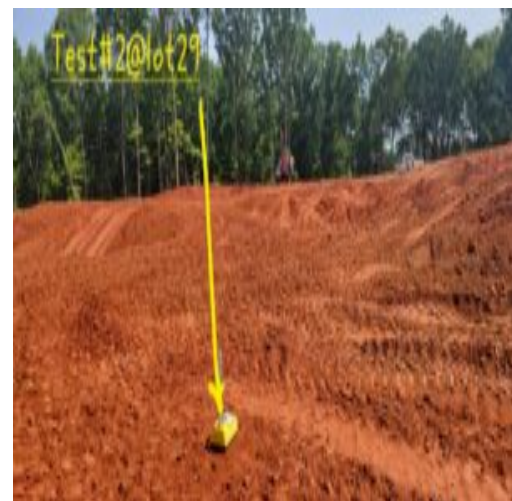
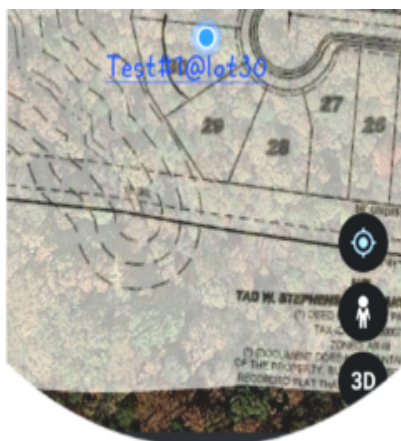
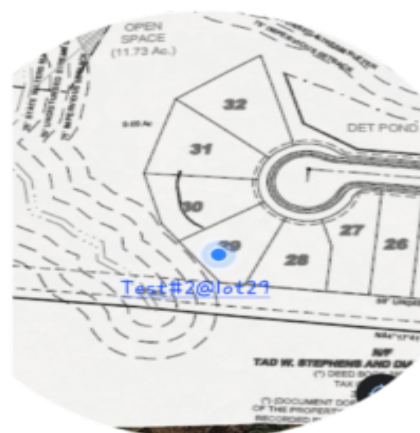
The placement and compaction of backfill soils for Lots #29 and 30 continued this day.

At the time of arrival, our representative observed that work was in progress with lifts being placed to about 1 foot below finished grade and compacted using a P56B compactor.

Density test results will be provided once the Moisture-Density Relationship is performed.
