Date : 07/17/2023  
Project No : 2023C144  
Client Company : CCG  
Arrival Time : 07/17/2023 08:40  
Onsite Hours : 10:15

ASEC Report ID : 60306  
Name of the Project : Carodel Farms @ Union Church Rd  
Project Location : Flowery Branch  
Weather : Cloudy  
Departure Time : 07/17/2023 19:00  
ASEC Technician Name : Vidal Shengan

On 7/17/2023, our AS Engineering and Consulting (ASEC) representative, visited the Carodel Farms site to perform quality control inspection and testing services. Visual observation techniques were employed to ensure compliance with project drawings/specifications, applicable codes, and material submittals. The following observations were made on-site:

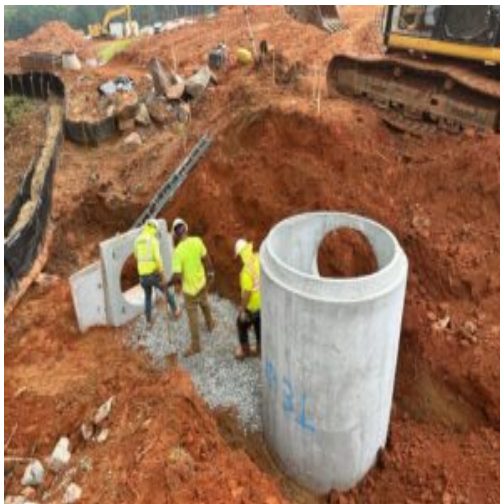
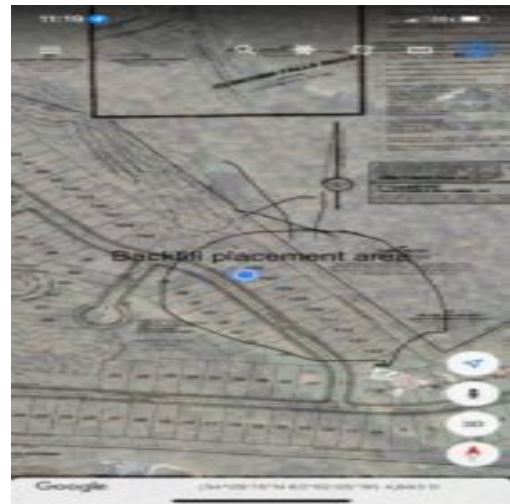
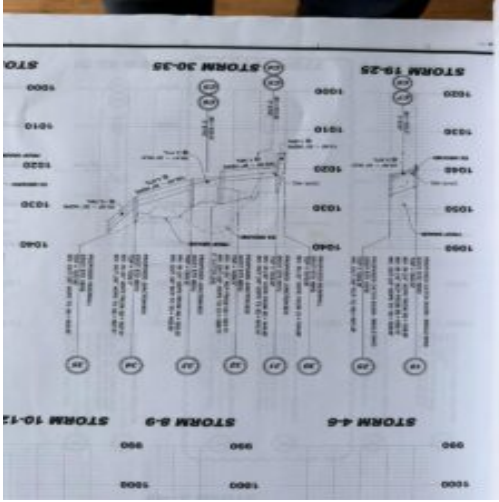
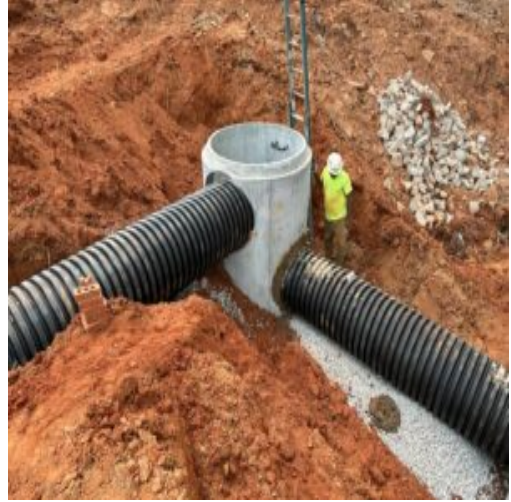
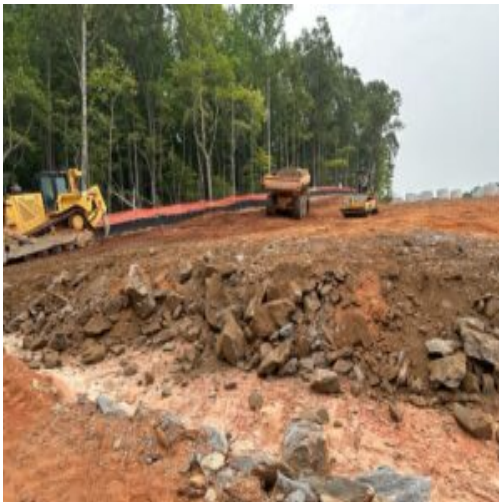
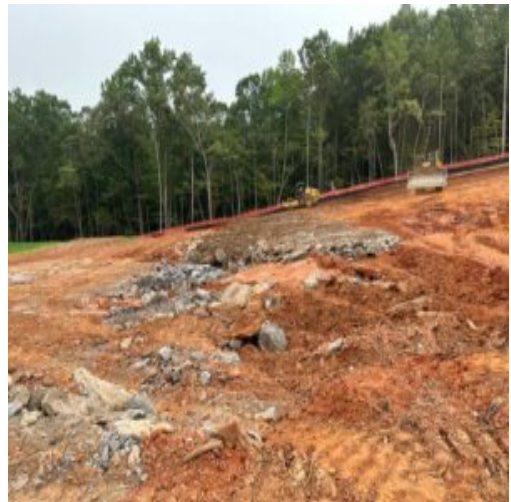
1. Installation of Precast Concrete Units: The contractor installed precast concrete units numbered 30 and 31 (from sheet C12.1). Visually inspected the installation of the precast units and confirmed that they met the project requirements.

2. Installation of HDPE Pipes: Between precast concrete units numbered 30 and 31 on sheet C12.1 the contractor also installed HDPE (High-Density Polyethylene) piping. Visually inspected the pipe installation and verified that it was in accordance with the project specifications.

3. Rock Drilling: A total of 105 holes were drilled in the rock over an area of 5,145 square feet (105 x 49). The spacing between the drilled holes was 7 feet, and the hole diameter was 4 inches. Drilling results were collected between started depths and termination depths of rocks. The drilling activities were carried out as per the project specifications.

4. Observed backfilling of soil: backfill soil mix with big rocks were placed between Lot #106 and Lot #116 to depths of 8 foot below finished grade, as previously identified on sheet C 0.1. The quality control representative visually inspected the placement and compaction activities and determined them to be in compliance with project requirements. No issues were noted during the observation.
