Date : 07/20/2023  
Project No : 2023C144  
Client Company : CCG  
Arrival Time : 07/20/2023 08:45  
Onsite Hours : 9:45

ASEC Report ID : 60431  
Name of the Project : Carodel Farms @ Union Church Rd  
Project Location : Flowery Branch  
Weather : Cloudy  
Departure Time : 07/20/2023 18:30  
ASEC Technician Name : Vidal Shengan

Our AS Engineering and Consulting (ASEC) representative visited the Carodel Farms site to conduct quality control inspection and testing services. Visual observation techniques were employed to ensure compliance with project drawing/specifications, applicable codes, and materials submittals. The following observations were made on-site:

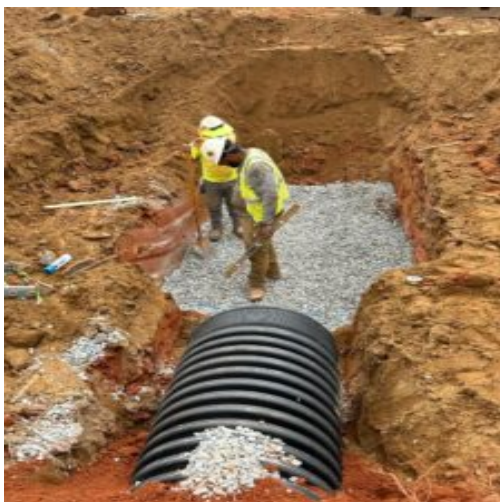
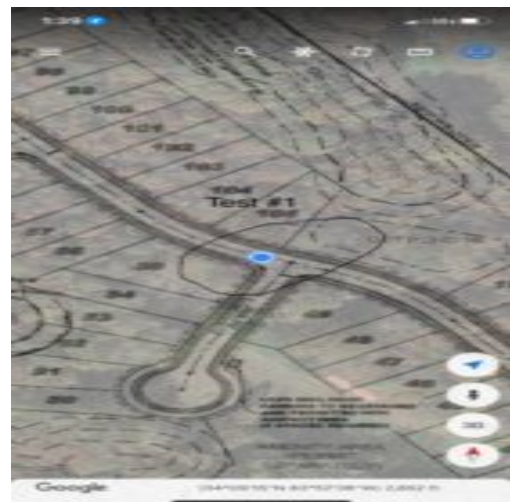
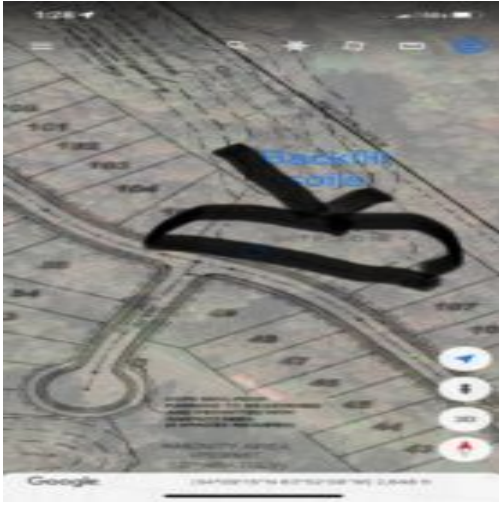
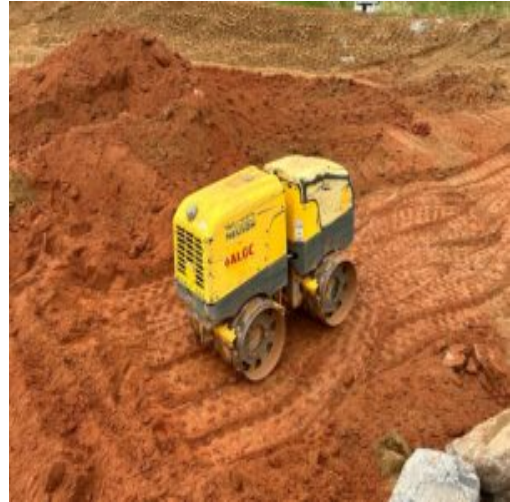
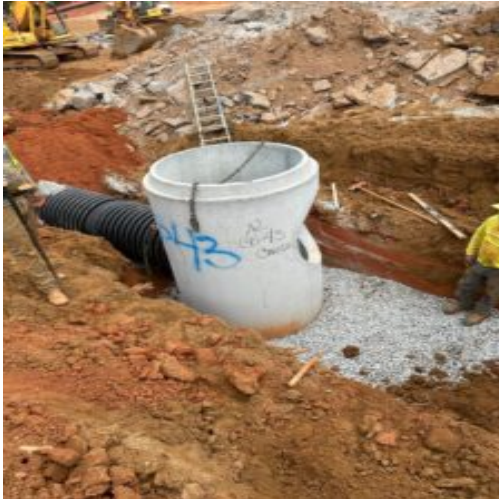
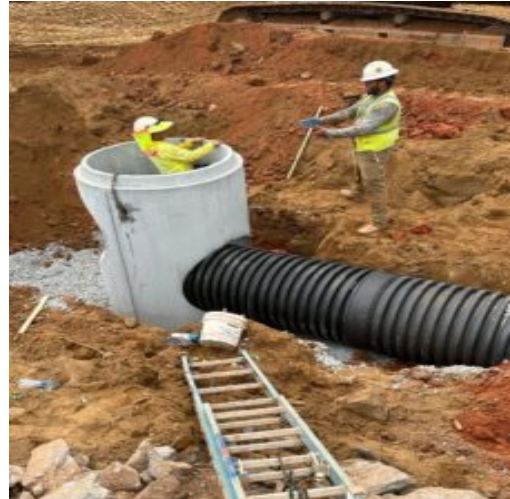
1. Installation of manhole 43: The contractor installed manhole 43 with 4 inches of #57 stone at the base before placing the manhole. The quality control representative visually inspected the installation and verified that it met the project requirements.

2. Installation of HDPE Pipe: Between manhole 43 and manhole 37, the contractor installed HDPE (High-Density Polyethylene) pipe. Before placing the pipes, the contractor prepared the bottom with 4 inches of #57 stone and also covered the pipes with 4 inches of stone. The quality control representative visually assessed the installation and confirmed that it was executed according to the project specifications.

3. Backfilling Operations: The contractor placed backfill soil in detention pond 1B and backfill soil on the road between detention pond 1b and Lots #55, 49 and 105. One density test was performed in the center of the road, 3 feet below finished grade. The testing result indicated that the compaction met project requirements of 92% of the maximum dry density obtained by the ASTM D698-12 standard method. WD=108.0, DD=88.3, m%=22.2%

4. Drilling Operations: Driller 1 drilled a total of 50 holes with a drilled area of 2,205 cubic feet. The hole spacing length was 7 feet by 7 feet, and the hole diameter was 4 inches. Driller 2 drilled 46 holes with a drilled area of 1568 cubic feet. The quality control representative monitored the drilling operations and confirmed that they were conducted safely and efficiently.
