ASEC Report ID : 60736  
Name of the Project : Carodel Farms @ Union Church Rd  
Project Location : Flowery Branch  
Weather : Cloudy  
Departure Time : 08/02/2023 17:30  
ASEC Technician Name : Vidal Shengan

On 08-02-2023, the AS Engineering and Consulting (ASEC) representative visited the Carodel Farms site to conduct quality control inspection and testing services. Visual observation techniques were employed to ensure compliance with project drawing/specifications, applicable codes, and materials submittals. The following observations were made on-site:

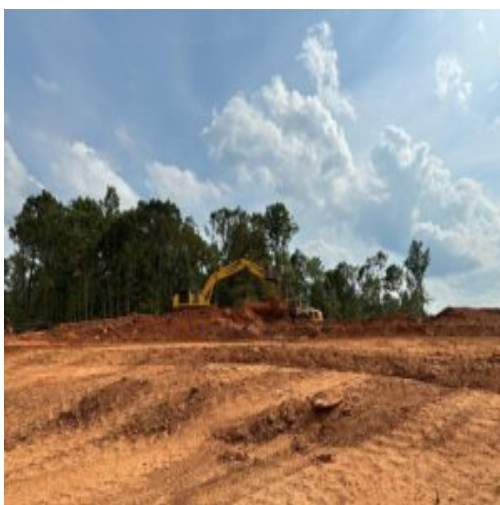
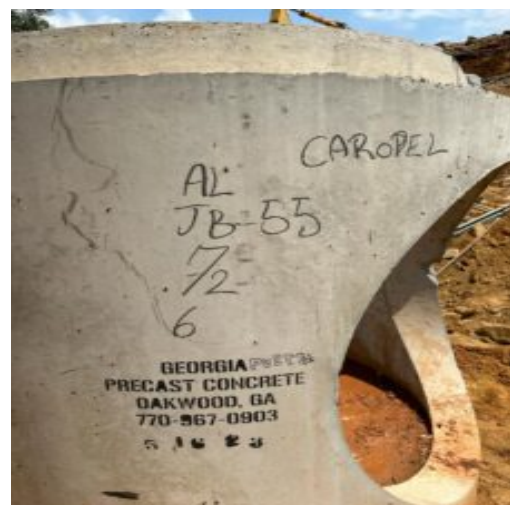
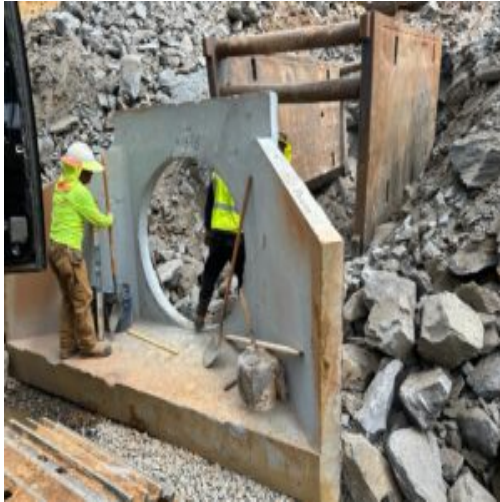
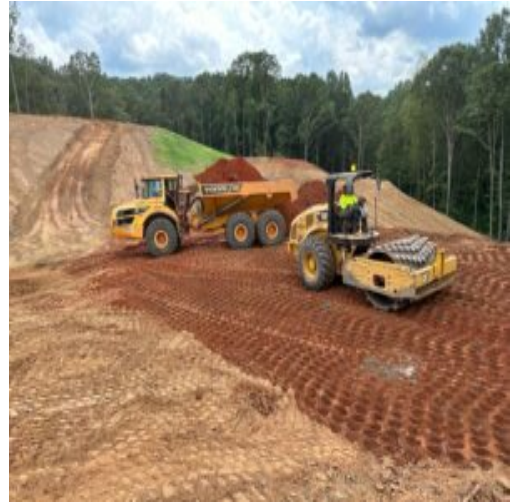
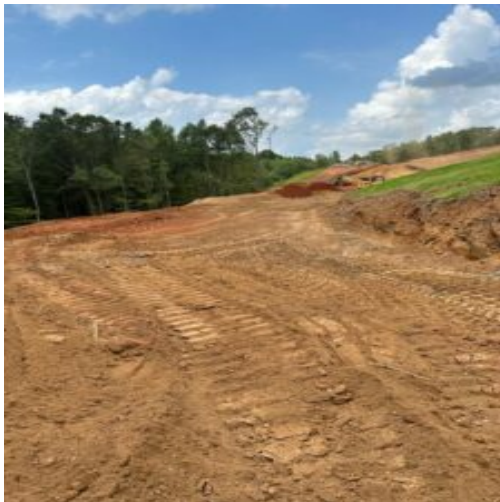
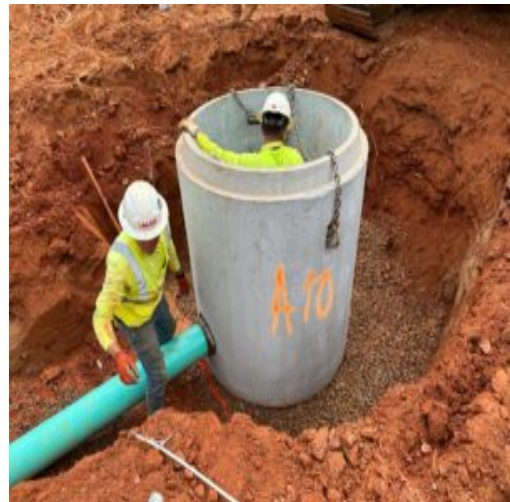
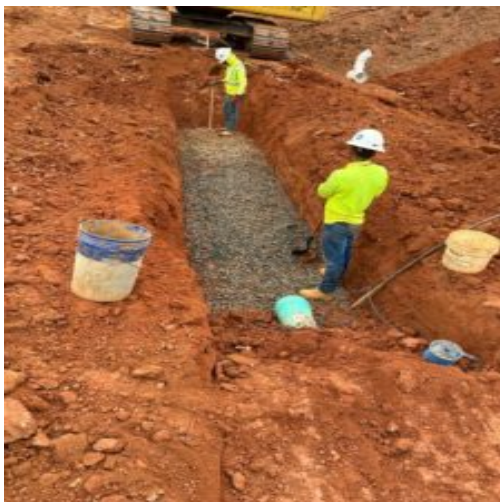
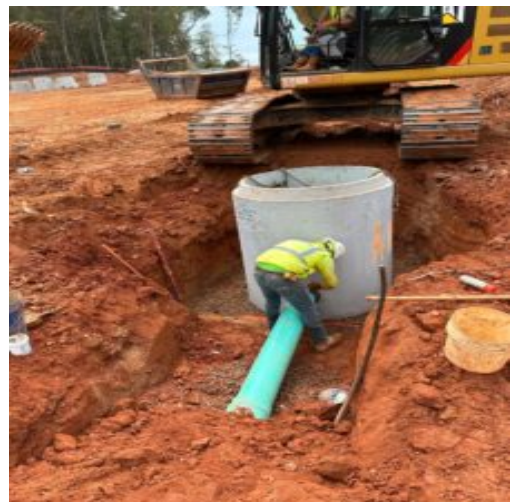
1. Installation of Manhole: Contractor installed Manhole A-10 and manhole JB-55 with 4" stone (057) at the bottom before placing the manhole. The quality control representative visually inspected the installation and observed that it met the project requirements.

2. Installation of HDPE Pipe: Between Manhole A-9 and Manhole A-10, the contractor installed HDPE (High-Density Polyethylene) pipe. Before placing the pipes, the contractor prepared the bottom with 4" stone and also covered the pipes with 4" stone. The quality control representative visually assessed the installation and observed that it was executed according to the project specifications.

3. Backfilling and Topsoil Operations: contractor placed backfill soil in zone x. The quality control representative visually inspected the backfilling operations.

4. Drilling Operations: Driller 1 drilled a total of 36 holes with a drilled area of 1764 cubic feet. The hole spacing length was 7 feet by 7 feet, and the hole diameter was 4 inches. The quality control representative monitored the drilling operations and confirmed that they were conducted safely and efficiently.
