ASEC Report ID : 60974  
Name of the Project : Carodel Farms @ Union Church Rd  
Project Location : Flowery Branch  
Weather : sunny  
Departure Time : 08/22/2023 13:00  
ASEC Technician Name : Aminullah Azimi

As requested, our ASEC representative was on site to observe the construction of the welded wire basket retaining wall. The following was observed:

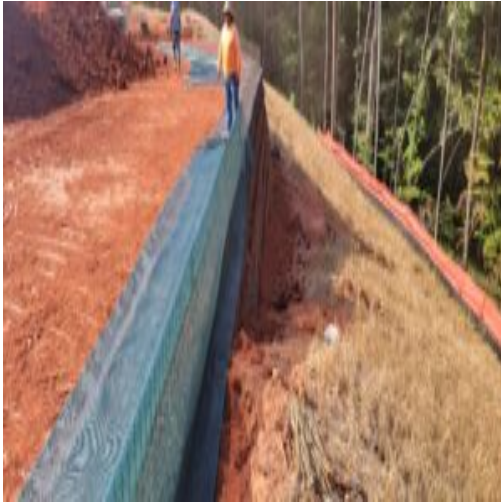
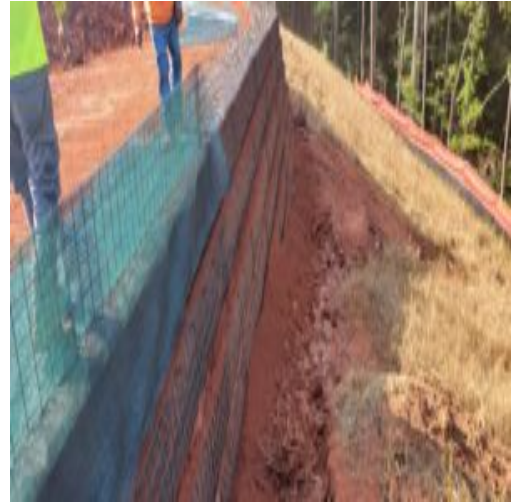
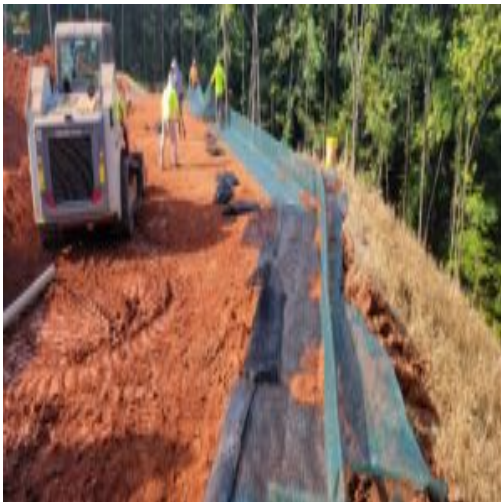
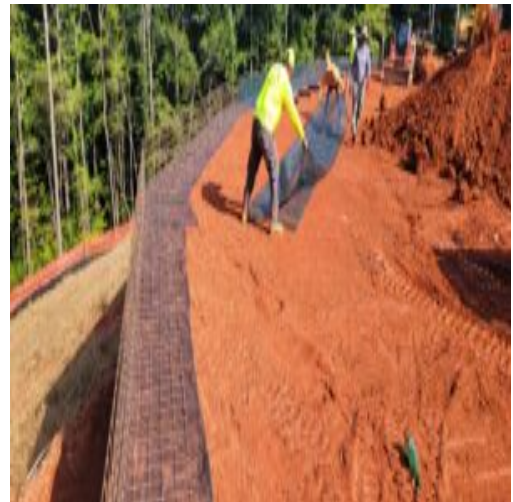
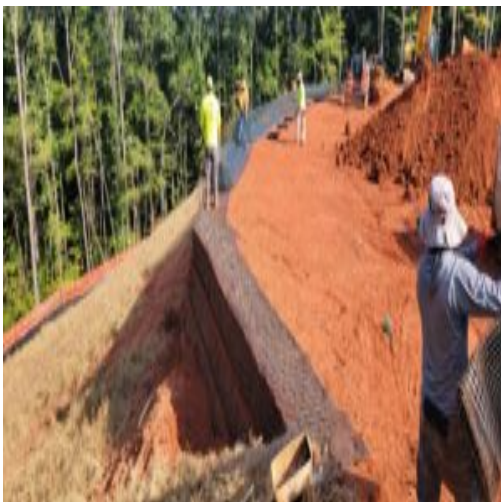
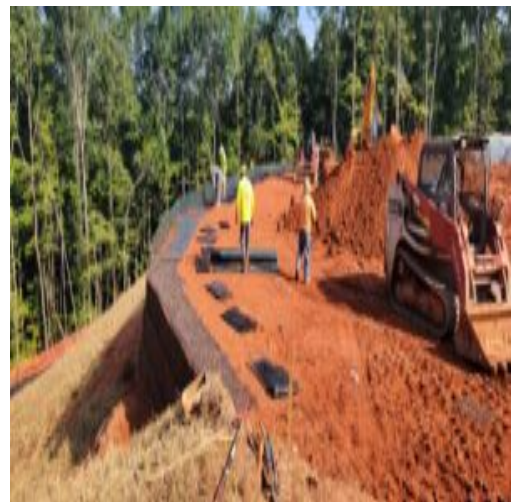
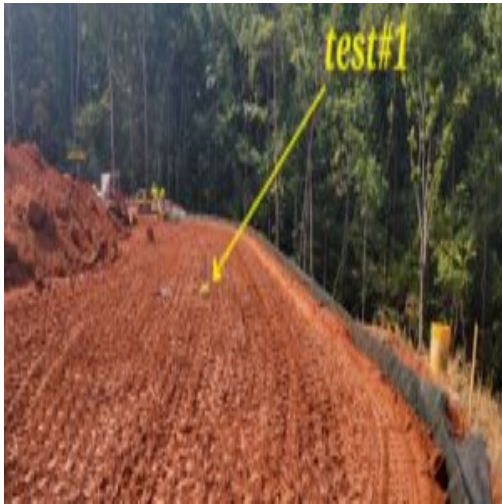
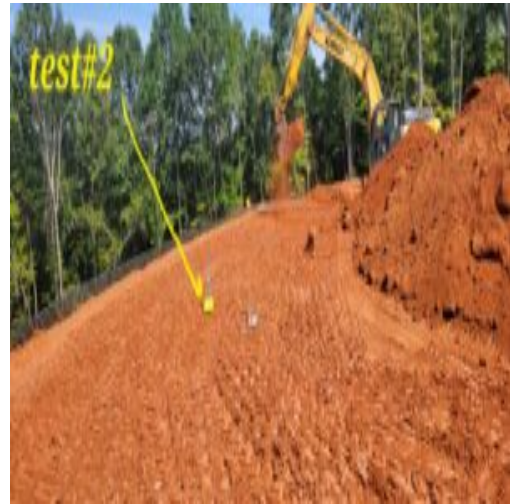
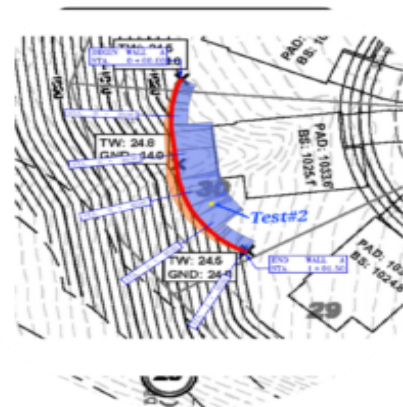
The retaining wall utilized welded wire baskets, each measuring approximately 18" x 18". These baskets were observed to be installed in accordance with the project design drawings for size, spacing and quantity. The reinforced zone behind the wire baskets extended to a distance of approximately 18 feet, as specified in the project design. The backfill soil was placed in layers of 8 to 10 inches and compacted using a sheepsfoot roller.

The reinforced zone behind the wire baskets extended to approximately 18 feet. Backfill soil was placed in layers of 8 to 10 inches. The sheepsfoot roller was used to compact the backfill soil.

The backfill soil compaction was tested using a nuclear gauge. Results are attached. General probing using a 3/8" diameter probe rod was also performed.
