ASEC Report ID : 61215  
Name of the Project : Carodel Farms @ Union Church Rd  
Project Location : Flowery Branch  
Weather : sunny  
Departure Time : 09/01/2023 12:00  
ASEC Technician Name : Aminullah Azimi

As requested, our ASEC representative was on site to observe the placement of welded wire basket Retaining Wall B. The following was observed:

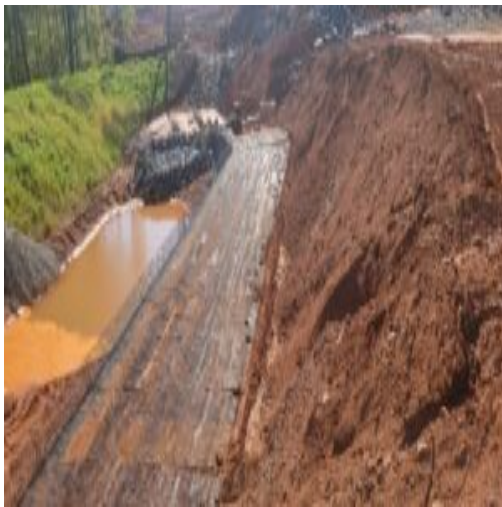
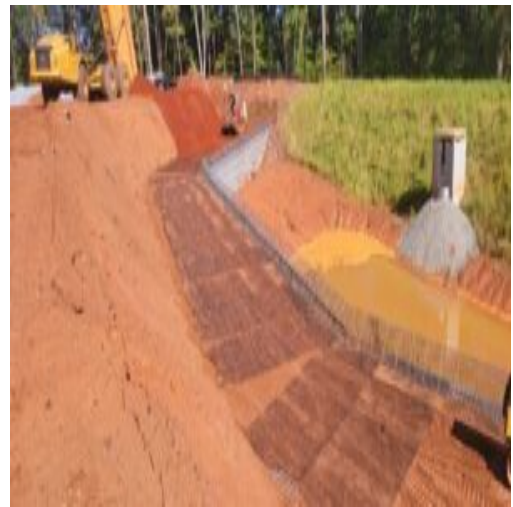
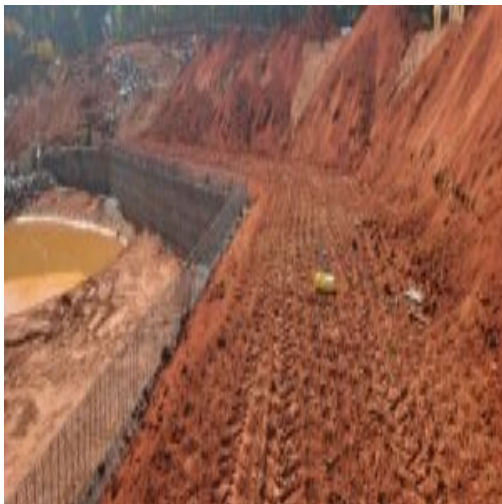
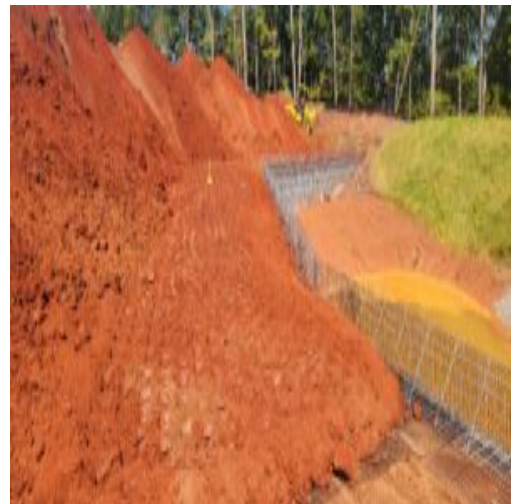
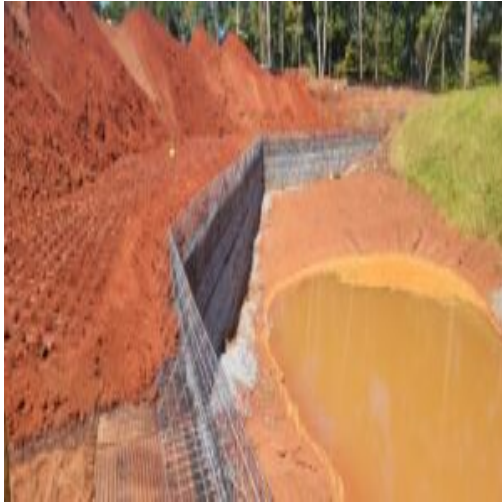
The retaining wall utilized welded wire baskets, each measuring approximately 18" x 18". These baskets were installed in accordance with the project design drawings for size, spacing and quantity. The reinforced zone behind the wire baskets extended to a distance of approximately 18 feet, as specified in the project design. The backfill soil was placed in layers of 8 to 10 inches and compacted using a pad foot roller.

The reinforced zone behind the wire baskets extended to approximately 18 feet. Backfill soil was placed in layers of 8 to 10 inches and compacted. A pad foot roller was used to compact the backfill soil.

The backfill soil was tested using a nuclear gauge to assess compaction levels and general probing using a 3/8" diameter probe rod was also conducted to verify uniformity and stability.
