ASEC Report ID : 61293  
Name of the Project : Carodel Farms @ Union Church Rd  
Project Location : Flowery Branch  
Weather : sunny  
Departure Time : 09/05/2023 16:30  
ASEC Technician Name : Aminullah Azimi

As requested, our ASEC representative was on site to observe the installation of Retaining Wall B. The following were observed:

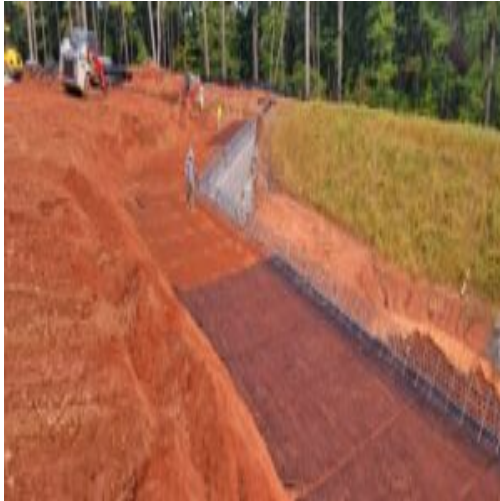
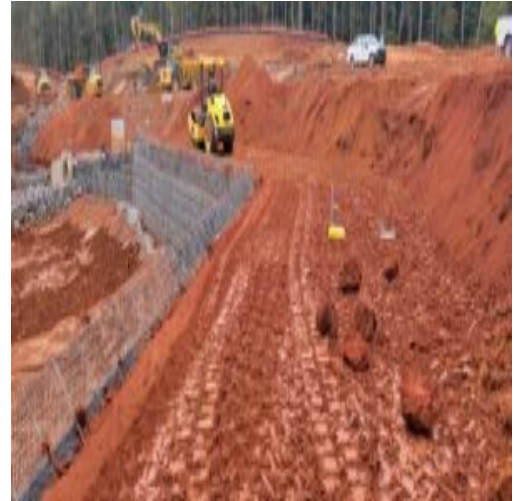
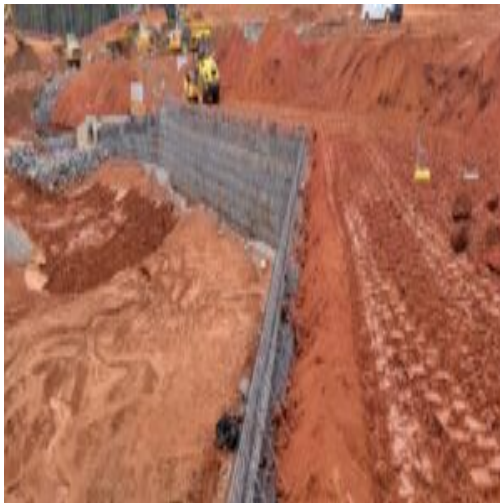
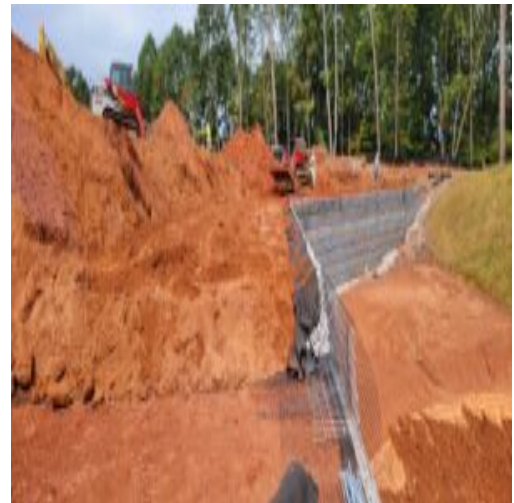
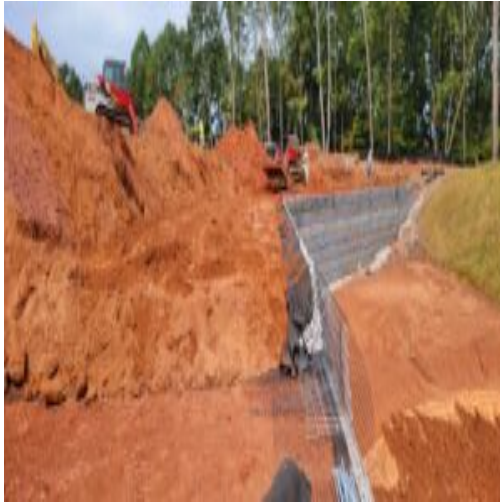
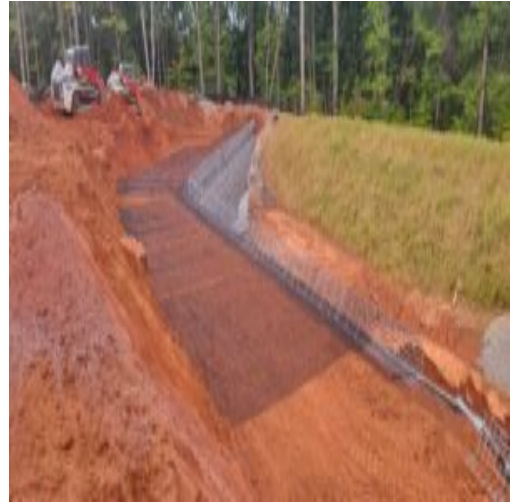
The retaining wall utilized welded wire baskets, each measuring approximately 18" x 18". These baskets appeared to be installed in accordance with the project design drawings. The reinforced zone behind the wire baskets extended to a distance of approximately 18 feet, as specified in the project design. The backfill soil was placed in layers of 8 to 10 inches and compacted using a pad foot roller.

The reinforced zone behind the wire baskets extended to approximately 18 feet. Backfill soil was placed in layers of 8 to 10 inches then compacted using a pad foot roller.

The backfill soil compaction was tested using a nuclear density gauge. General probing using a 3/8" diameter probe rod was also conducted to verify stability.

The construction of the welded wire basket retaining wall B at [Carodel Farm@Union Church Rd] appeared to be installed in accordance with the project design drawings and specifications.
