ASEC Report ID : 62691  
Name of the Project : Carodel Farms @ Union Church Rd  
Project Location : Flowery Branch  
Weather : sunny  
Departure Time : 10/18/2023 16:00  
ASEC Technician Name : Aminullah Azimi

The placement and compaction of backfill soils for the storm trench between MH3 to MH4, continued this day.

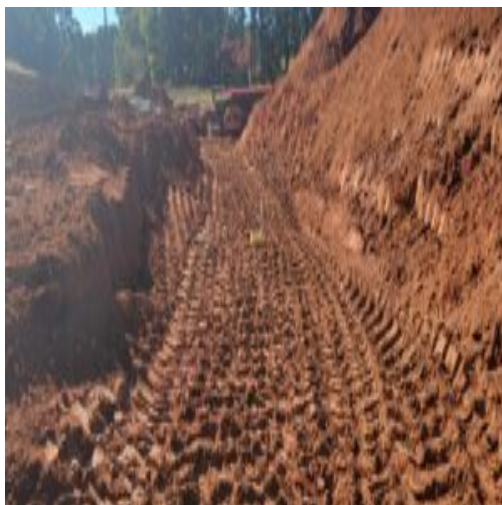
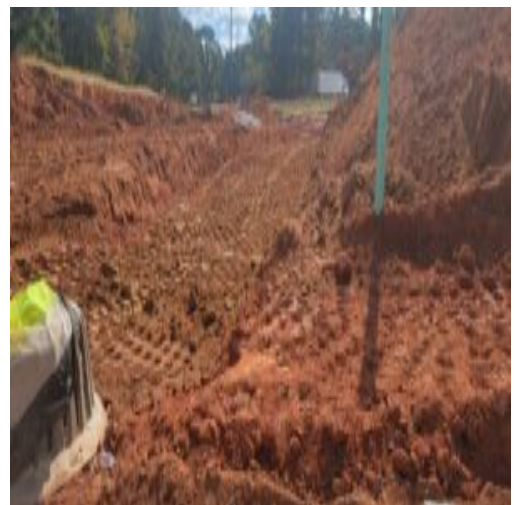
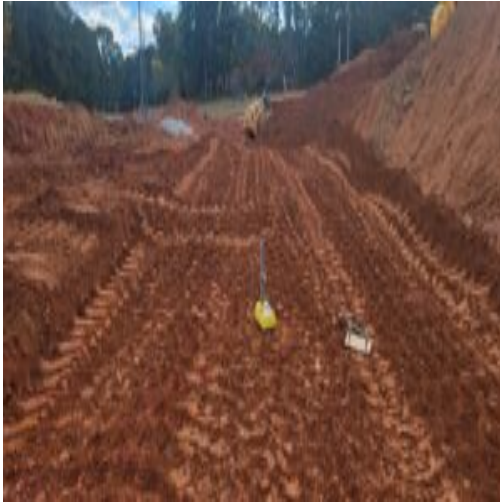
At the time of arrival, our representative observed that work was in progress for the storm trench with approximately one (1) foot lifts being placed at finished grade and compacted using a sheeps-foot compactor.

Density test results indicate that the compacted materials met the project requirement of 90% for Storm trench, of the maximum dry density obtained by the (Standard Proctor ASTM 698). Results are attached.
