ASEC Report ID : 65361  
Name of the Project : Lakeside Sub., Calhoun  
Project Location : Calhoun  
Weather : overcast  
Departure Time : 03/14/2024  
ASEC Technician Name : Russell Hendrix

**Project Location:** South of 4.3 for Lot 084-02

**Overview:** Continuation of sanitation sewer work involved the placement of a lateral (8-inch green pipe) just south of 4.3 for Lot 084-02. The installation process included the use of stone bedding and subsequent lifts, along with specific measures for road preparation and compaction testing considerations.

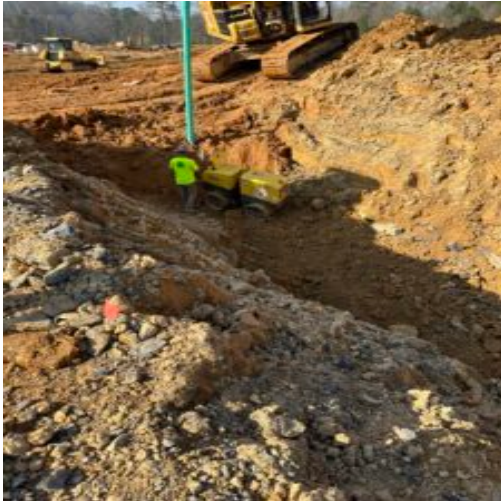
- The lateral (8-inch green pipe) was placed just south of 4.3 for Lot 084-02.
- Approximately 6 inches of 57 stone bedding was utilized to provide stable support for the sanitation pipe.

- Following the placement of the sanitation pipe, an additional 6 inches of 57 stone was placed above the pipe.

- Subsequent lifts ranged between approximately 3 to 4 feet in depth. We recommended that lift thicknesses be kept to 8 to 12 inches.

Sanitation lateral sewer placement

- Regular monitoring of the sewer installation and compaction efforts should be maintained.

- Implementing quality assurance measures, such as visual inspections and adherence to established guidelines, can help mitigate potential issues during installation.

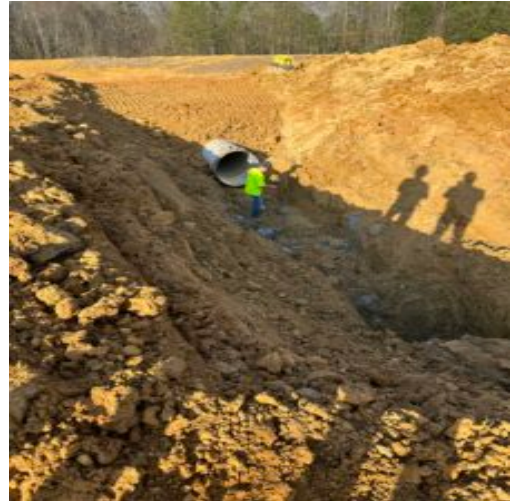
storm drain placement
