Date : 02/21/2024  
Project No : 2024C112  
Client Company : SR Homes  
Arrival Time : 02/21/2024  
Onsite Hours :

ASEC Report ID : 64230  
Name of the Project : Sterlington  
Project Location : Canton  
Weather : sunny  
Departure Time :  
ASEC Technician Name : Russell Hendrix

1. Introduction: A site visit was conducted by a representative from AS Engineering and Consulting (ASEC) to provide quality control inspection and testing services for the Lakeside project located Sterlington in Canton. The purpose of the visit was to verify compliance with project drawings/specifications, applicable codes, and materials submittals using visual observation techniques.

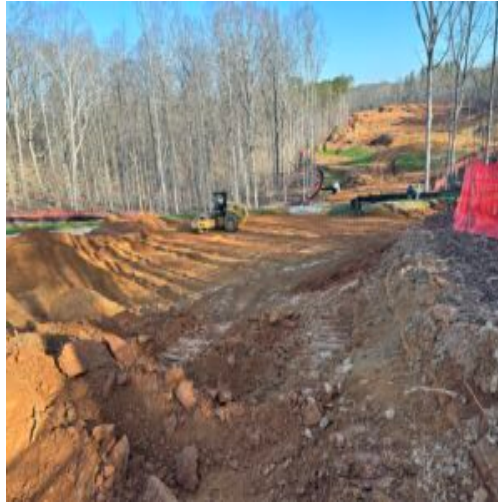
3. Observations: During the site visit, the following observations were made:
  - Equipment Activity: Upon arrival, a CP54B sheeps-foot vibratory compactor was observed finishing the last lift located at the center of the road at station 9.00+50.

- Density-Moisture Ratio(proctor) and Testing: An optimum proctor was 94.8 dry density and 25% moisture content was referenced. Two tests were conducted using a Troxler 3430:

1. Test 1: Dry Density (DD) of 94.0 and moisture content of 21%
    2. Test 2: Dry Density (DD) of 93.6 and moisture content of 21% - Both tests resulted in a 99% compaction.

future roadway center of project and testing location

4. Recommendations: Based on the observations, the following recommendations are made:
  - Schedule proof-roll: Coordinate with the project team to schedule a proof-roll to verify the compaction meets project requirements before proceeding with asphalt paving.
