Date : 05/06/2024  
Project No : 2024C112  
Client Company : SR Homes  
Arrival Time : 05/06/2024 7:30  
Onsite Hours : 03:00

ASEC Report ID : 66423  
Name of the Project : Sterlington  
Project Location : Canton  
Weather : sunny  
Departure Time : 05/06/2024 10:30  
ASEC Technician Name : Aminullah Azimi

Our ASEC representative arrived onsite to observe CMU block placement for retaining wall #1.

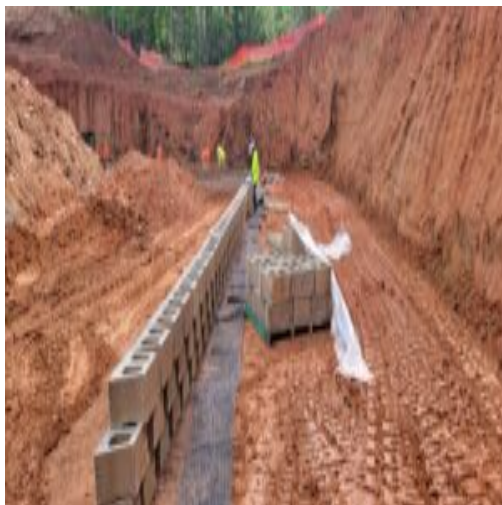
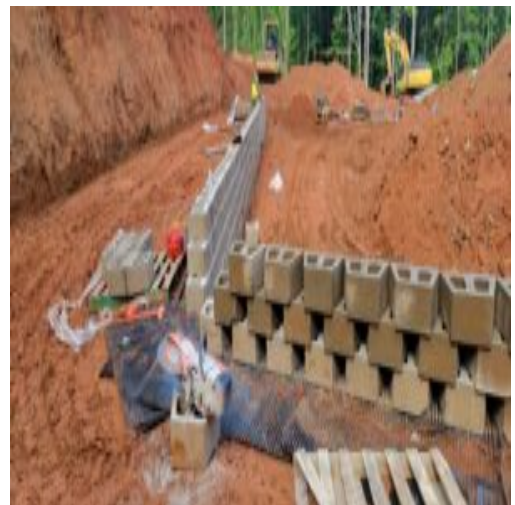
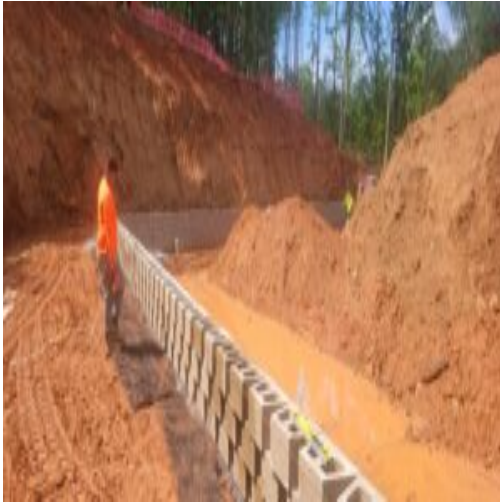
Every 3rd course of block "Geo-Grid" was placed.

No. 57 stone was utilized 1 foot behind the block and within the cells.

No backfill was placed on this day due to the fill material being high in moisture content.
