Date : 05/08/2024  
Project No : 2024C112  
Client Company : SR Homes  
Arrival Time : 05/08/2024 9:00  
Onsite Hours : 08:00

ASEC Report ID : 66447  
Name of the Project : Sterlington  
Project Location : Canton  
Weather : cloudy  
Departure Time : 05/08/2024 17:00  
ASEC Technician Name : Aminullah Azimi

The undersigned arrived onsite to observe CMU block retaining wall #1 installation.

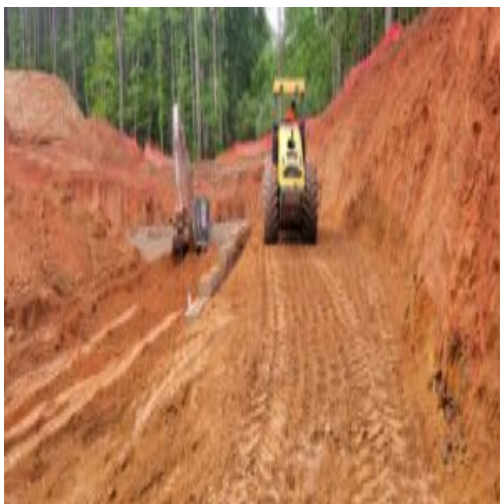
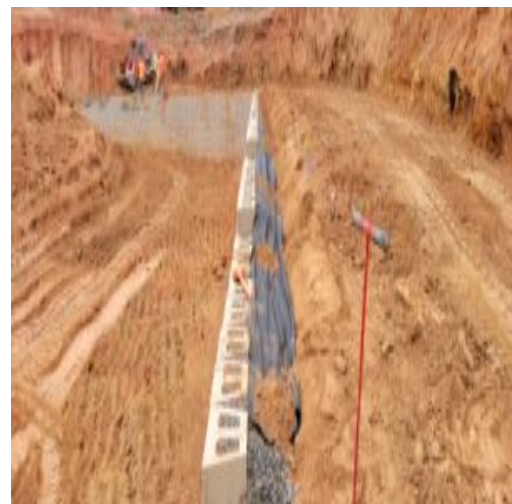
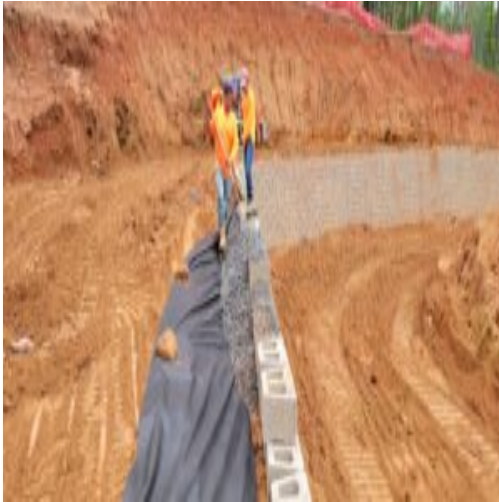
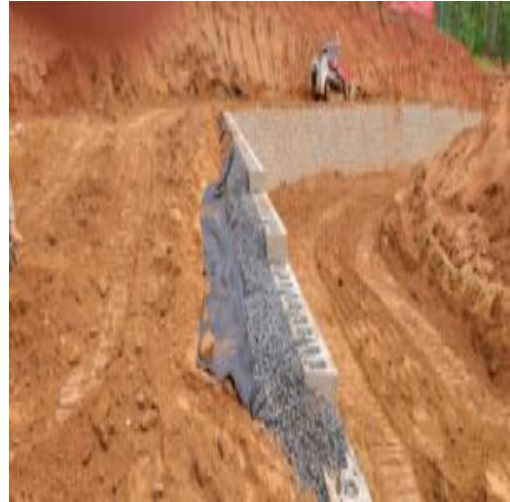
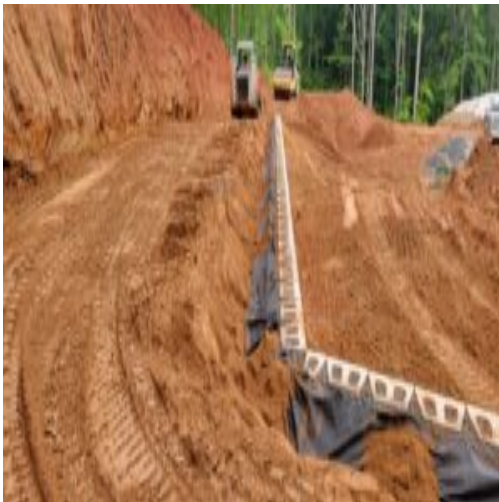
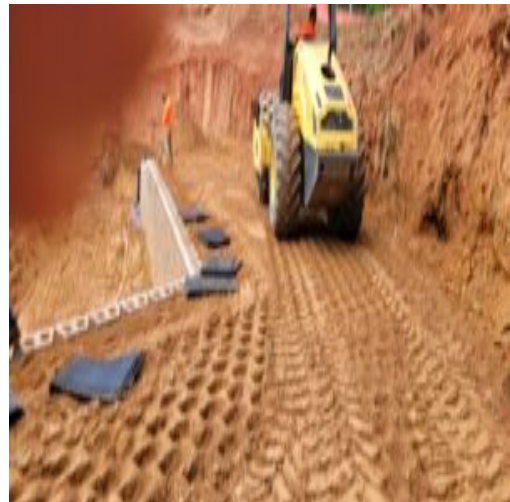
The undersigned noted that base course material was used as backfill behind the block and in the cells (crushed #57 stone).

Geo-Grid was placed every 3rd course of the wall. Backfill was placed in 12-inch lifts and compacted using a 12-ton pad-foot and trench compactor.

#57 stone was also utilized 1 foot behind the block and within the cells.
