Date : 05/02/2024  
Project No : 2024C116  
Client Company : Peeples Owner, LLC  
Arrival Time : 05/02/2024  
Onsite Hours :

ASEC Report ID : 66369  
Name of the Project : Peeples Valley Rd, Overlook at Pettit  
Project Location : Cartersville  
Weather : sunny  
Departure Time : 05/02/2024  
ASEC Technician Name : Russell Hendrix

This report documents the assessment and actions taken regarding subgrade preparation and proof-rolling evaluation at the project site. The evaluation covered two distinct areas, detailing the procedures conducted, observations made, and recommendations provided for further action.

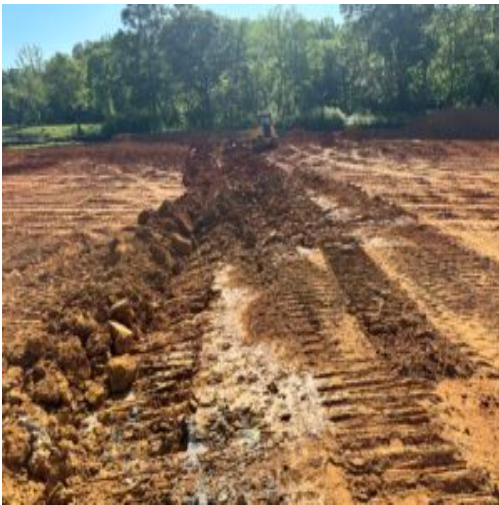
- Area: Approximately 150 feet x 100 feet, located on the northeast side of the project.
- Scope: Included future Mallard Point Road from STA 4+00 to 5+00, partially Lots #33 to 41, and the back parking lot.
- Assessment: The initial proof-roll conducted with a loaded tandem off-road dump truck (refer to attached photo) displayed severe pumping and/or rutting.
- Action Taken:
  - The area was scarified and aerated for three hours and turned with a Komatsu dozer.
  - This area was re-compacted using a Caterpillar CP54B ride-on vibratory sheep's foot.
- Follow-up: Another proof roll was conducted, with marginal improvement observed.
- Recommendation: Based on discussion with our ASEC engineer, it was advised to add several 8-inch compacted lifts and conduct additional proof-rolls to assess improvements.

area 1 being scarified

1. For Area #1:
  - Continue with the implementation of several 8-inch lifts and conduct additional proof-rolls to monitor progress.
  - Slope and seal the area in anticipation of upcoming rain events to mitigate potential damage.
2. For Area #2:
  - Implement appropriate measures to address subgrade concerns based on further evaluation.

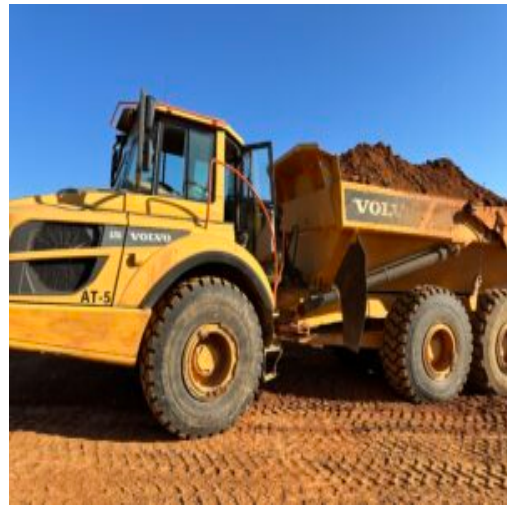
proof roll loaded tandem off road dump truck

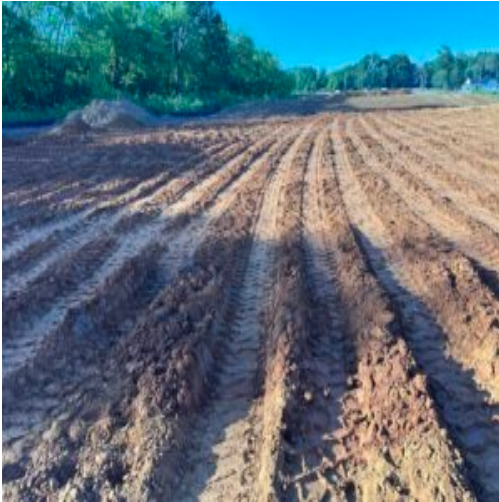
- Area: Approximately 115 feet x 100 feet, located on the west side of the project adjacent to the detention pond.
- Assessment: The initial proof roll was deemed unacceptable.
- Action Taken: The area was scarified; however, no further work was observed in this area.

area 2

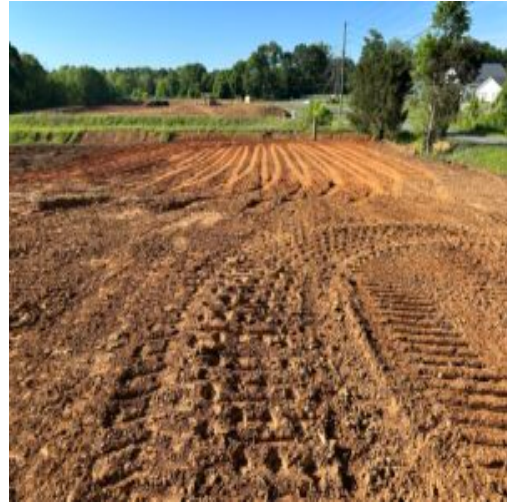
area 2
