ASEC Report ID : 67346  
Name of the Project : Peeples Valley Rd, Overlook at Pettit  
Project Location : Cartersville  
Weather : Sunny  
Departure Time : 06/13/2024  
ASEC Technician Name : Russell Hendrix

A meeting was convened to address issues affecting the detention pond area and to discuss potential solutions. This report details the key points discussed, the engineer's recommendations, and the agreed-upon actions.

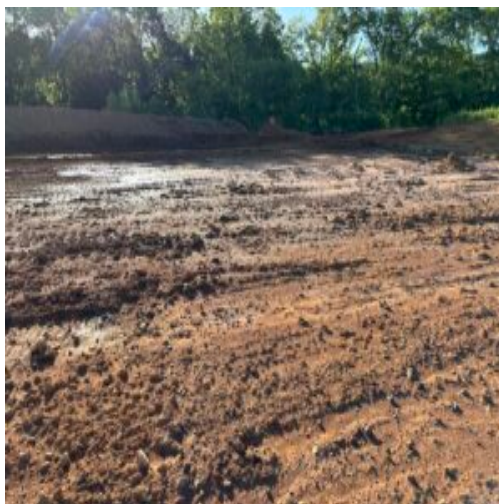
- Assessment of the affected area, including erosion, soil stability, and structural integrity.
- Review of previous inspections and reports by the soil technician.

Affected area

- **2-Foot Bridge Lift:**
  - The engineer recommended implementing a 2-foot bridge lift to stabilize the affected area.
- **Possible Need for Soil Cement:**
  - The engineer suggested that soil cement might be needed at a later date to further reinforce the area if initial measures are insufficient.

- Commence the construction of the 2-foot bridge lift as recommended by the engineer.
- Assign roles and responsibilities to the grading foreman, soil technician, and construction crew.
- Ensure procurement of necessary materials and equipment.
