Date : 08/20/2026  
Project No : 2026C101  
Client Company : Artisan  
Arrival Time : 08/20/2026 07:30  
Onsite Hours : 08:00

ASEC Report ID : 97048  
Name of the Project : Seven Hills PHASE 13, UNIT 3 Lots  
Project Location : Dallas  
Weather : Sunny  
Departure Time : 08/20/2026 15:30  
ASEC Technician Name : Clyde Smith

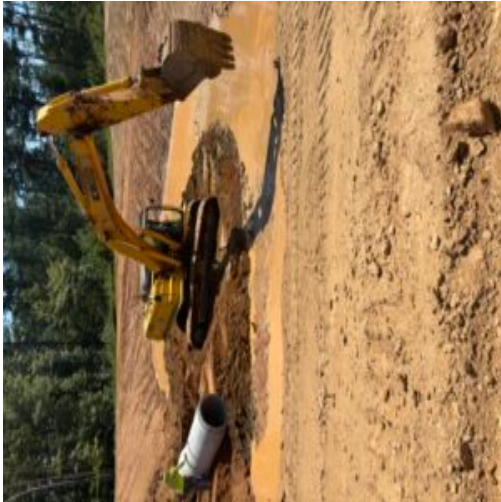
Installation of 36" rcp storm at detention pond OCS

The writer also observed the pipe contractor Savannah begin installation of 36" RCP storm line at the detention pond from outfall structure FO-STHW to F1-OCS. The contractor excavated through the existing dam embankment laying approximately 72 lineal feet of pipe. The pipe was bedded on suitable bearing residual soils.

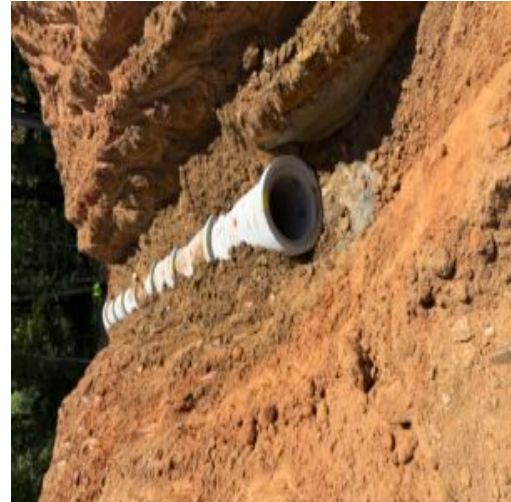
36" rcp between FO -STHW and OCS

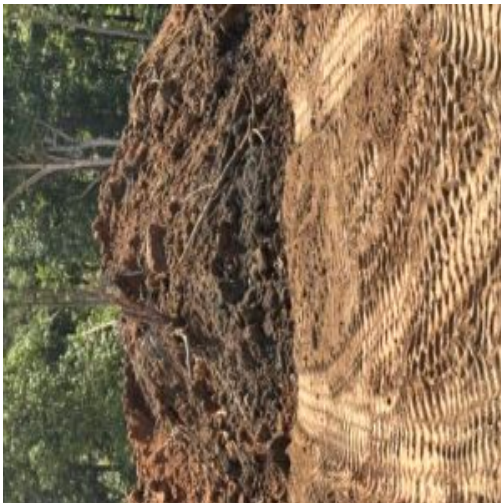
Topsoil being placed at slope embankment of pond  
and roadway

The writer observed the grading contractor Thompson continue placing a topsoil berm at the slope embankment only using a dozer to track material in place. The writer will observe installation of storm pipe through the embankment fill and determine repair measures necessary. The contractor has been informed of compaction requirements.

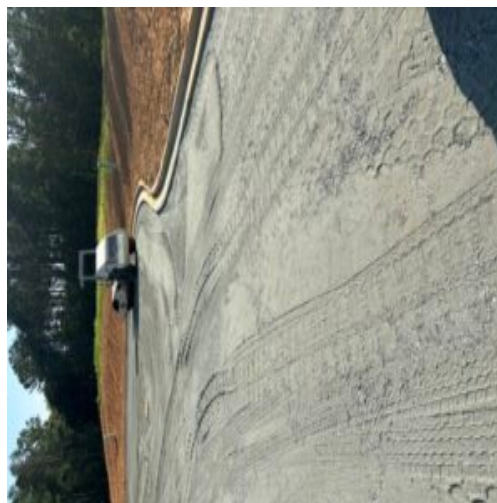
Placing sub base stone at roadway

On the above date our representative was on site to observe the paving contractor J&W continue placing base stone for the roadway to the cul-de-sac. The contractor also began to fine grade and compact base stone materials. A proof-roll for the subbase stone is scheduled for tomorrow.

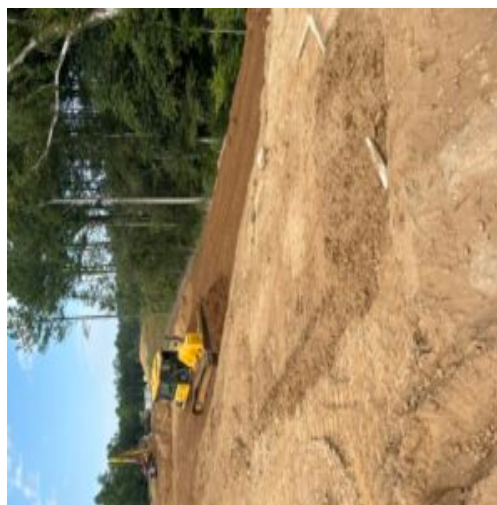
Placing fill at Slope embankment between Sanitary sewer manholes #3 and 2.

The writer also observed the grading contractor Thompson continue placing fill at the slope embankment at Naturewalk Parkway bridge abutment between manholes #3 and #2. The contractor used previous stockpiled soils having above optimum moistures with boulders with the contractor removing most of large boulders and compacting fill placement using a vibratory sheep-foot roller.
