Daily Field Report

ASEC Report ID : 58540
Name of the Project : Plant Gorgas Demolition and Grading
Project Location : 460 Gorgas Rd, Parrish, AL 35580
Weather : SUNNY
Departure Time : 04/10/2023 16:00
ASEC Technician Name : Ramchandra Mogulla

Date : 04/10/2023
Project No : 2022C235
Client Company : Jackson Demolition Service, Inc.
Arrival Time : 04/10/2023 06:00
Onsite Hours : 10:00

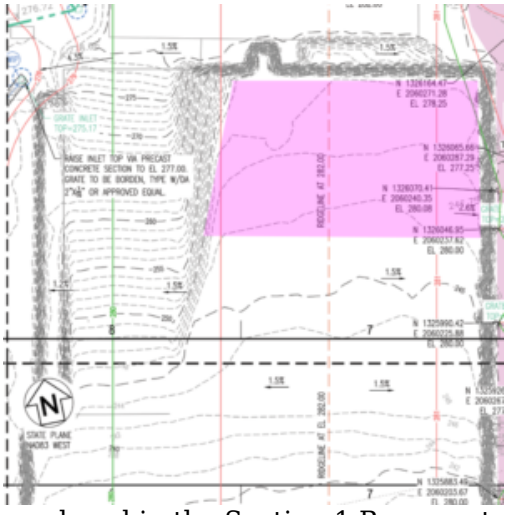
5 Lift was placed in the Section-1 Basement area B7

Compacted in the Section-2 Basement area B7
