Daily Field Report

ASEC Report ID : 69506
Name of the Project : Lakeside Sub. - Lovers Lane, Calhoun
Project Location : Calhoun
Weather :
Departure Time : 09/04/2024 17:00
ASEC Technician Name : Solomon Cherie

Date : 09/04/2024
Project No : 2023C180
Client Company : Artisan Communities
Arrival Time : 09/04/2024 08:00
Onsite Hours : 9:00

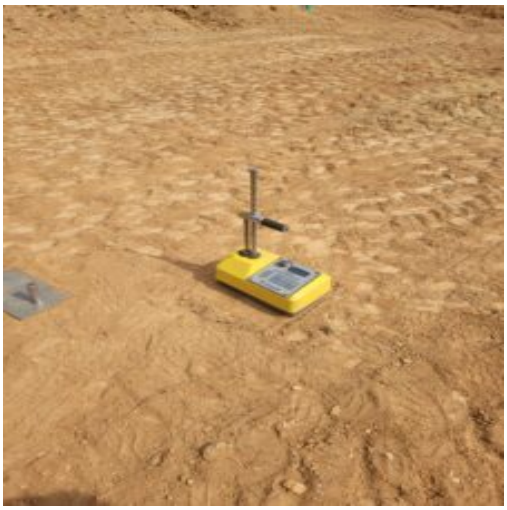
The machine and the model doing soil.compaction
