Daily Field Report

ASEC Report ID : 97451
Name of the Project : NW Unit 4 Parkway Ext. Phase 1
Project Location : Dallas
Weather : Sunny
Departure Time : 09/04/2026 16:00
ASEC Technician Name : Clyde Smith

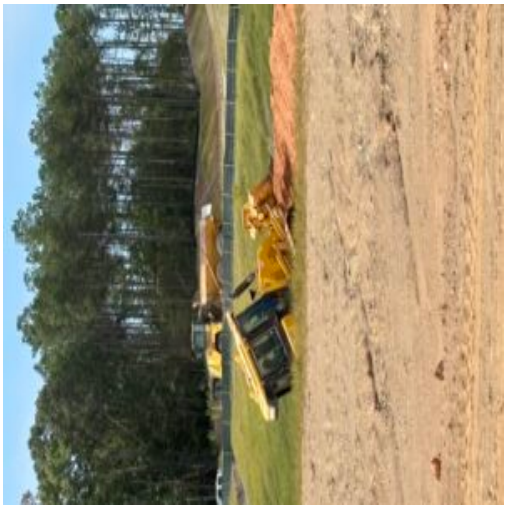
On the above date our representative was on site to observe the grading contractor continue subgrade preparation at NatureWalk Parkway between sanitary sewer manholes #3 and 2. The subgrade was proof-rolled after completion using a loaded off-road rock dump truck. The subgrade appeared stable under traffic but also will be reobserved prior to subbase placement using a loaded tandem duck truck. The contractor also continued repairing eroded reels at Unit 4 phase 2.

Repairing eroded reels at Unit 4 phase 2
