Date : 06/09/2023  
Project No : 2022C235  
Client Company : Jackson Demolition Service, Inc.  
Arrival Time : 06/09/2023 06:00  
Onsite Hours : 10:30

ASEC Report ID : 59667  
Name of the Project : Plant Gorgas Demolition and Grading  
Project Location : 460 Gorgas Rd, Parrish, AL 35580  
Weather : SUNNY  
Departure Time : 06/09/2023 16:30  
ASEC Technician Name : Avinash Bandham

AS ENGINEERING AND CONSULTING, LLC (ASEC) representative Avinash Bandam visited the site at the request of Jackson Demolition representative Josh Kelly. The undersigned representative was present to monitor, verify and document the ongoing project activities. (reference drawing E720661 S1 - R8, E720659 S1-R8.)

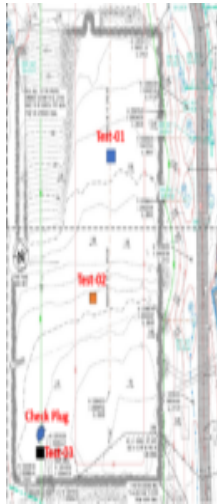
1. One thousand (1134) cubic yards of fill materials were placed for lift (13) in section 2 part 2 area G7 of the second part (drawing E720659) of the basement. The materials were placed in accordance with ITP-001, and the fill area is highlighted in brown as depicted in the attached drawing.
2. The area was probed, and three moisture density tests were performed in the basement, section 1 basement area B7 and in section 2 basement area G7. The attached drawing depicts the approximate test locations.
