Date : 09/11/2023  
Project No : 2022C235  
Client Company : Jackson Demolition Service, Inc.  
Arrival Time : 09/11/2023 06:00  
Onsite Hours : 10:30

ASEC Report ID : 61447  
Name of the Project : Plant Gorgas Demolition and Grading  
Project Location : 460 Gorgas Rd, Parrish, AL 35580  
Weather : SUNNY  
Departure Time : 09/11/2023 16:30  
ASEC Technician Name : Avinash Bandham

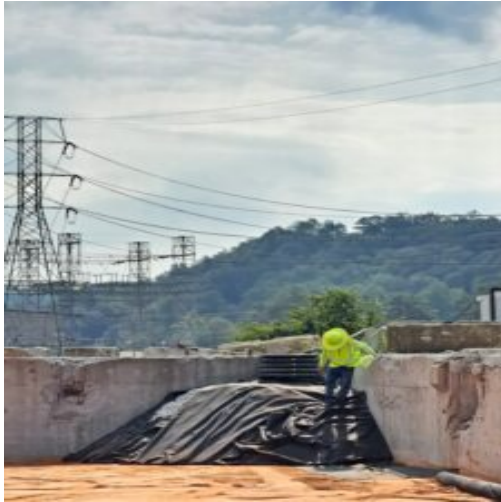
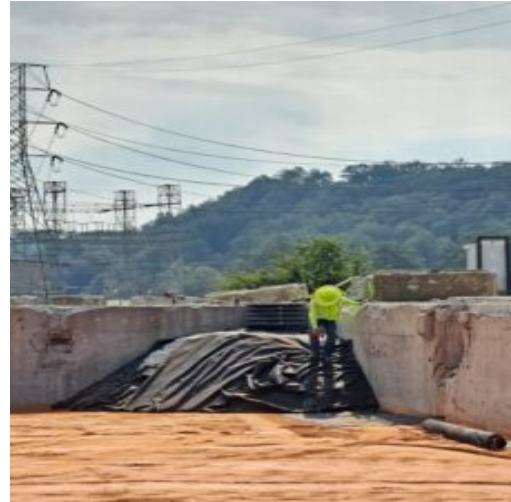
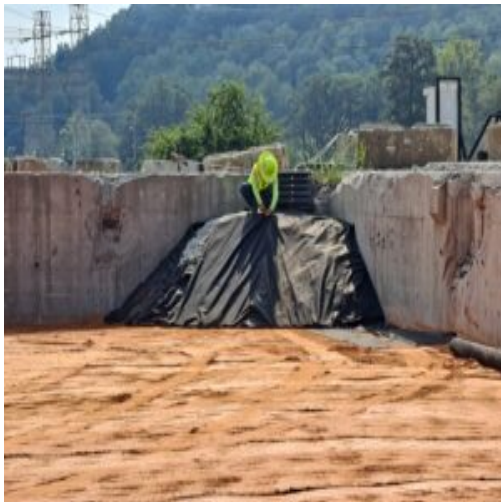
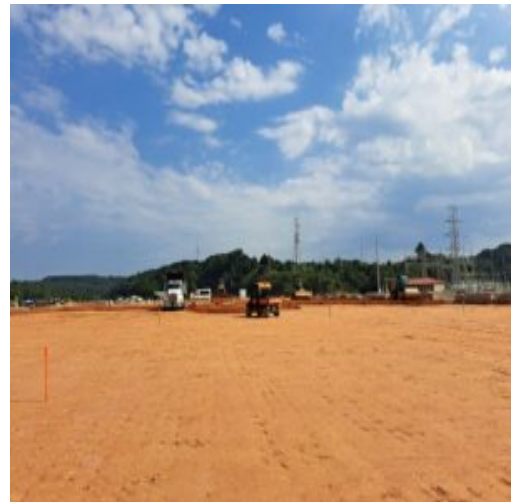
1. Three thousand five hundred and sixty-four (3564) cubic yards of structural-fill materials were placed for lift (6) in section 1 basement area B7 (E720661 S1-R8) and for lift (6) in section 2 basement are G7(E720659 S1-R8). The materials were placed and compacted in accordance with ITP-001, and the fill area is highlighted in brown as depicted in the attached drawing.

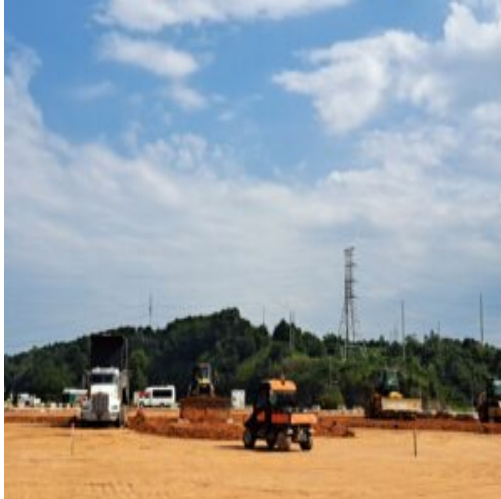
Placement of structural fill material in section 2  
basement area
