Date : 08/01/2023  
Project No : 2023C144  
Client Company : CCG  
Arrival Time : 08/01/2023 08:30  
Onsite Hours : 08:30

ASEC Report ID : 60724  
Name of the Project : Carodel Farms @ Union Church Rd  
Project Location : Flowery Branch  
Weather : Cloudy  
Departure Time : 08/01/2023 17:00  
ASEC Technician Name : Vidal Shengan

On 08-01-2023, the AS Engineering and Consulting (ASEC) representative visited the Carodel Farms site to conduct quality control inspection and testing services. Visual observation techniques were employed to ensure compliance with project drawing/specifications, applicable codes, and materials submittals. The following observations were made on-site:

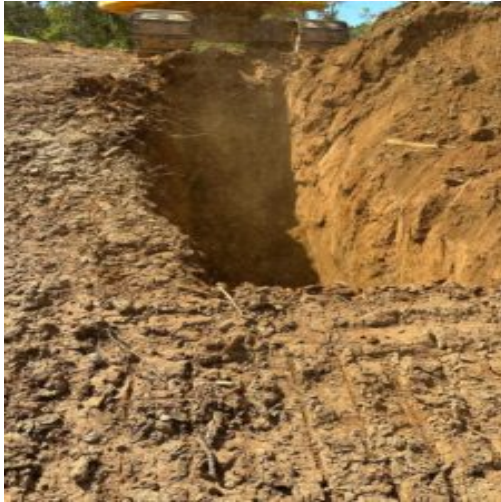
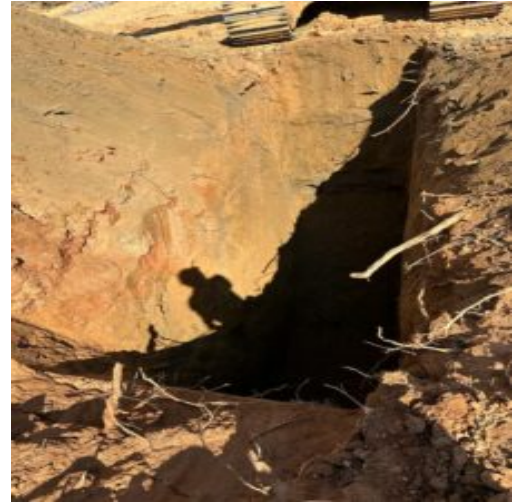
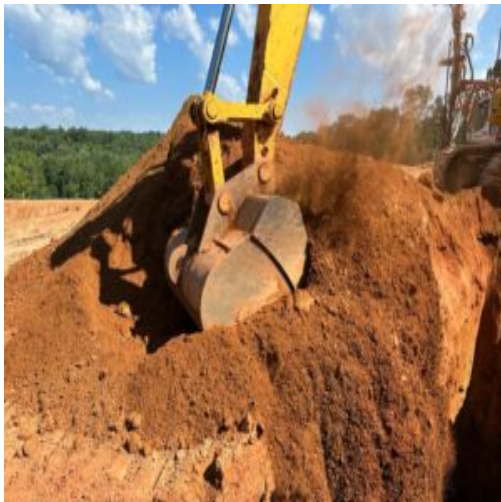
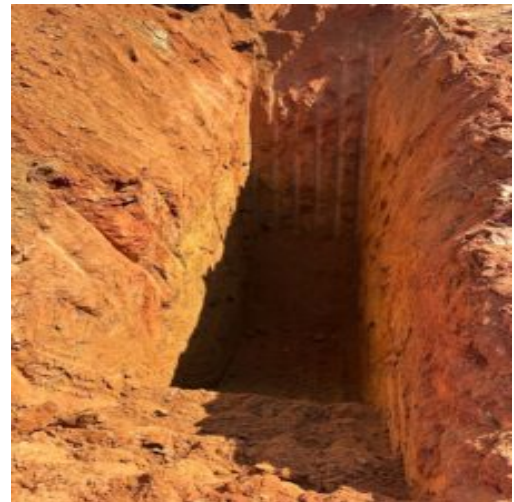
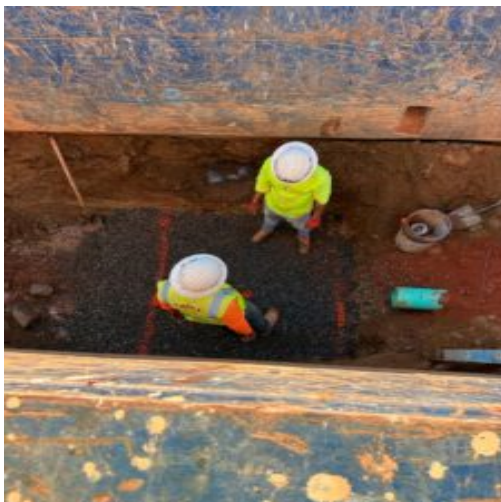
1. Installation of Manhole A-9: The contractor installed Manhole A-9 with 4" stone (057) at the bottom before placing the manhole. The quality control representative visually inspected the installation and noted that it met the project requirements.

2. Installation of HDPE Pipe: Between Manhole A-8 and Manhole A-9, the contractor installed HDPE (High-Density Polyethylene) pipe. Before placing the pipes, the contractor prepared the bottom with 4" stone and also covered the pipes with 4" stone. The quality control representative visually assessed the installation and confirmed that it was performed according to the project specifications.

3. Drilling Operations: We recommended to the contractor to do excavate a few pit tests on Lots 60 through 68 near the road to determine the exact mass of rocks in this area so as not to let the driller do unnecessary work and save time. No appreciable rock was encountered in these areas. Contractor then began to lay pipe within the street.
